BRIDGE NO.04671

33900 - GRISWOLD
CARROLL ROAD
over
PACHAUG RIVER

Routine and Underwater Inspection

4/14/2021

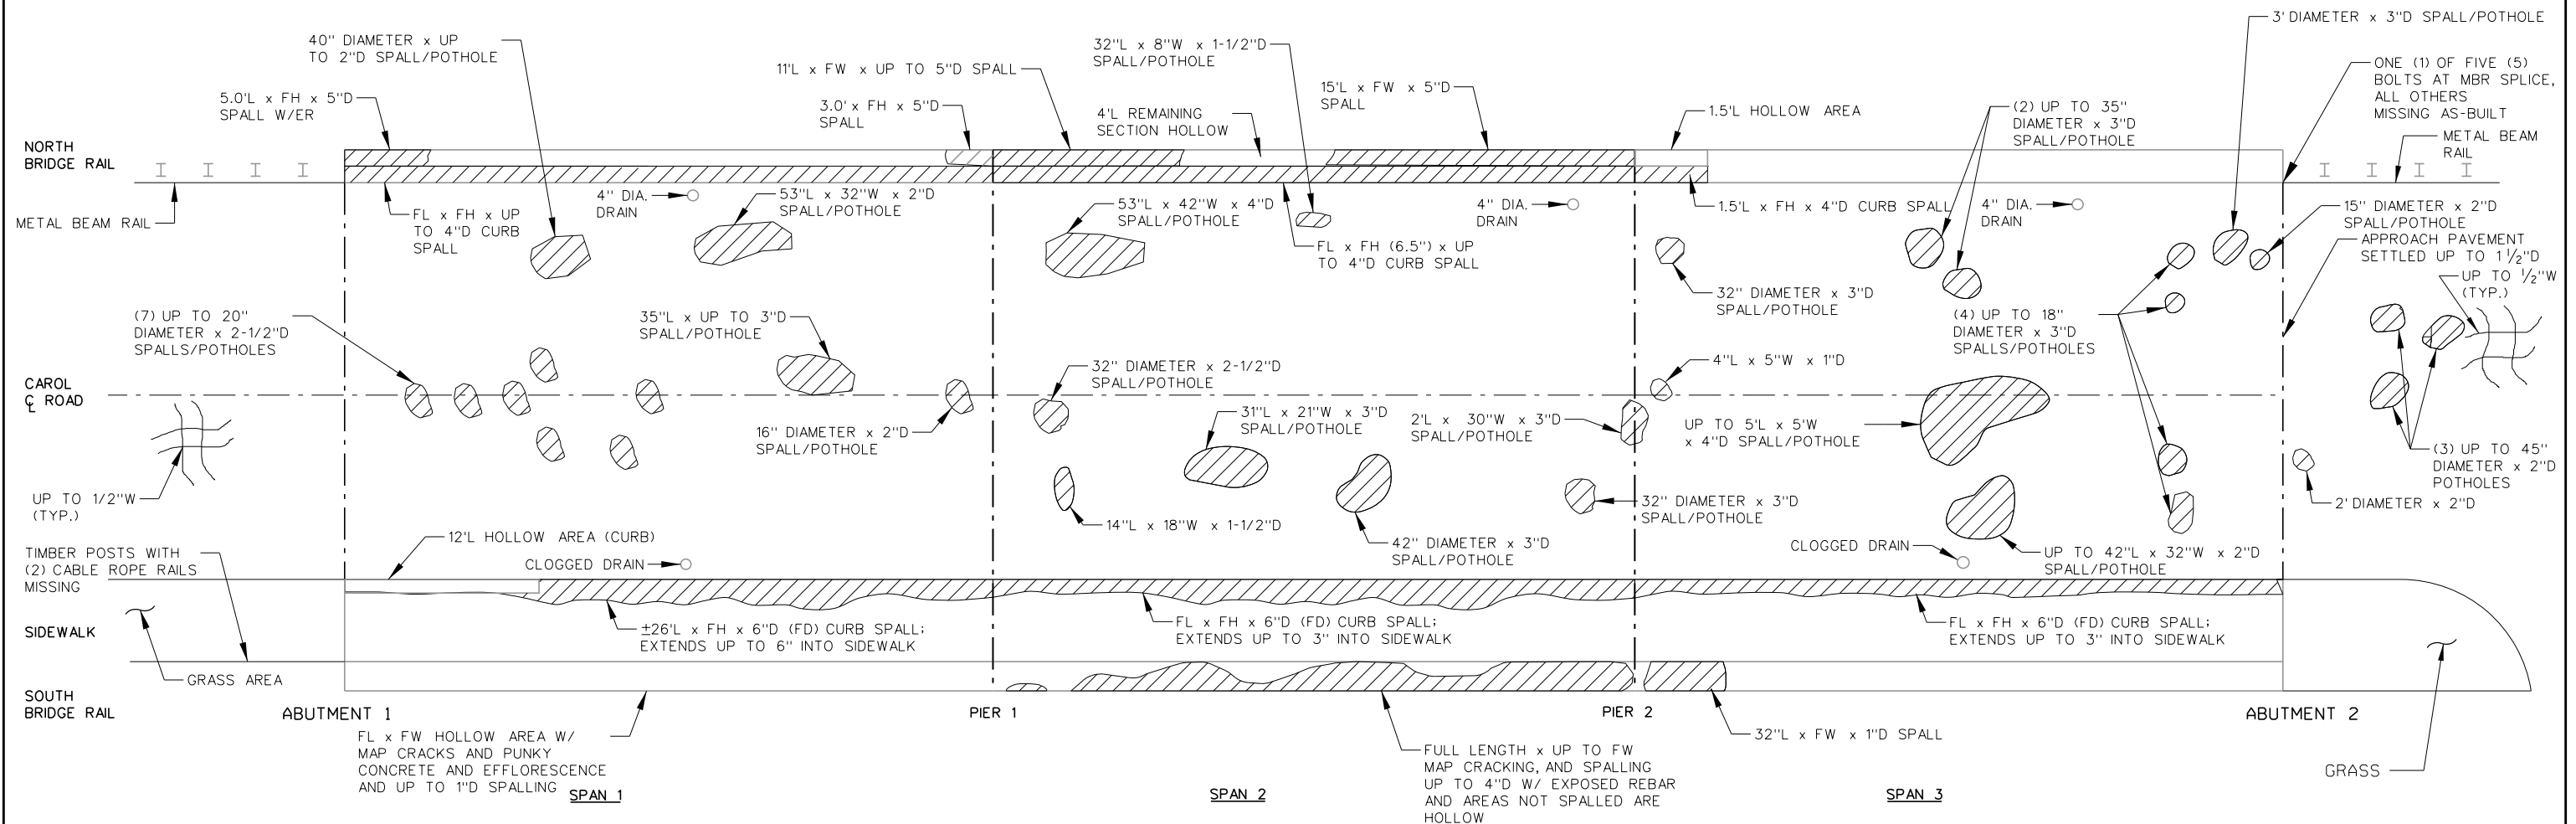
Overlay: 3	The bituminous concrete overlay in Spans 1, 2 & 3 has the following deficiencies: <ul style="list-style-type: none"> • Overlay is ± 1-1/2" thick, uneven and covered with sand. • Overlay is dull / hollow sounding. • Random bituminous patches with punky concrete and deteriorating bituminous up to 1" deep throughout. • Potholes throughout up to 5' long x 5' wide x up to 4" deep (any pothole greater than 1-1/2" deep are also spalls in the top of deck). <p>(See Sketch 2 and Photos 8 - 11)</p>
Deck - Str. Condition: 3	Refer to 'Girders' item below.
Curbs: 3	The right (south) curb is monolithic with the sidewalk. The left and right concrete curbs have the following deficiencies: <ul style="list-style-type: none"> • Spalling / severe scale up to full length x full height x full depth (6" deep) throughout. • Right curb spalls extend up to 6" into the concrete sidewalk. <p>Average curb reveals (taken at remaining curb areas): Left curb: 7" Right curb: 8"</p> <p>(See Sketch 2 and Photos 12 - 15)</p>

1. BITUMINOUS OVERLAY IS UNEVEN AND COVERED WITH SAND, OVERLAY IS $\pm 1\frac{1}{2}$ " THICK, ANY POTHOLE $> 1\frac{1}{2}$ " DEEP IS ALSO A SPALL IN THE DECK. OVERLAY IS TYPICALLY DULL/HOLLOW SOUNDING WITH RANDOM PATCHES/PUNKY CONCRETE AND TRANSVERSE AND HORIZONTAL CRACKS UP TO $\frac{1}{4}$ " WIDE IN ALL SPANS. POTHOLES PATCHED W/ DETERIORATING BITUMINOUS THROUGHOUT.

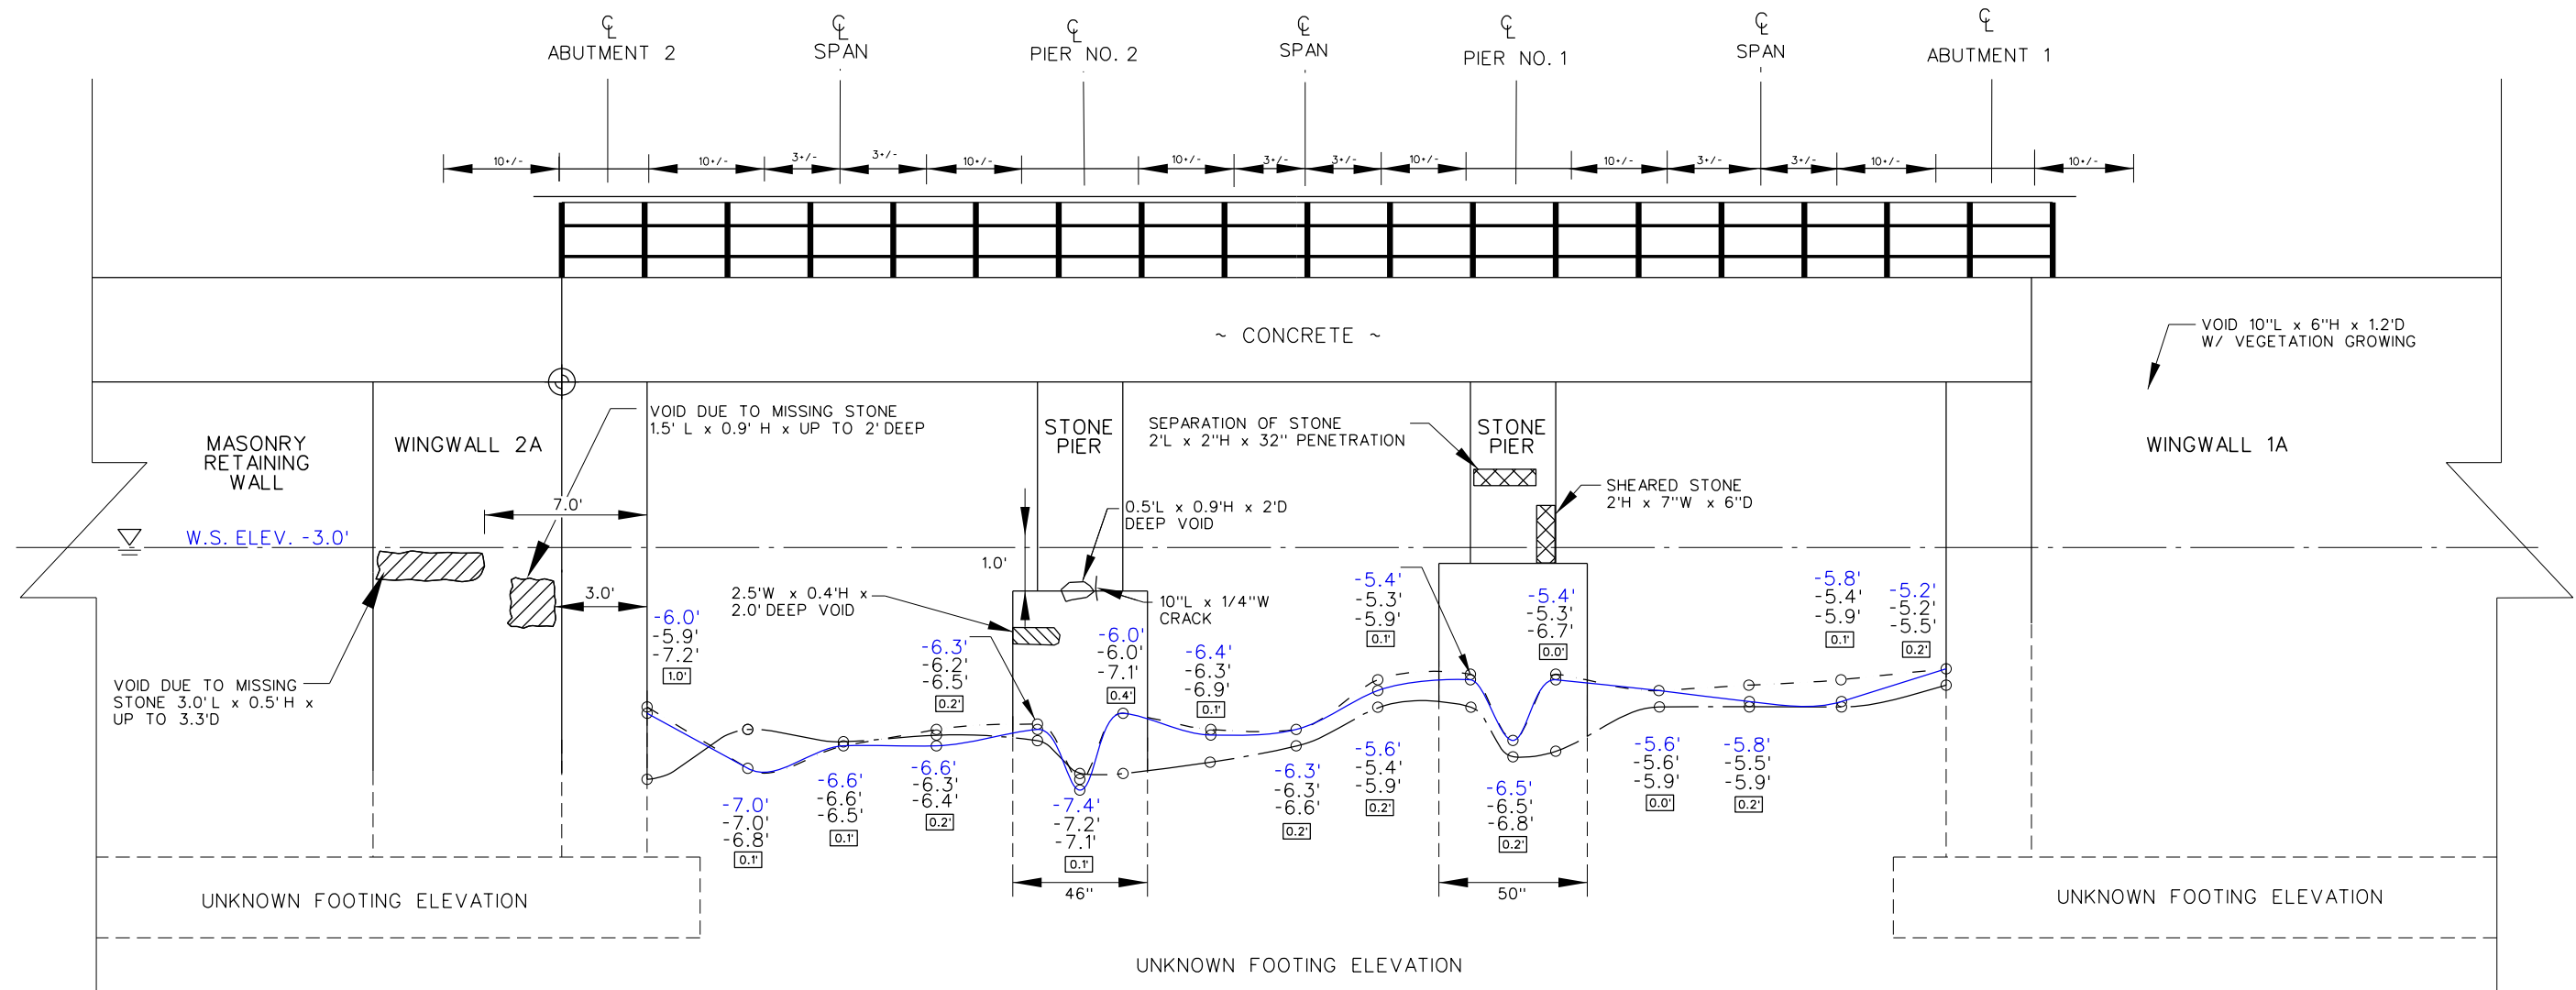
UW DRAWING 2

- MISSING CRACKED MORTAR AND CHINKING STONES, UP TO 50% EXTENDING FROM 1.0' ABOVE THE WATERLINE TO THE CHANNEL BOTTOM. PENETRATION UP TO 30".
- MASONRY JOINT AT WATER SURFACE AT NORTH END OF ABUTMENT IS OPEN 8"L.
- RANDOM VOIDS AT WINGWALL 1A UP TO 8"L x 8"H x 2"D.
- TREE UP TO 10" DIAMETER GROWING OUT OF WINGWALL 1B.
- SEVERAL VOIDS HAVE BEEN PATCHED AND SOME MASONRY HAS BEEN REPOINTED.
- RANDOM CRACKS UP TO 3'L x 1/4"W.

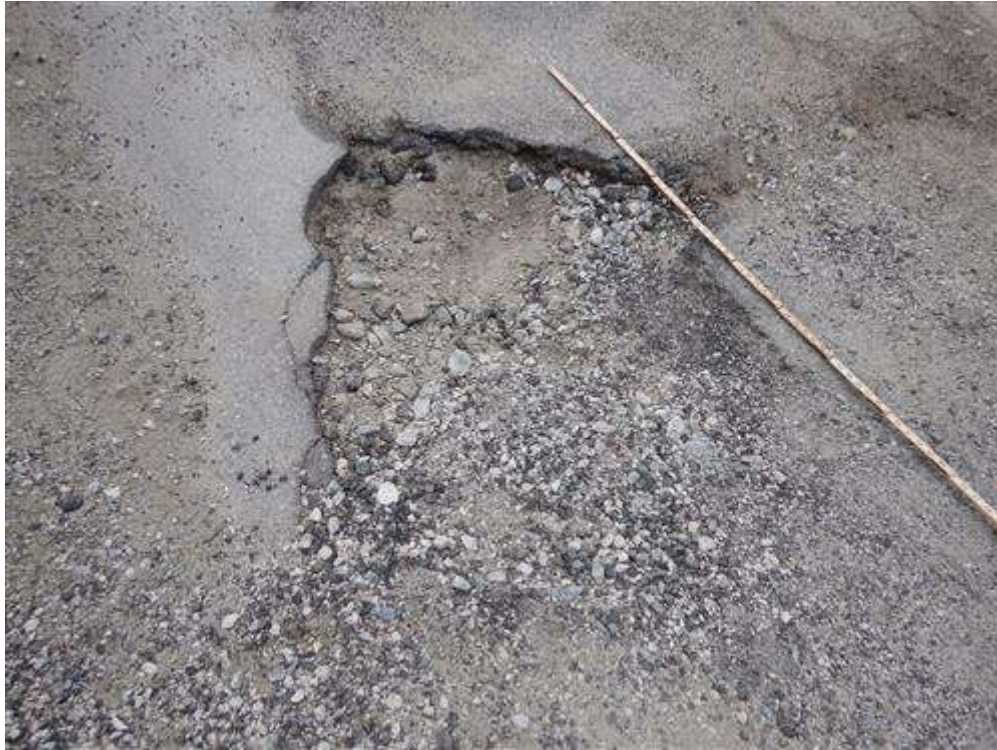
Photo Number: 9

Span 2 Overlay Near Left (North) Curb

Note: Pothole / spall.

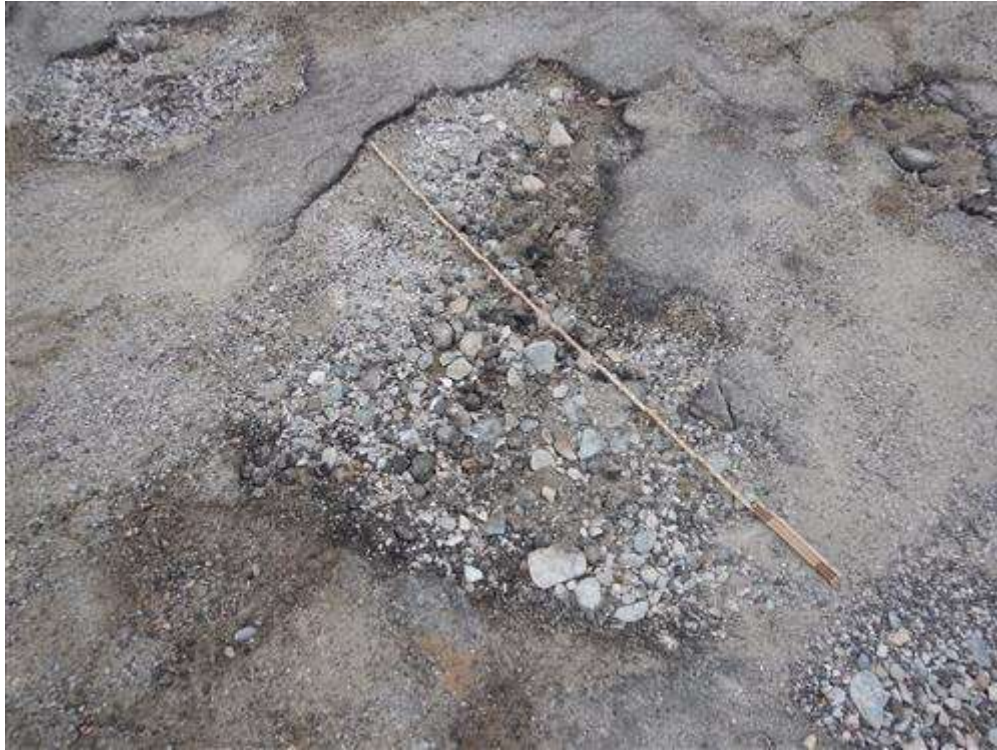
Photo Number: 11

Span 3 Overlay Near Right (South) Curb

Note: Pothole / spall.

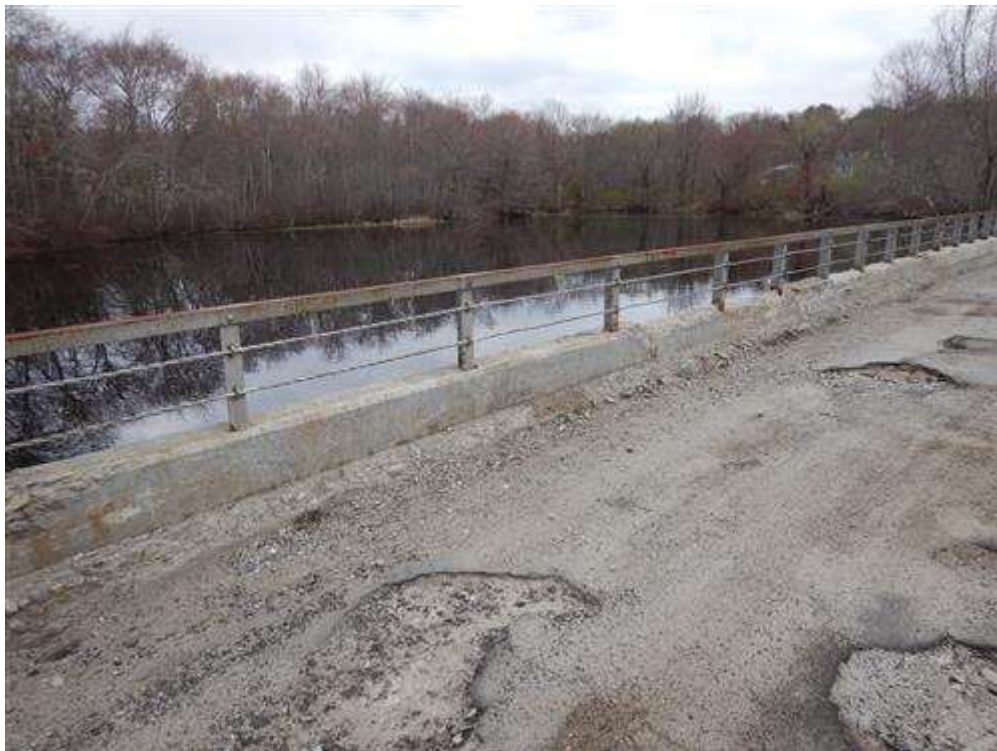
Photo Number: 12

Median: N	
Sidewalks: 4	The right (south) concrete sidewalk has the following deficiencies: <ul style="list-style-type: none"> • Covered with sand and gravel. • Heavy debris accumulations. • Hollow areas throughout with up to 1-1/2" deep spalls with punky concrete x full length of bridge. • Areas of severe scale greater than 1" deep throughout with loose concrete along the edges. <p>Refer to 'Curbs' item above.</p> <p>(See Sketch 2 and Photos 13 & 15)</p>
Parapet: 3	The reinforced concrete parapets have the following deficiencies:

Left (North) Curb, Parapet and Bridge Rail

Note: Extensive spalling.

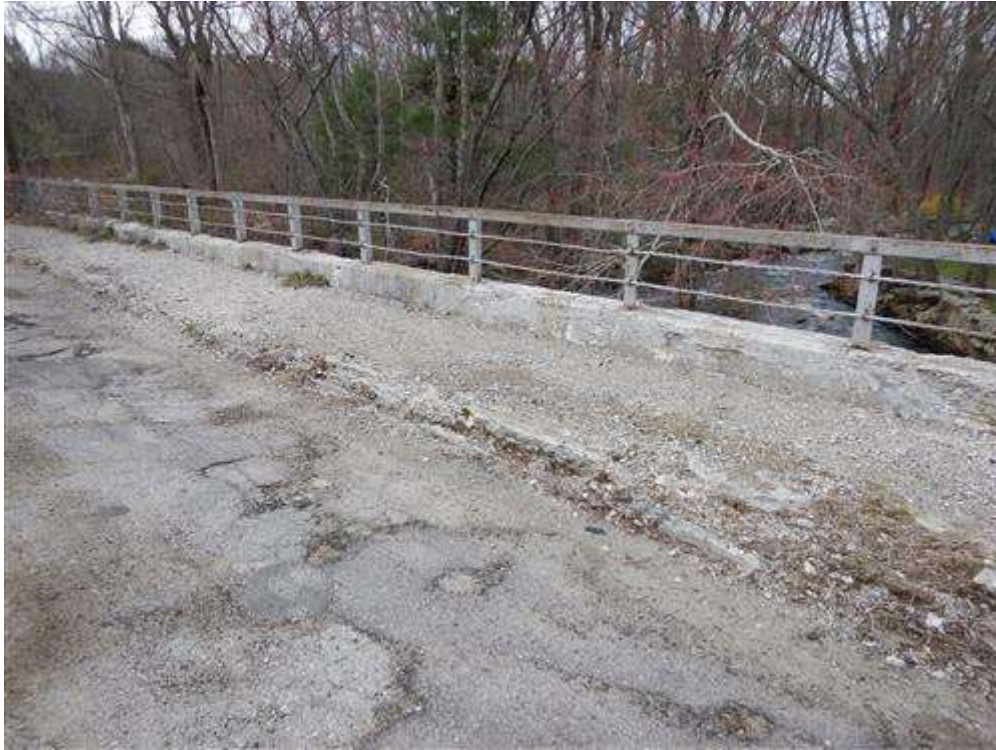
Photo Number: 13

Right (South) Curb, Sidewalk, Parapet and Bridge Rail

Note: Extensive spalling.

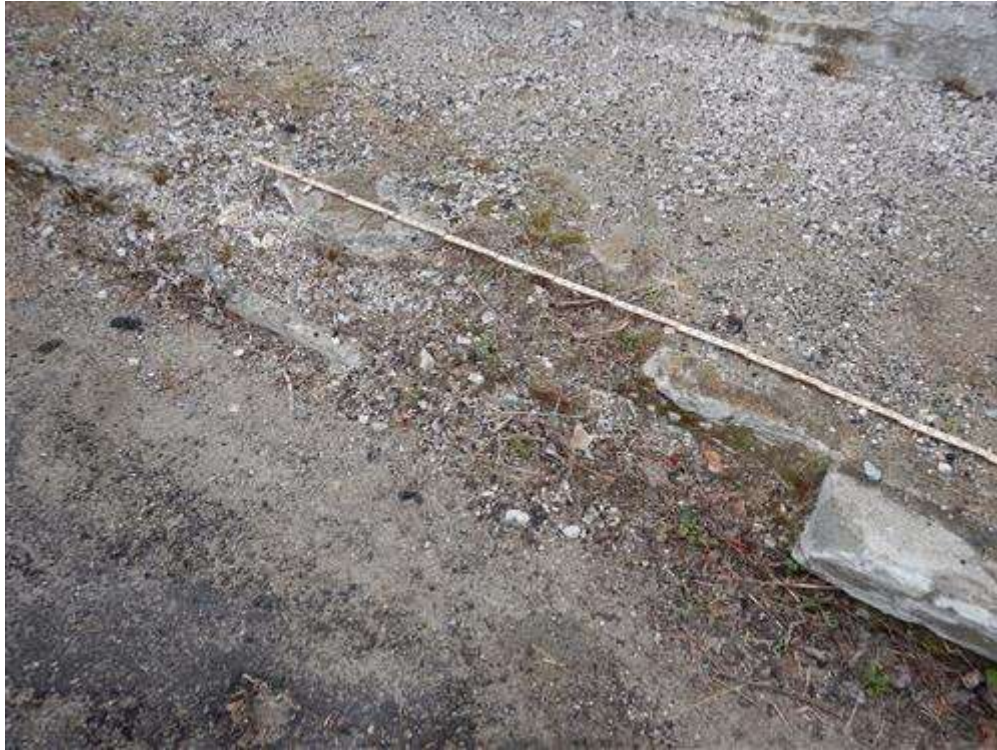
Photo Number: 15

Right (South) Curb in Span 1 - Typical

Note: Up to 6" deep (full depth) spalling extending into sidewalk.

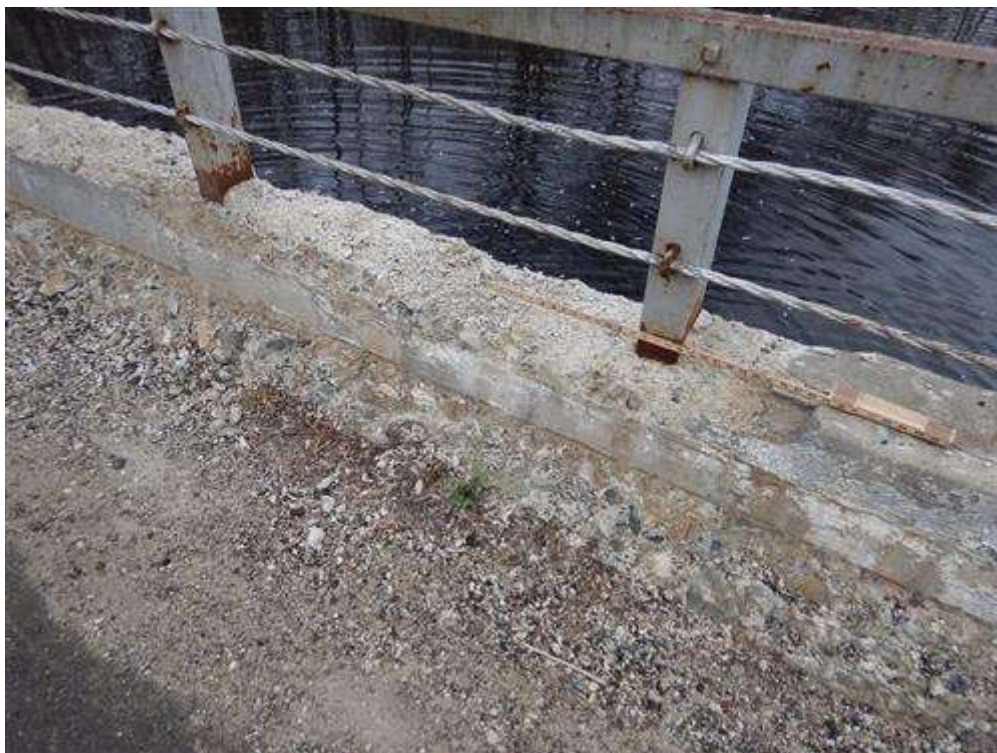
Photo Number: 16

Left (North) Parapet in Span 2

Note: Up to 5" deep spall.

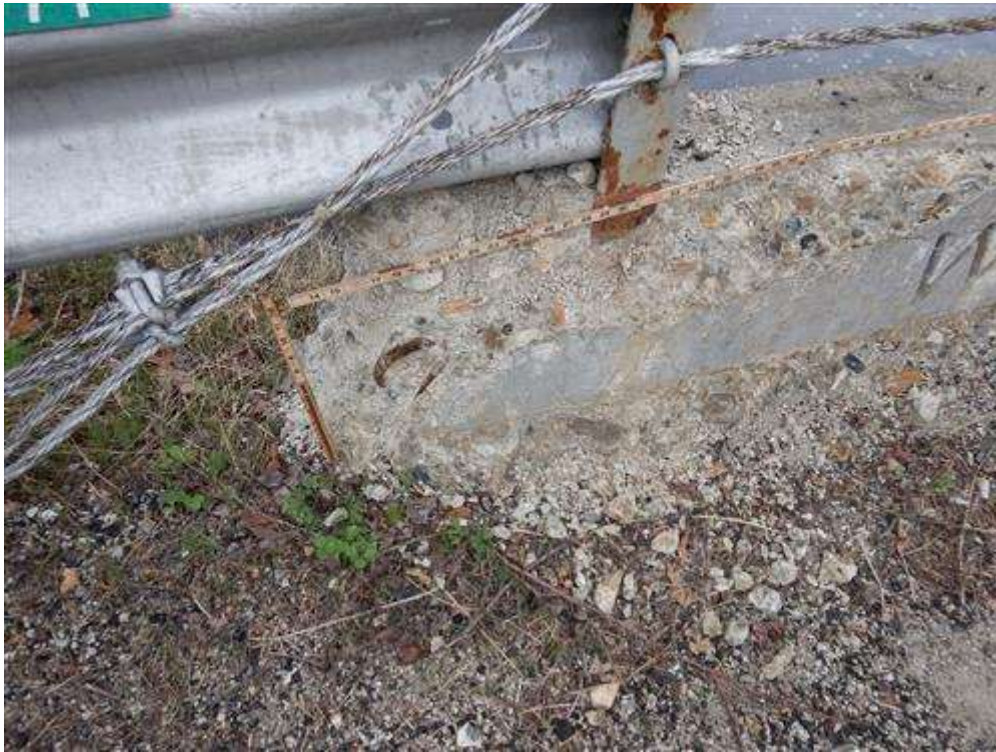
Photo Number: 17

Left (North) Parapet at Abutment 1

Note: 5' long x full height x 5" deep spall with exposed rebar.

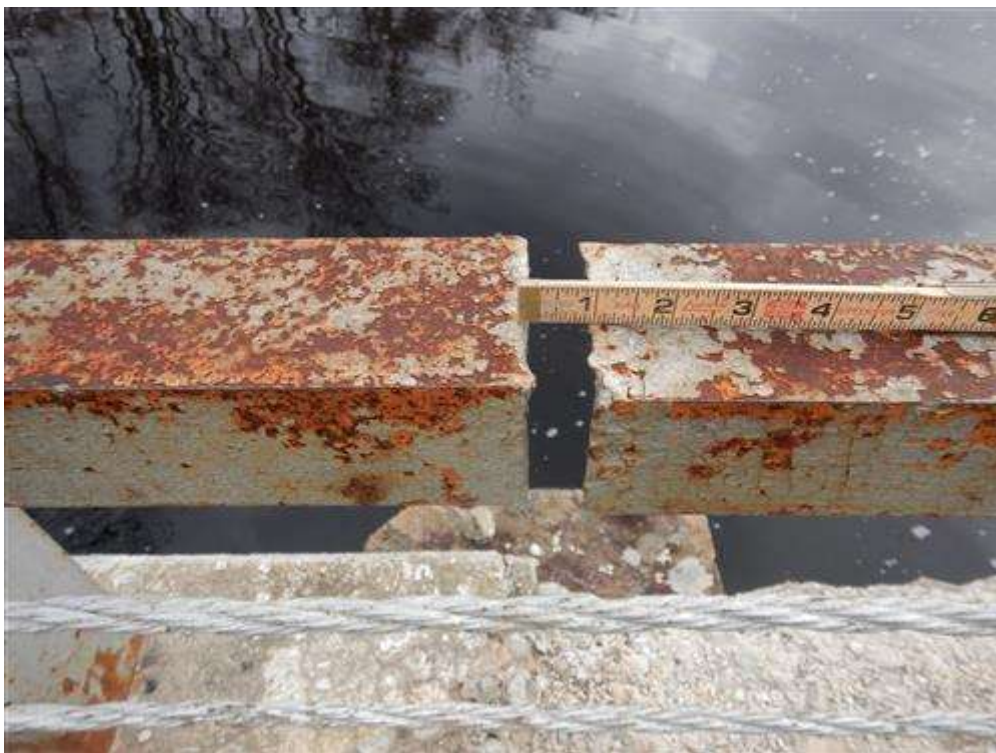
Photo Number: 18

- Peeling paint throughout.
- Chips, scrapes and light rust throughout.
- Welded splices in the top rail are cracked at Pier 1, left and right rails, and at Pier 2, right rail only.

Left (North) Metal Bridge Rail at Pier 1

Note: Cracked / broken weld.

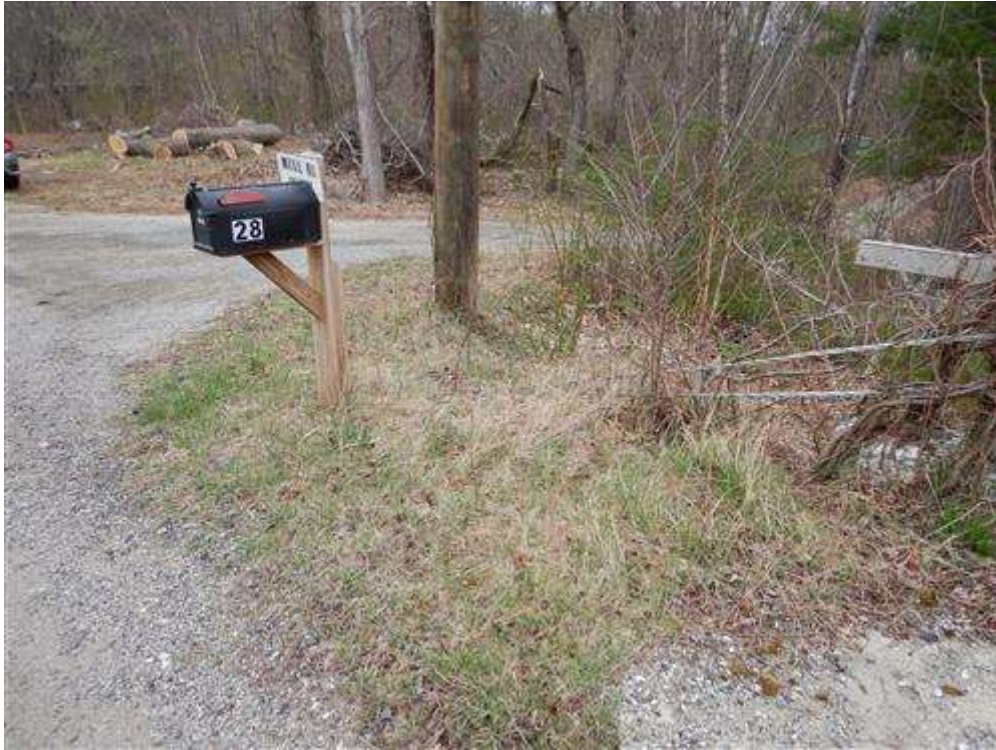
Photo Number: 23

Approach Guide Rail: 4 The Southeast approach has no guide rail installed. The Southwest approach has a two-cable guide rail mounted on timber posts. The Northwest and Northeast approaches have metal beam guide rails on steel posts. The Southwest, Northwest and Northeast guide rails have the following deficiencies:

Southeast Approach

Note: No guide rail.

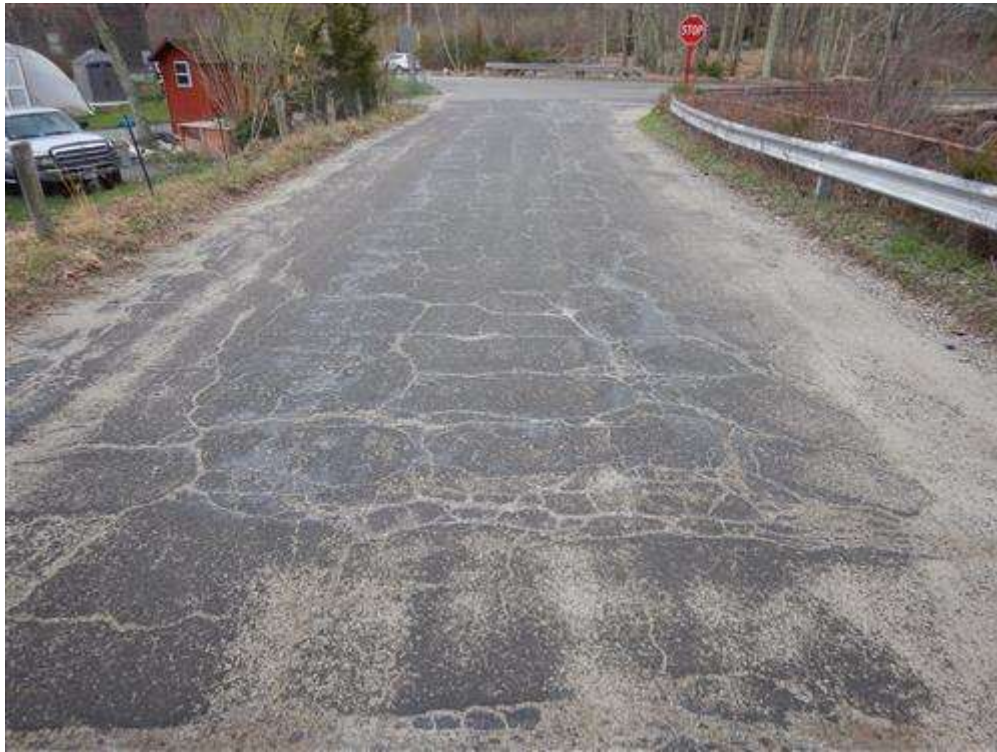
Photo Number: 25

West Approach Pavement

Note: Map cracking.

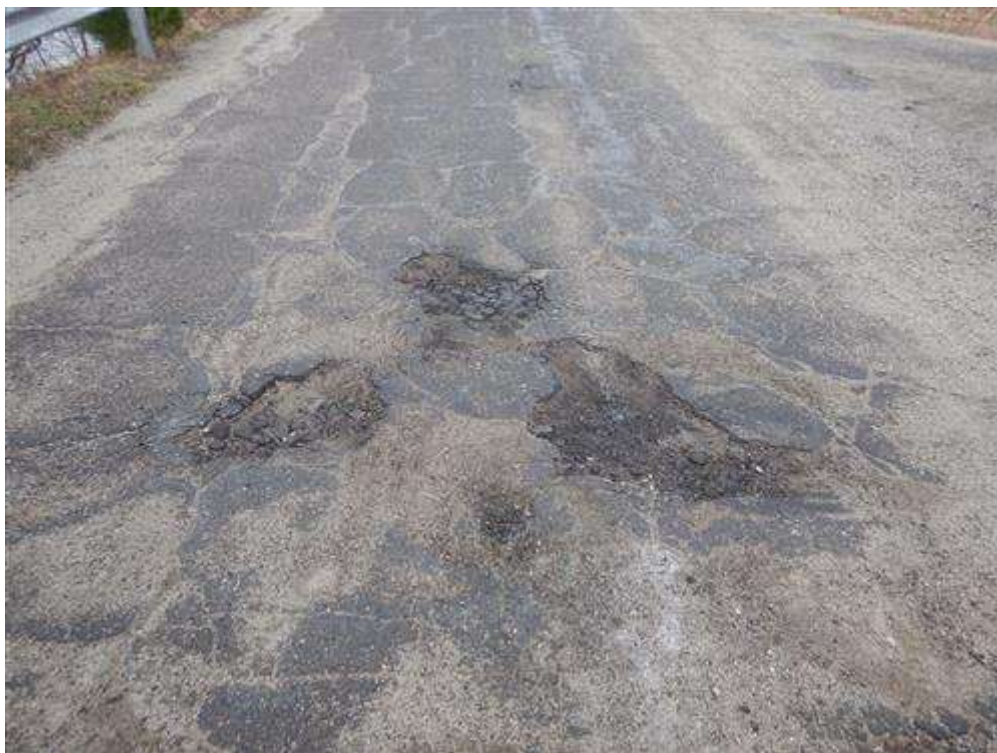
Photo Number: 26

- Map cracking up to 1/2" wide throughout.
- East approach has (4) potholes up to 45" diameter x 2" deep.
- East approach pavement is settled 1-1/2" at the bridge

East Approach Pavement

Note: Potholes, map cracking, and sand accumulation.

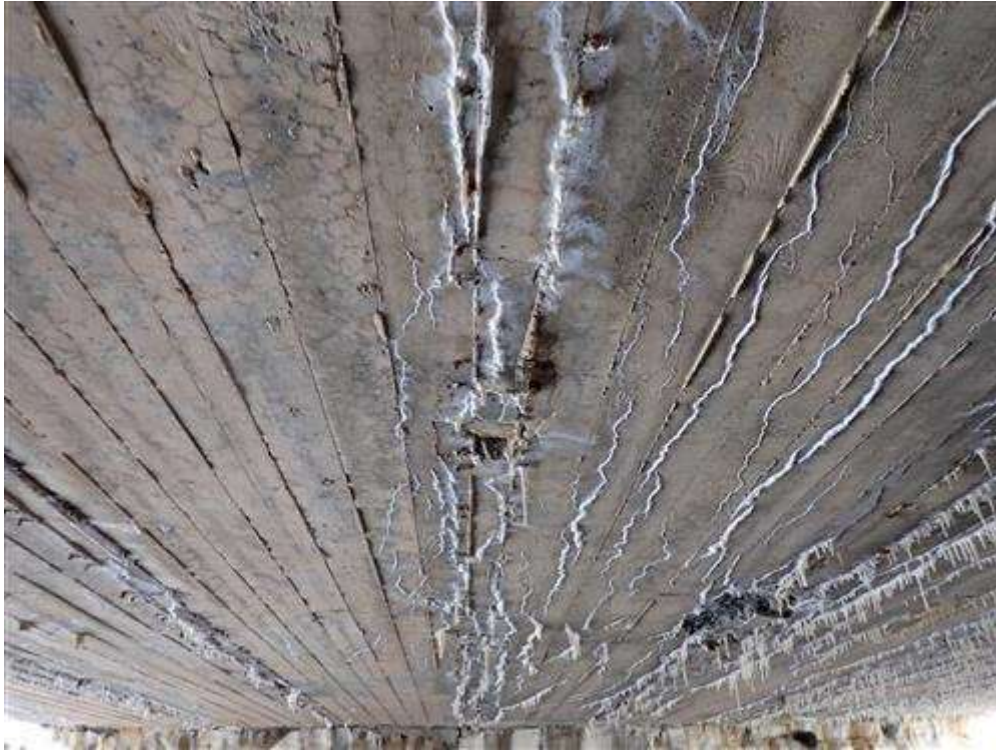
Photo Number: 27

Underside of Deck, Span 1 - Typical

Note: Longitudinal cracks with efflorescence and stalactites, spalls with exposed rebar with section loss.

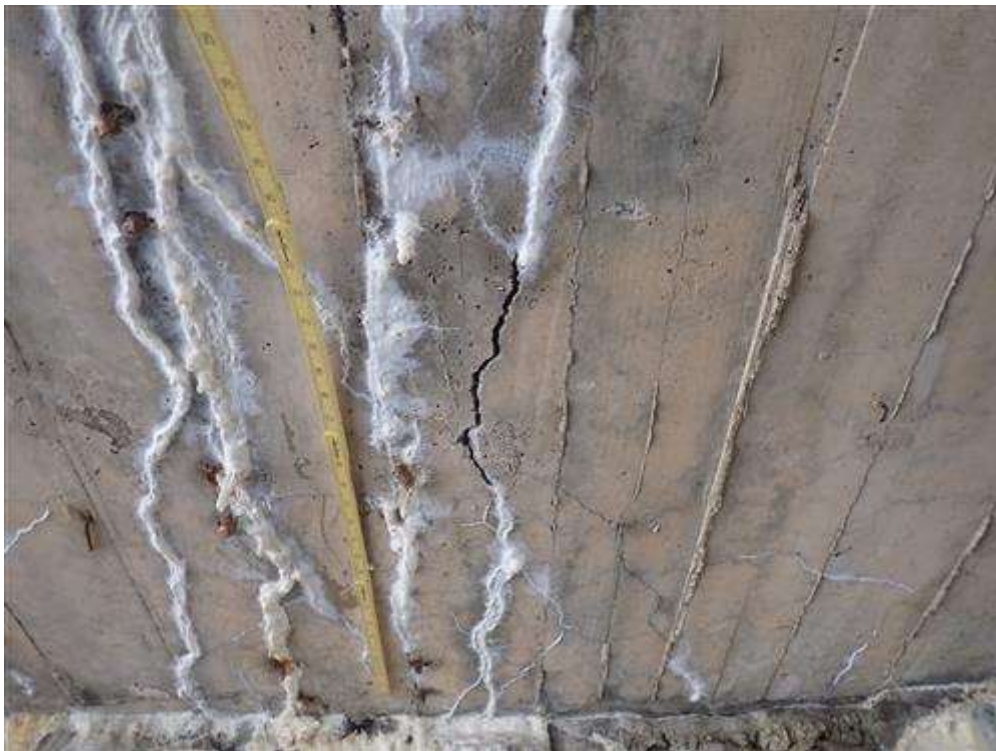
Photo Number: 28

Underside of Deck, Span 1

Note: Full length x up to 3/16" wide longitudinal crack and map cracking with efflorescence.

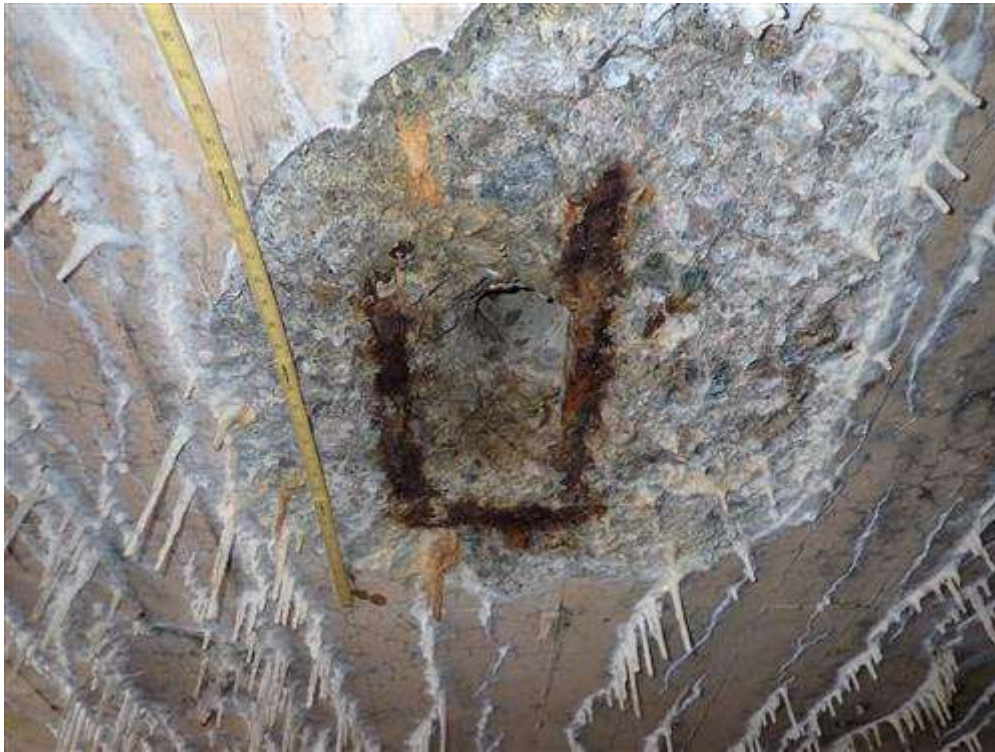
Photo Number: 29

- Spalls up to 3'-4" long x up to 2' wide x 3" deep around deck drains with punky concrete, exposed rebar with rust and up to 30% section loss.

Underside of Deck, Span 1

Note: Spall with exposed rebar with section loss around drain.

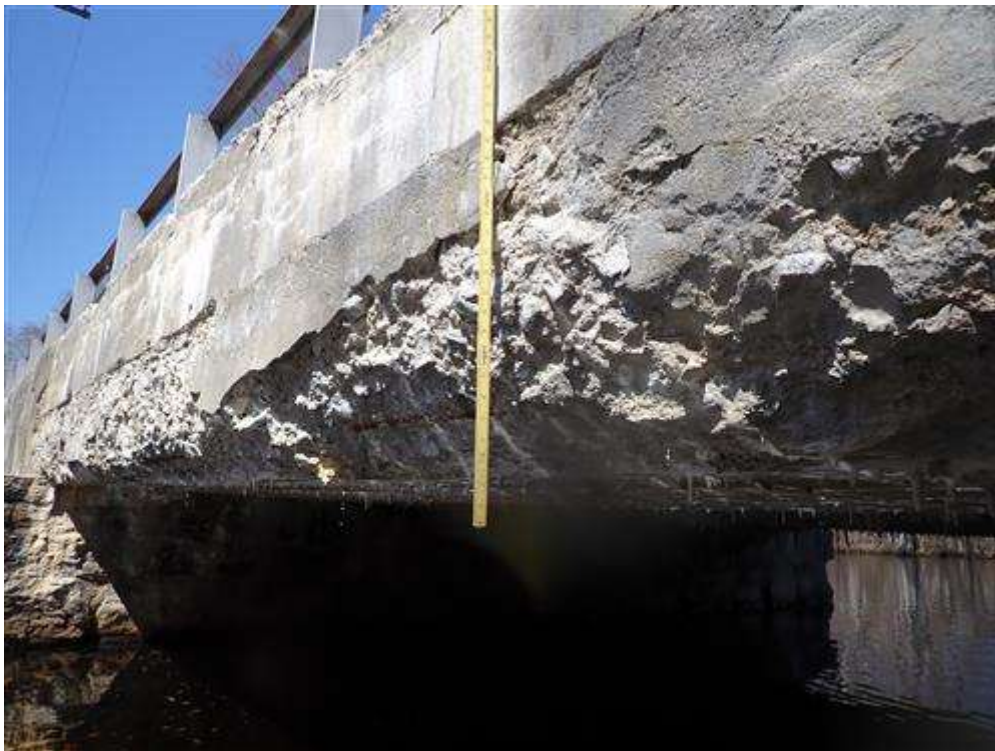
Photo Number: 30

Deck, Span 2 at Downstream (South) Fascia

Note: Full length spall/hollow area with punky concrete, efflo. and exposed debonded rebar with section loss.

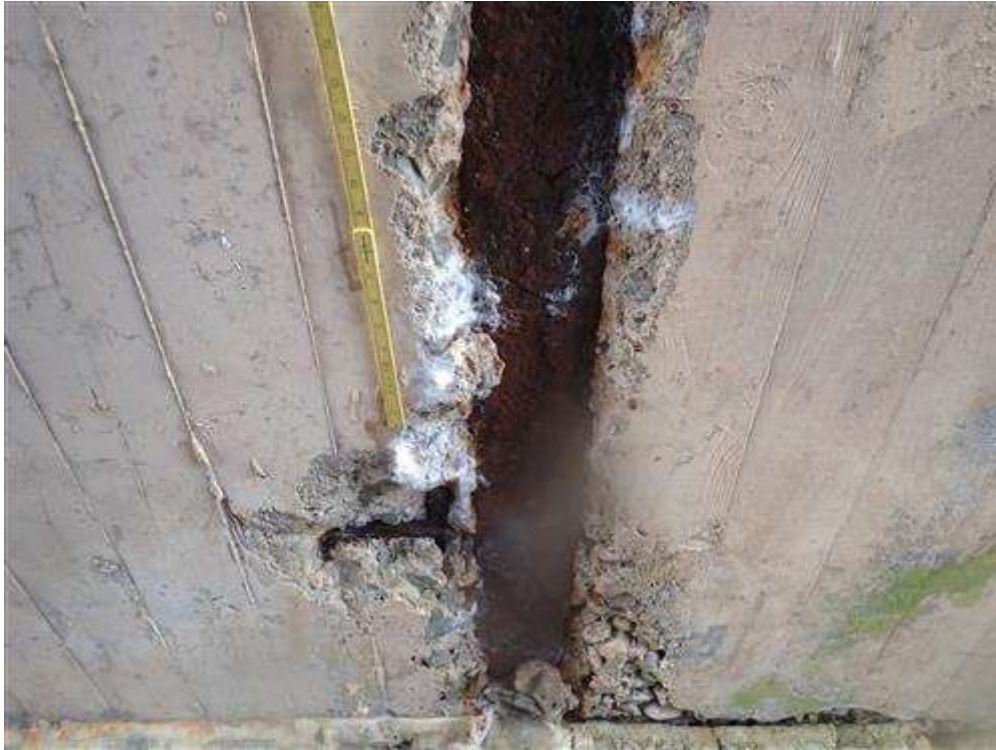
Photo Number: 31

- Spalls and hollow areas up to full span length x up to 3'-3" wide x up to 3" deep with and without punky concrete, exposed rebar with laminated rust and up to 100% section loss, steel beam bottom flanges with up to laminated rust with up to 1/4" thick steel remaining (original flange thickness unknown).

Underside of Deck, Span 2

Note: Spall with bottom flange exposed with rust & section loss and exposed rebar with section loss.

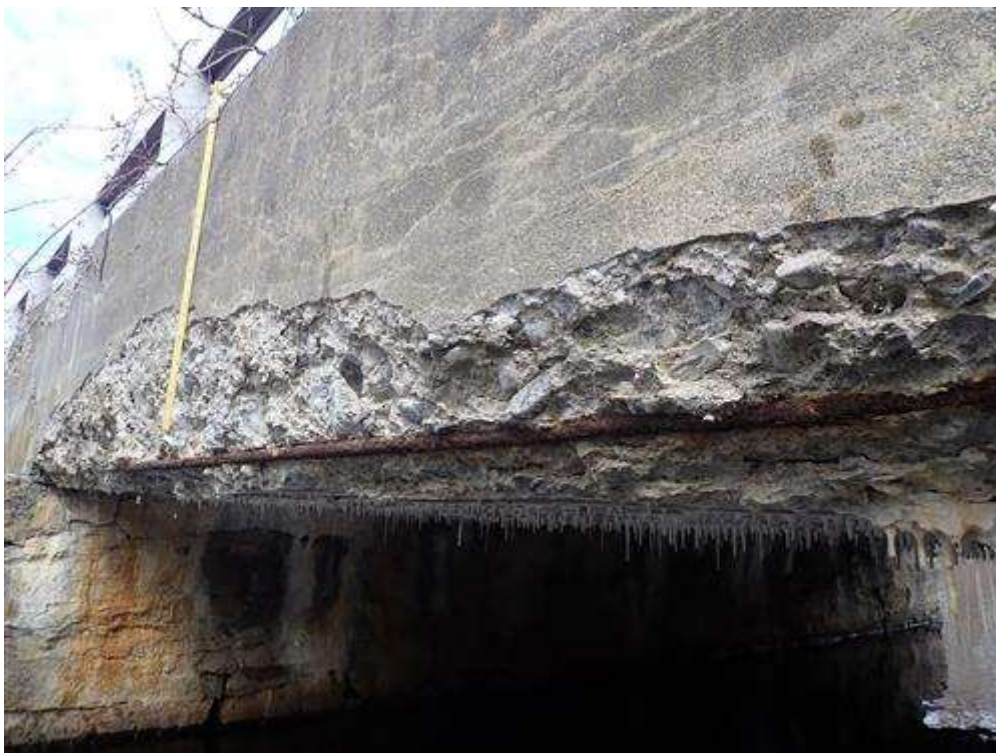
Photo Number: 32

Deck, Span 3 at Upstream (North) Fascia

Note: Spall/hollow area with exposed debonded rebar with section loss.

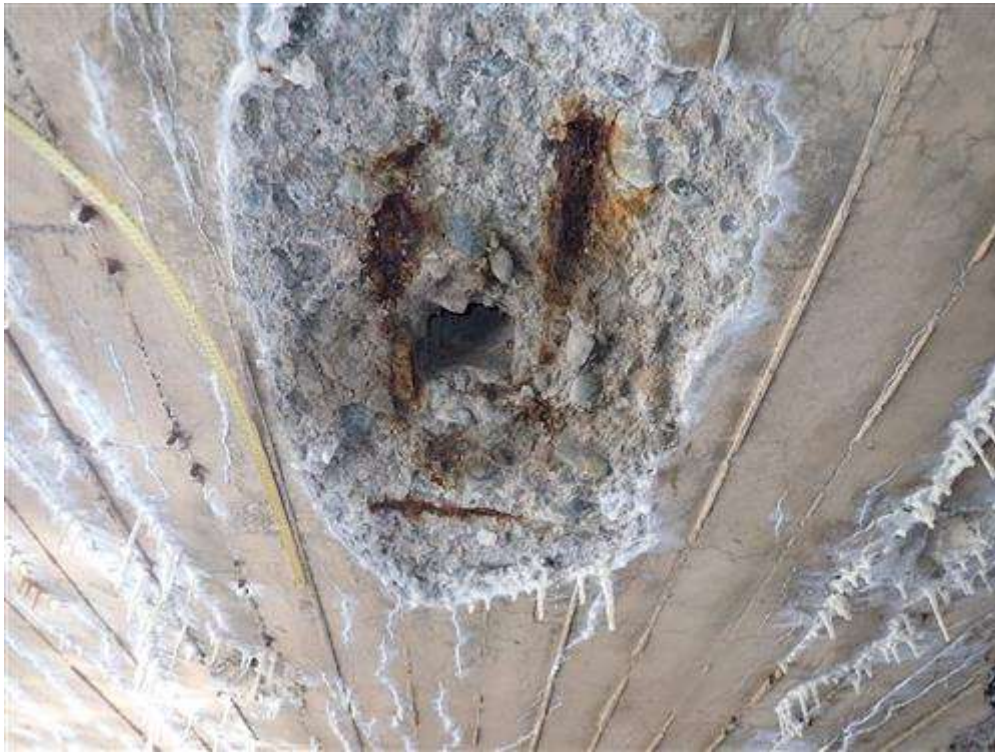
Photo Number: 33

Underside of Deck, Span 3

Note: Spall around drain with exposed rebar with section loss.

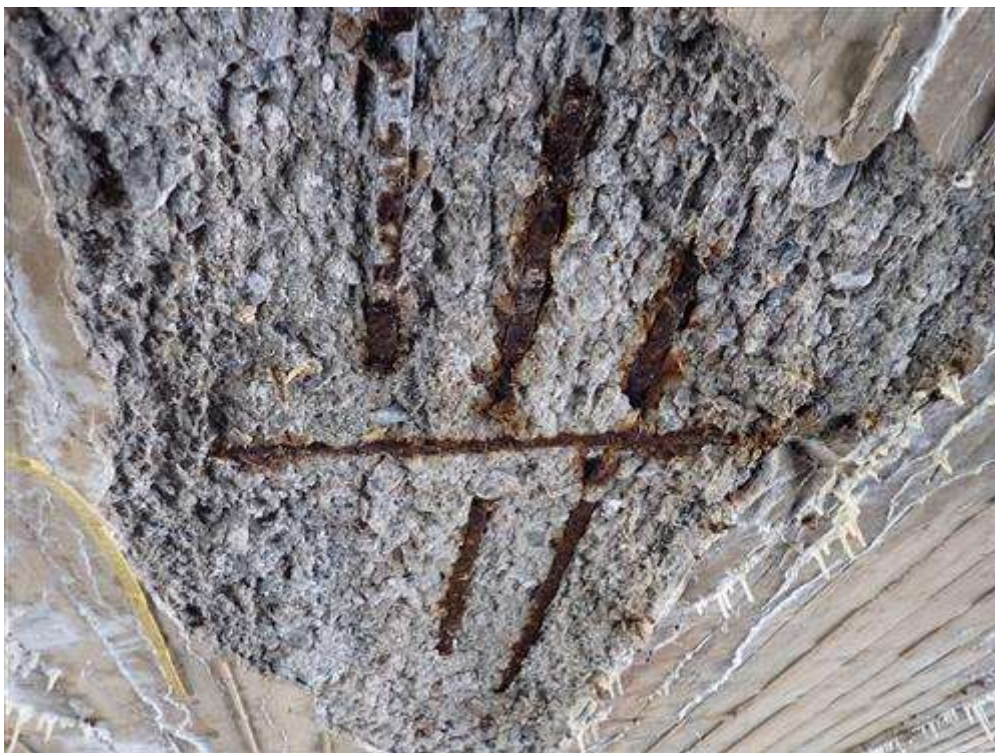
Photo Number: 34

Underside of Deck, Span 3

Note: Spall with exposed rebar with section loss.

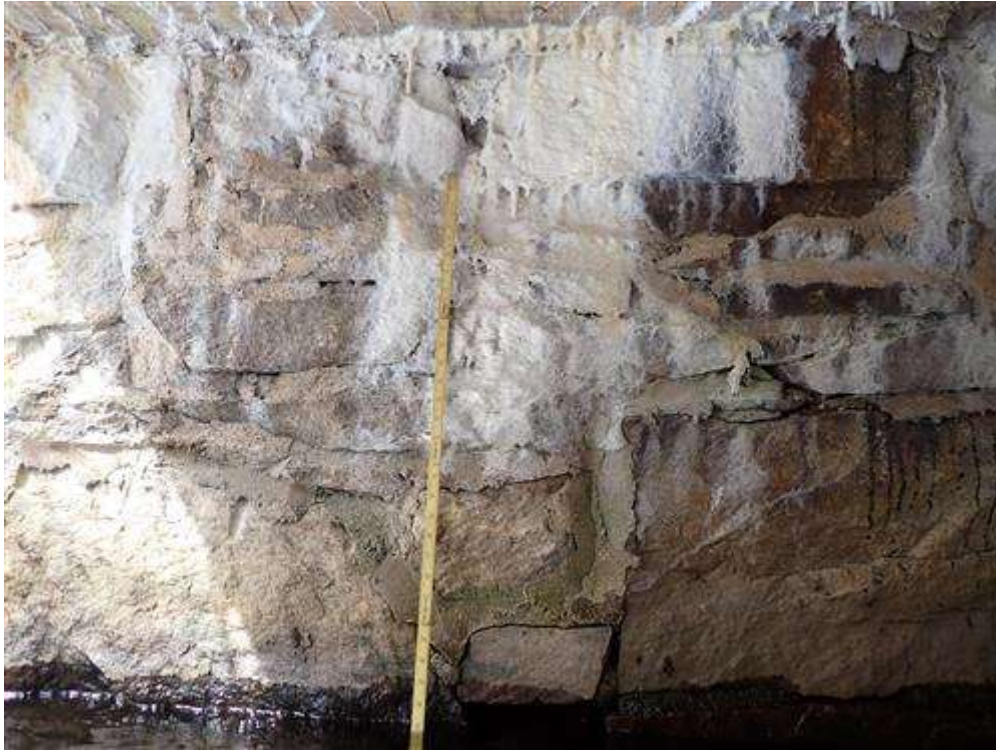
Photo Number: 37

Abutment 1 Downstream End

Note: Efflorescence.

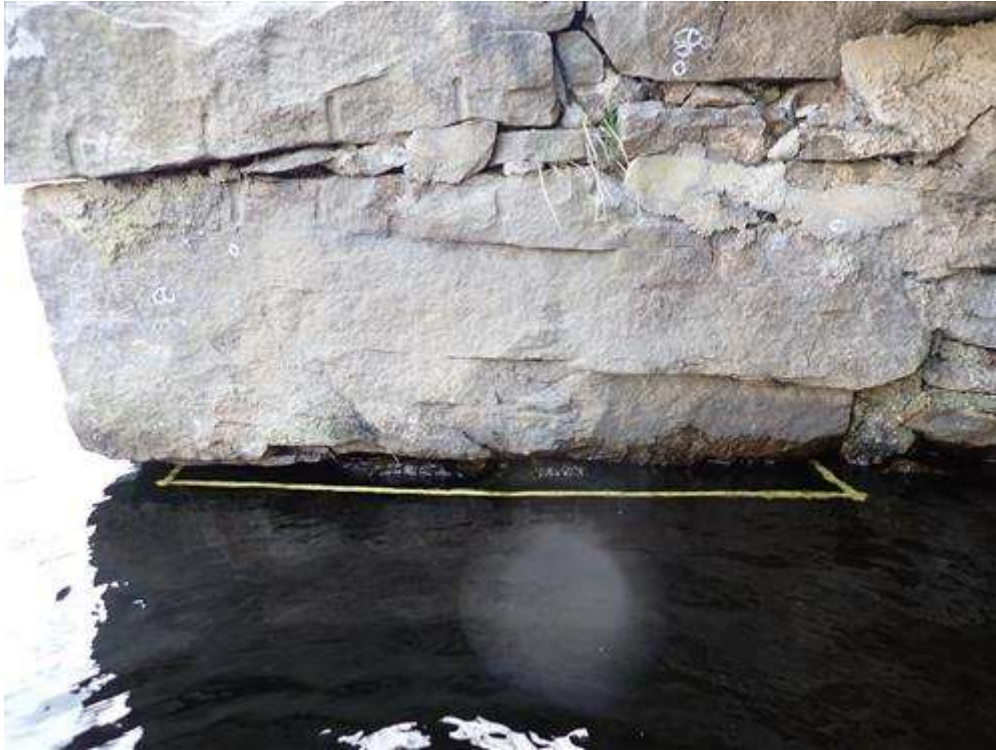
Photo Number: 39

Rating lowered from '4' to '3' based on areas with up to 100% mortar loss, missing stone and chinking stone voids with up to 6.2 penetrations.

Abutment 2 Left (North) End

Note: Voiding with penetration at water surface.

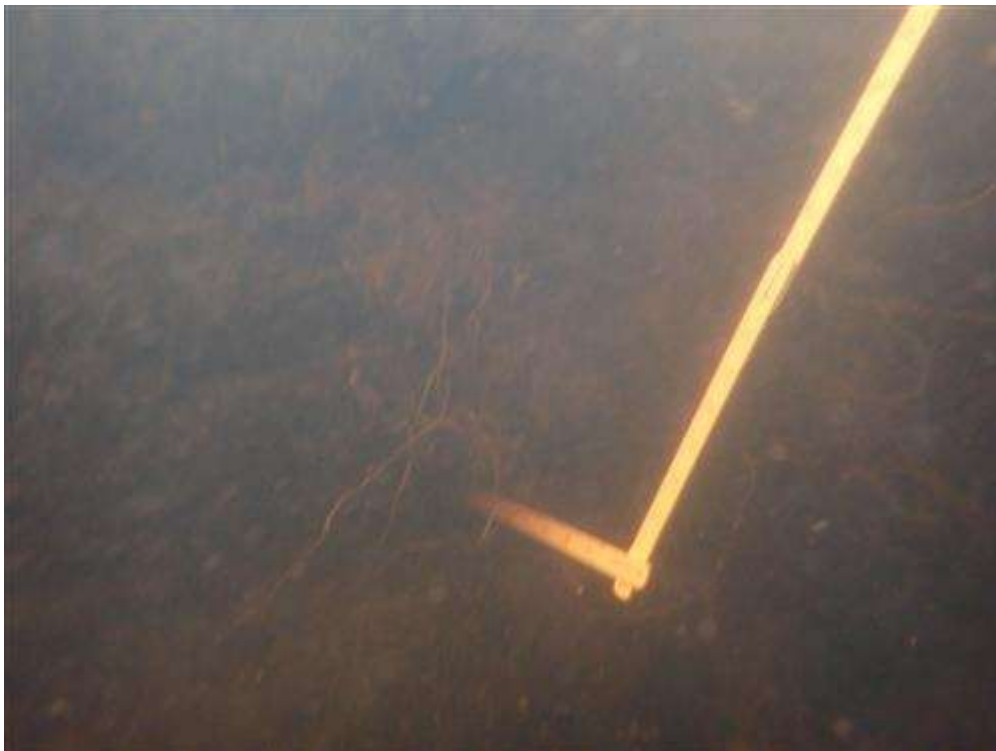
Photo Number: 40

Abutment 2 Left (North) End

Note: Void with penetration below water surface.
