BRIDGE NO.04671

33900 - GRISWOLD
CARROLL ROAD
over
PACHAUG RIVER

Routine and Underwater Inspection

4/14/2021

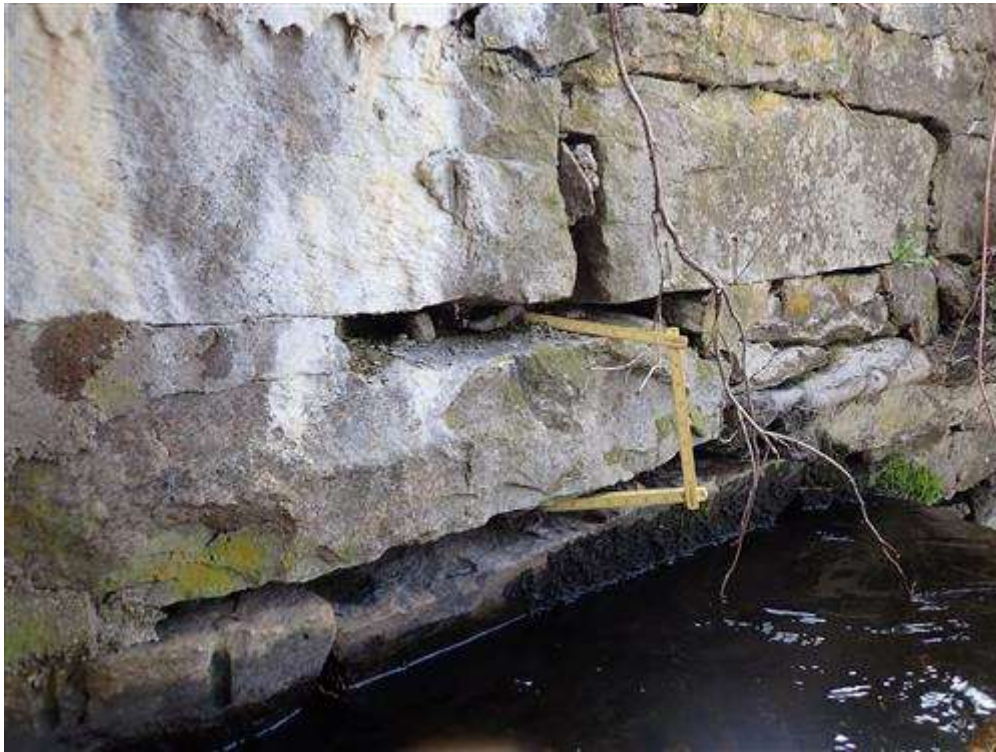
Photo Number: 41

Abutment 2 at Right (South) End

Note: Voiding with penetration near water surface.

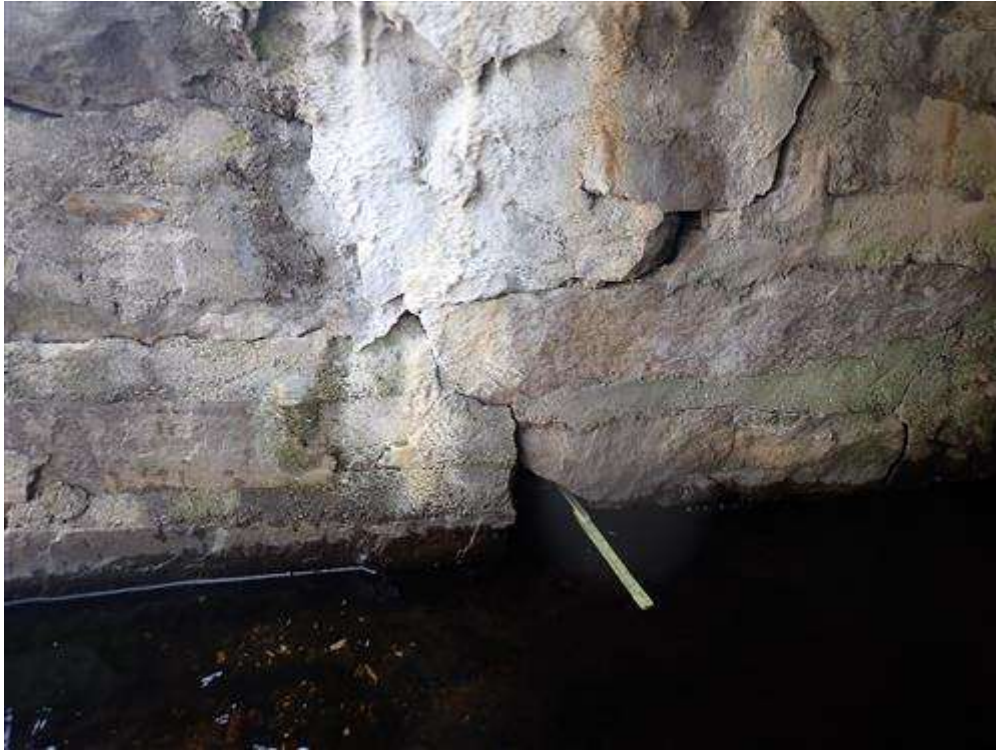
Photo Number: 49

Pier 1 West at Left (North) End

Note: Full depth void.

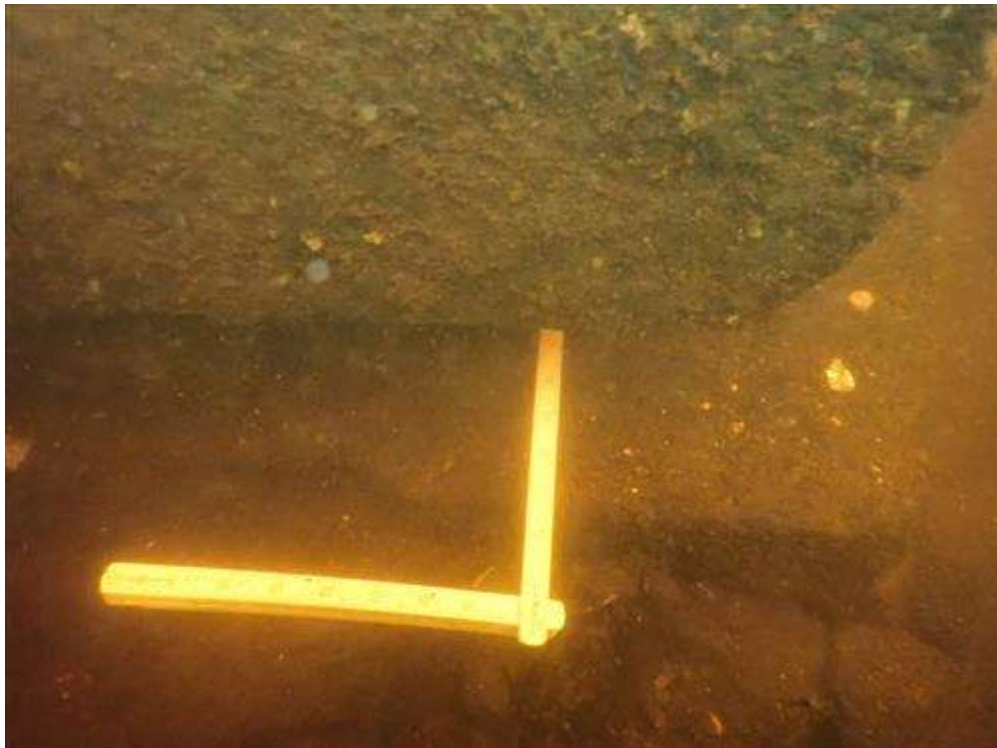
Photo Number: 52

Pier 1 East at Left (North) End Underwater

Note: Voiding with penetration.

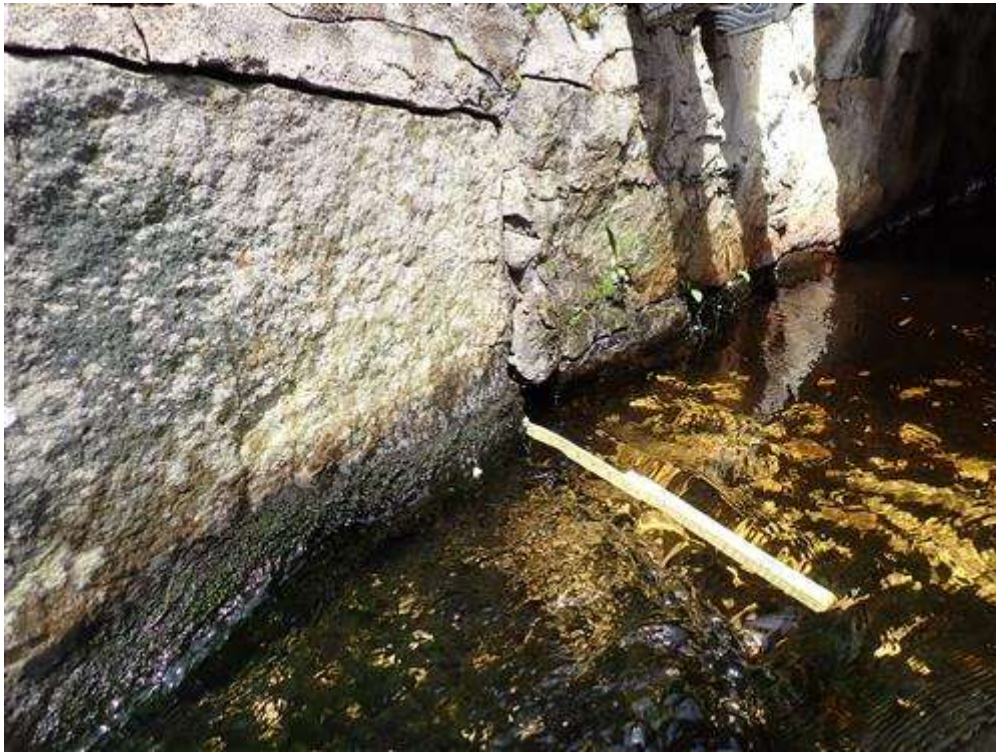
Photo Number: 53

Pier 1 East at Right (South) End

Note: Void with full depth penetration.

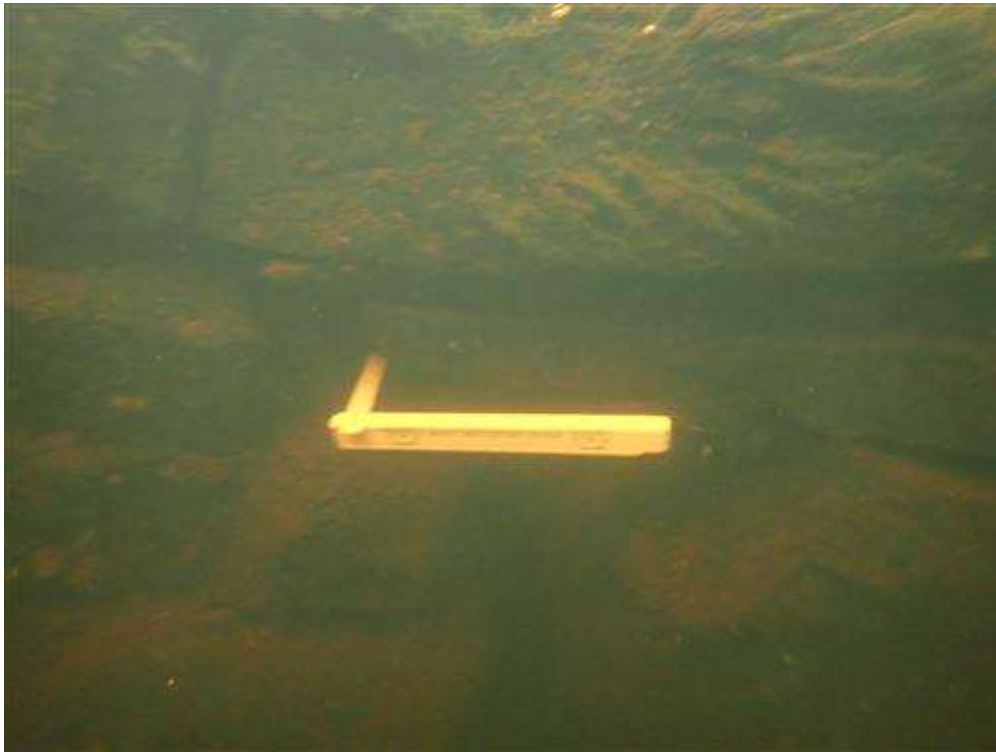
Photo Number: 55

Pier 2 West Left (North) End - Underwater

Note: Mortar loss with penetration.

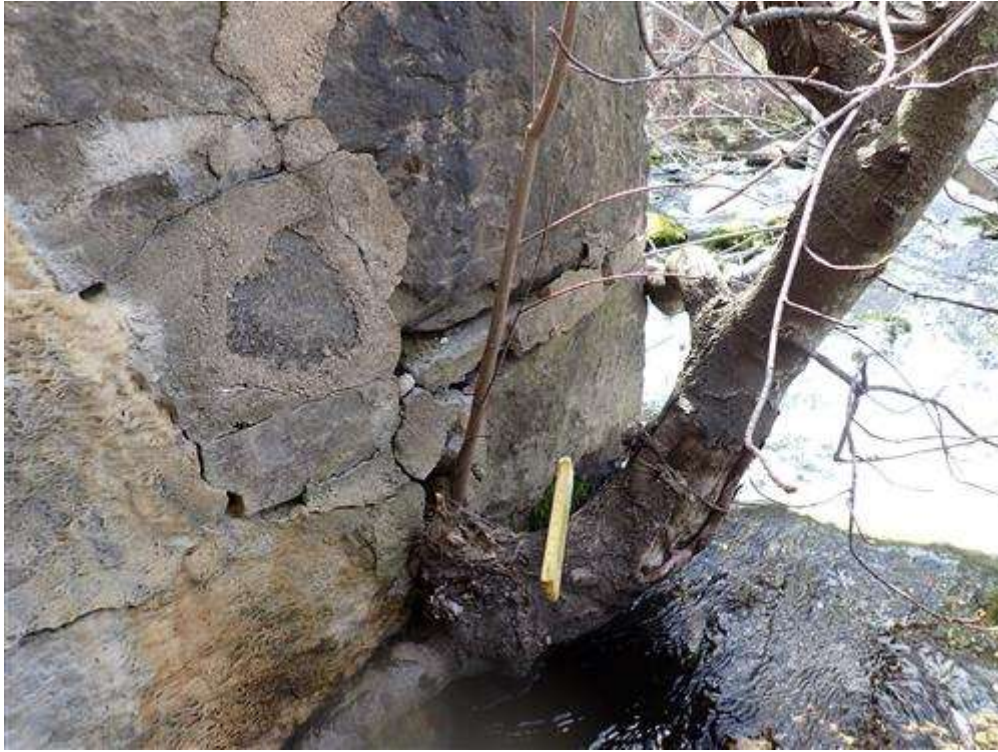
Photo Number: 57

Pier 2 West Downstream Vegetation Growing From Stone

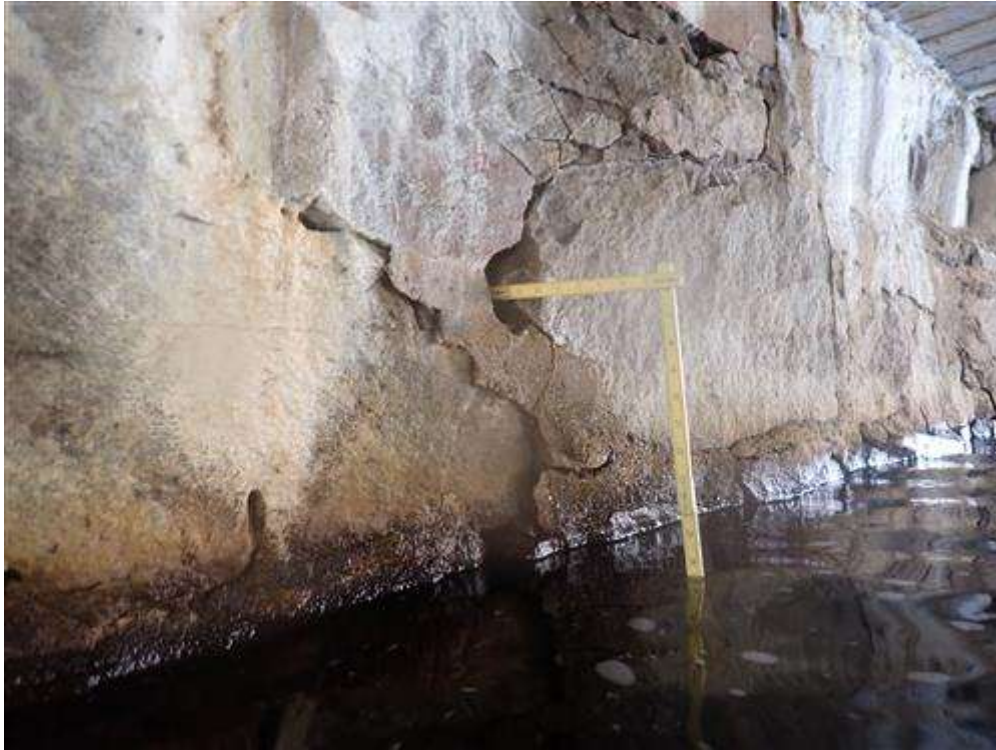
Photo Number: 59

Pier 2 East near Centerline

Note: Hole with penetration; cracks in mortar; efflorescence.
