CONNECTICUT DEPARTMENT OF TRANSPORTATION

BRIDGE NO. 04671
CAROL ROAD OVER PACHAUG RIVER
CONNECTICUT

INSPECTED: SS, MB, AT, GM
REVISIED BY: FH
SCALE: AS SHOWN
DATE OF INSPECTION: 04 / 14 / 21
DRAWING NO. 04671A

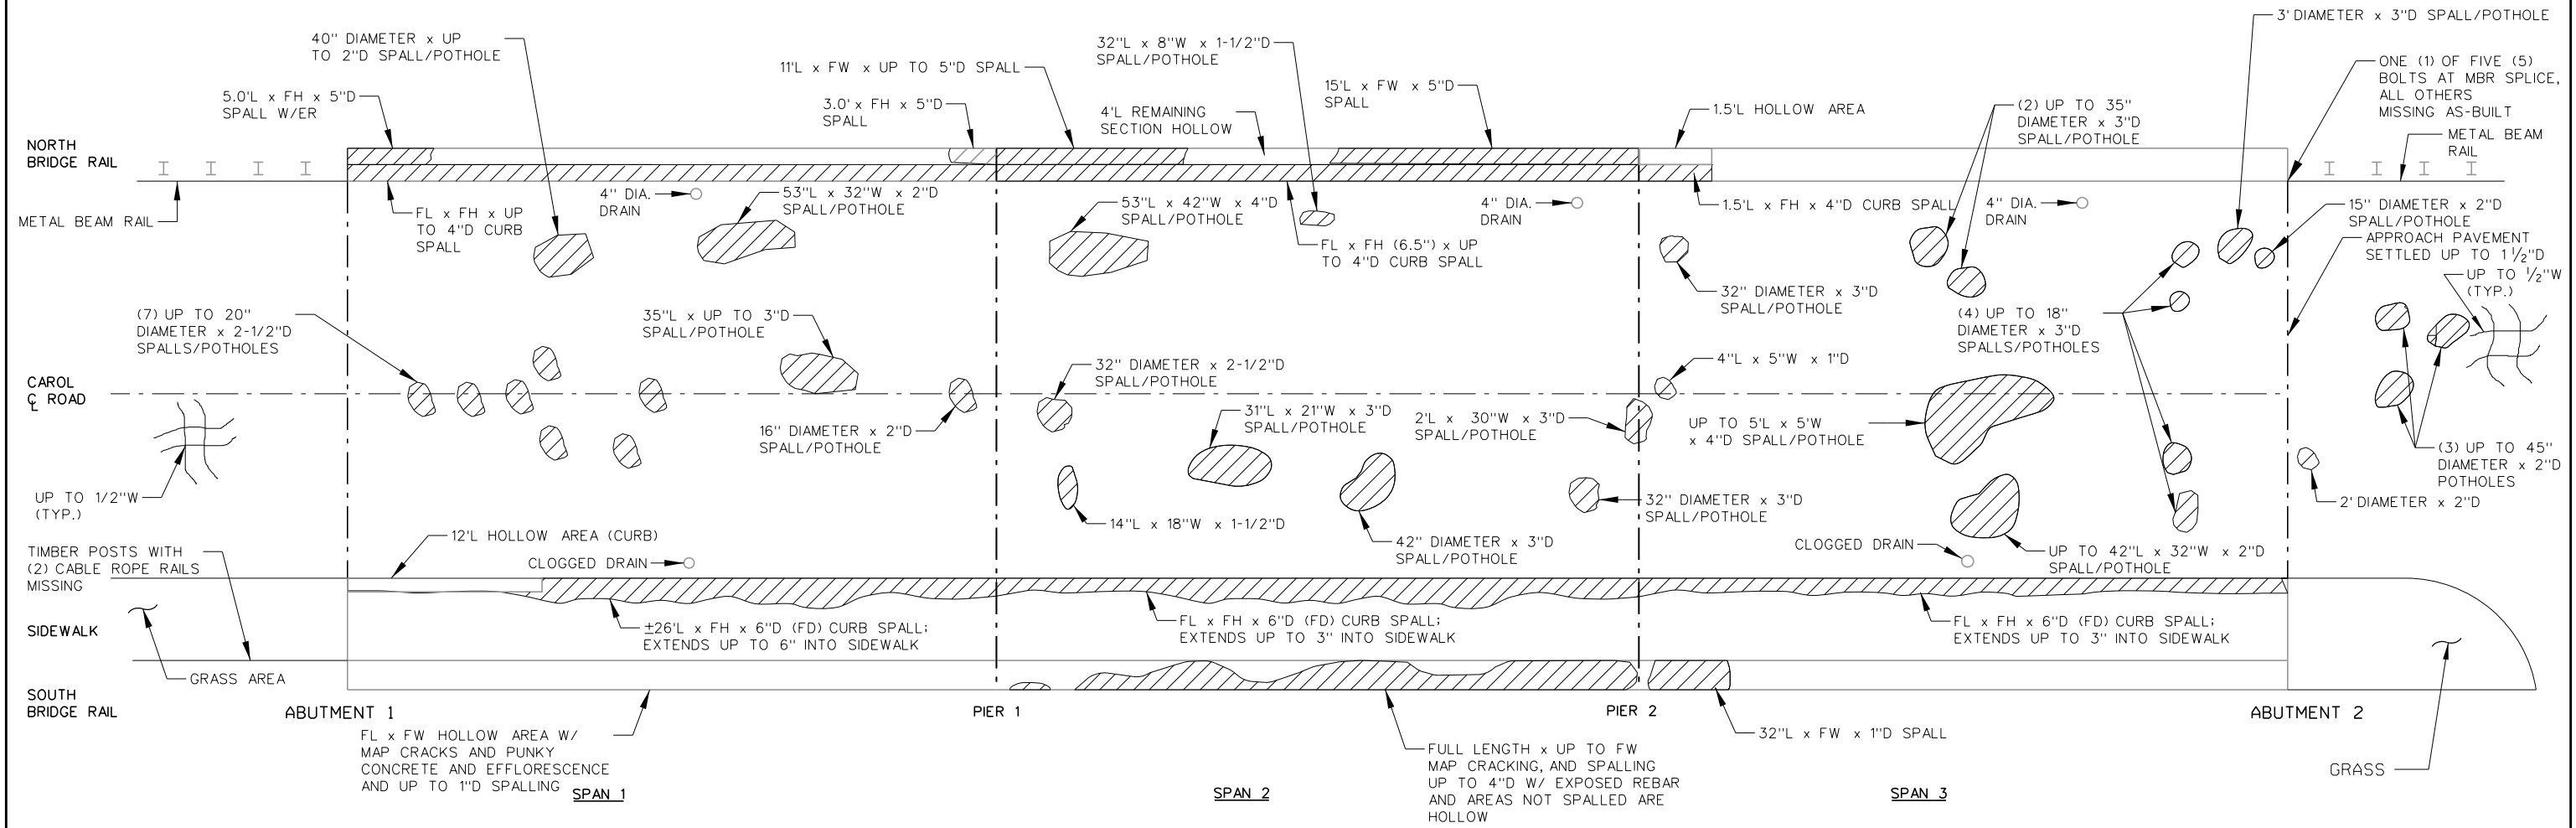
TOP OF DECK
N.T.S.

1. BITUMINOUS OVERLAY IS UNEVEN AND COVERED WITH SAND, OVERLAY IS $\pm 1\frac{1}{2}$ " THICK, ANY POTHOLE $> 1\frac{1}{2}$ " DEEP IS ALSO A SPALL IN THE DECK. OVERLAY IS TYPICALLY DULL/HOLLOW SOUNDING WITH RANDOM PATCHES/PUNKY CONCRETE AND TRANSVERSE AND HORIZONTAL CRACKS UP TO $\frac{1}{4}$ " WIDE IN ALL SPANS. POTHoles PATCHED W/ DETERIORATING BITUMINOUS THROUGHOUT.

2. PARAPETS HAVE HAIRLINE TO $\frac{1}{16}$ " WIDE MAP CRACKS W/ EFFLORESCENCE AND SEVERE SCALE.
3. TWO-CABLE GUIDE RAIL IN SOUTHWEST APPROACH HAS NO CABLES, TIMBER POSTS HAVE CHECKS UP TO $\frac{1}{16}$ " WIDE AND ROT UP TO 6" DEEP ON TOP.

4. PAINTED STEEL BRIDGE RAILINGS HAVE PEELING PAINT, CHIPS, SCRAPES, AND LIGHT RUST.
5. SIDEWALK HAS AREAS OF SEVERE SCALE (> 1 " DP). LOOSE CONCRETE ALONG EDGES, AND IS COVERED WITH SAND AND GRAVEL.

6. RANDOM BITUMINOUS POTHoles WITH DETERIORATION (UP TO 1"D).
7. TOP OF RAIL WELDED SPLICE CRACKED OR SEPARATED AND PAINTED OVER AT PIER 1 BOTH NORTH AND SOUTH RAILS AND SOUTH RAIL ONLY AT PIER 2.

8. NORTHEAST APPROACH GUIDE RAIL HAS LIGHT SURFACE RUST.
9. NORTHWEST APPROACH GUIDE RAIL HAS (4) TITLED POSTS AND UP TO 4" LONG TEARS AT ALL SPLICES.
10. THERE IS NO GUIDERAIL AT THE SOUTHEAST APPROACH.

11. PARAPET EXTERIORS HAVE AREAS OF HAIRLINE TO $\frac{1}{8}$ " WIDE MAPCRACKING WITH EFFLORESCENCE THROUGHOUT.

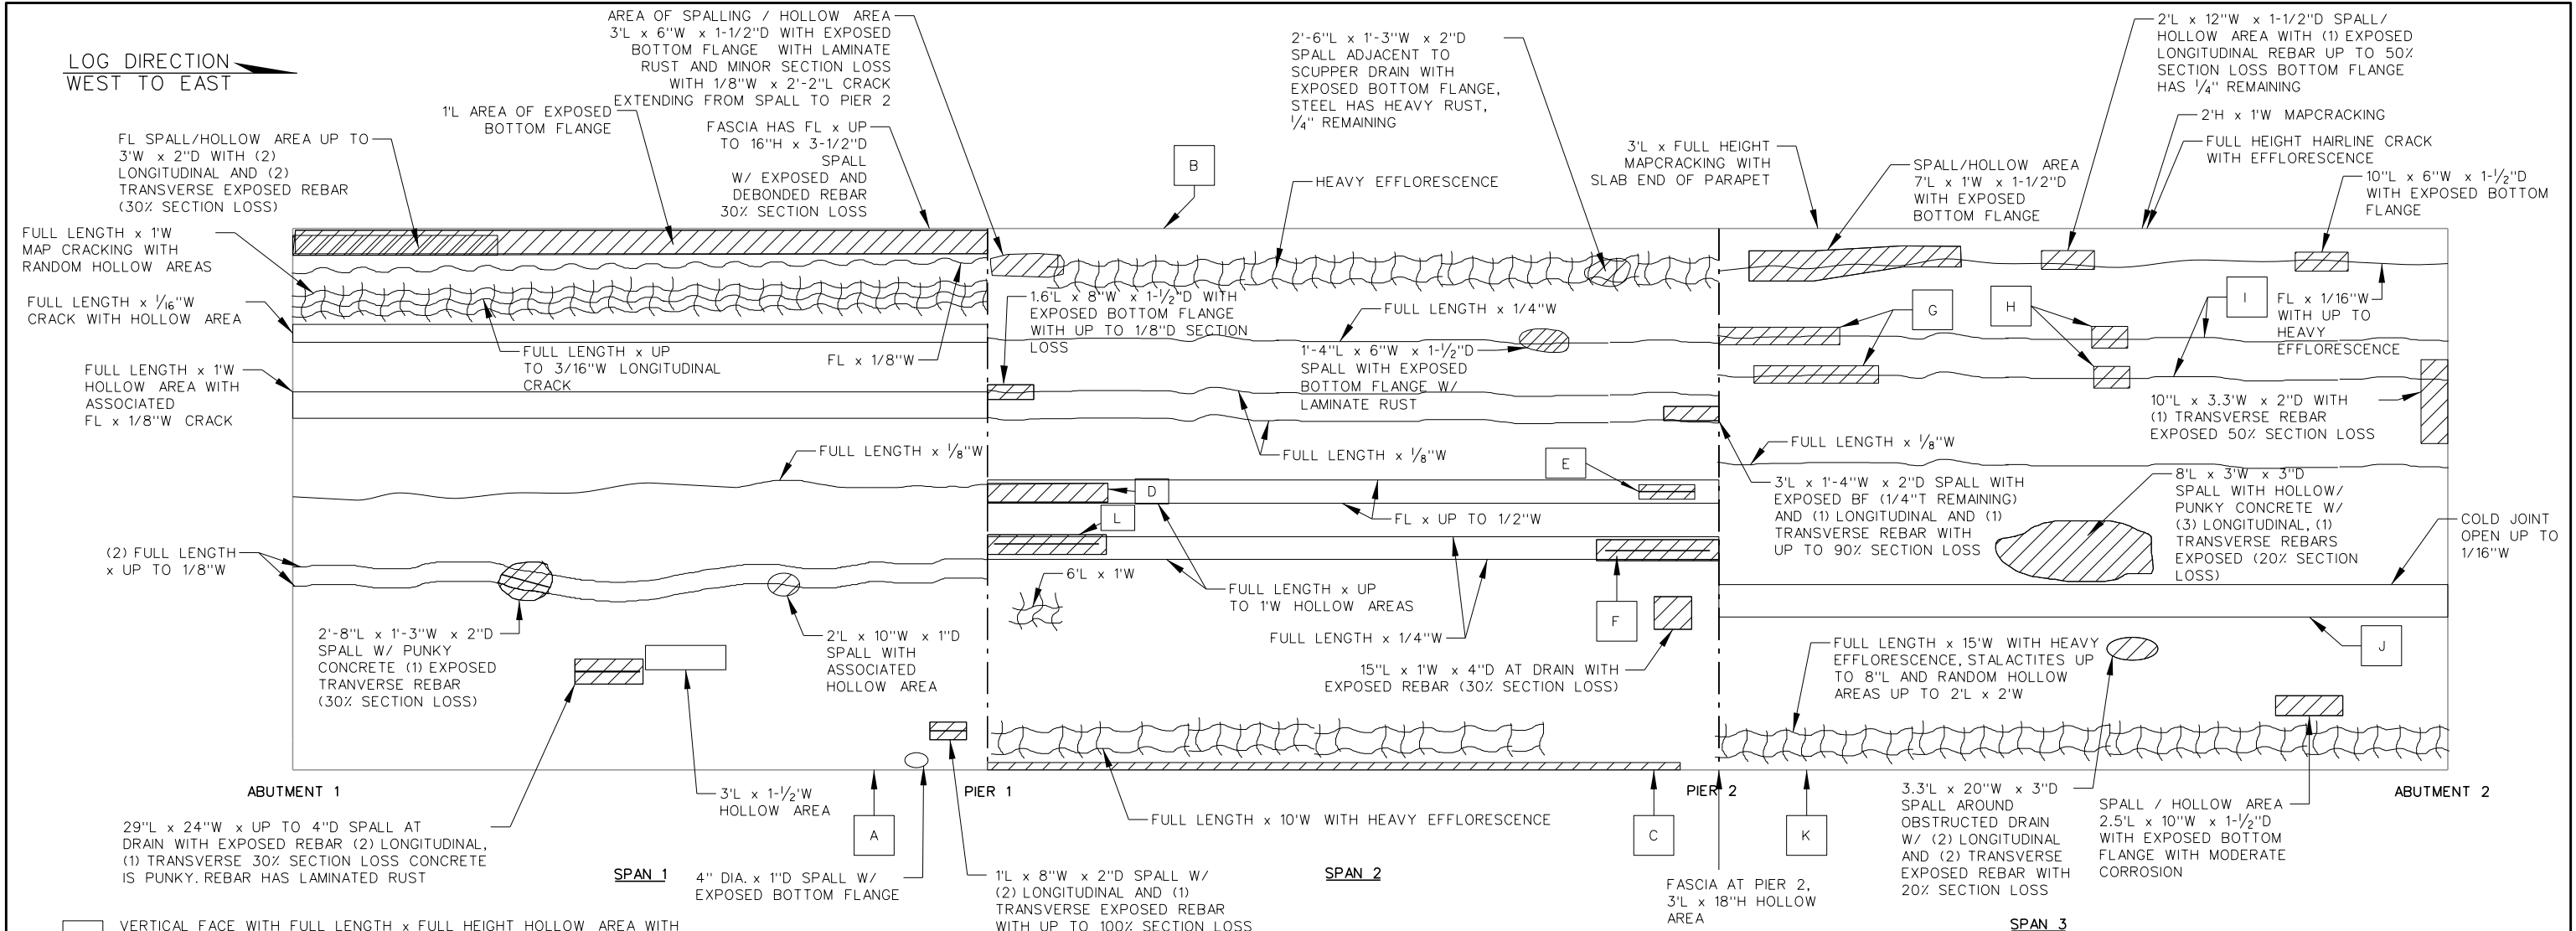
UNDERSIDE OF SLAB
N.T.S.

- A** VERTICAL FACE WITH FULL LENGTH x FULL HEIGHT HOLLOW AREA WITH FAILED PATCHES, HAIRLINE MAP CRACKS, EFFLORESCENCE AND UP TO 2"D SPALLS WITH PUNKY CONCRETE.

- B** FASCIA WITH FULL LENGTH x UP TO FULL HEIGHT HOLLOW AREA WITH UP TO 4"D SPALLING WITH PUNKY CONCRETE AND EFFLORESCENCE, (1) EXPOSED AND DEBONDED LONGITUDINAL REBAR WITH 30% SECTION LOSS; EXTENDS UNDER BRIDGE 1'W

- C** VERTICAL FACE OF SLAB WITH FULL LENGTH x 16"H x 3"D SPALLS/SCALE/HOLLOW AREA WITH PUNKY CONCRETE WITH (1) LONGITUDINAL EXPOSED REBAR (10% SECTION LOSS) EXTENDS UNDER FASCIA 8"W.

- D** HOLLOW AREA 3.3'L x 10"W x 1"D SPALL WITH EXPOSED BOTTOM FLANGE WITH LAMINATE RUST (1/8"D SECTION LOSS).
- E** AREA OF SPALLING / HOLLOW AREA WITH EXPOSED BOTTOM FLANGE 6.5'L x 10"W x 1-1/2"D WITH 1/2" T LAMINATE RUST WITH UP TO 1/4"D SECTION LOSS.

- F** 9'L x UP TO 1'-6"W x 1-1/2"D SPALL W/EXPOSED BOTTOM FLANGE AND 1/2" T LAMINATED RUST WITH UP TO 1/4"D SECTION LOSS.
- G** 7'L x 6"W x 1-1/2"D SPALL W/ EXPOSED BOTTOM FLANGE AND EFFLORESCENCE.

- H** 1.3'L x 8"W x 1-1/2"D SPALL WITH EXPOSED BOTTOM FLANGE
- I** FULL LENGTH 1/16"W LONGITUDINAL CRACK WITH EFFLORESCENCE
- J** FULL LENGTH UP TO 1/8"W LONGITUDINAL CRACK WITH HEAVY EFFLORESCENCE, AS WELL AS MAP CRACKING, AND HOLLOW AREAS UP TO 1'W

- K** FULL LENGTH x UP TO 18"H x 3"D SPALL/HOLLOW AREA WITH EXPOSED REBAR WITH ISOLATED AREAS UP TO 40% SECTION LOSS AT VERTICAL FACE OF SLAB AND EXTENDS UNDER SLAB 10"W. REMAINING FACE HAS HAIRLINE CRACKS WITH EFFLORESCENCE.

L SPALLING/HOLLOW AREA 8'L x 9"W x 1-1/2"D WITH EXPOSED BOTTOM FLANGE WITH HEAVY CORROSION UP TO 1/8"D SECTION LOSS.

- NOTES:**
1. HAIRLINE CRACKS UP TO FULL LENGTH WITH EFFLORESCENCE THROUGHOUT.
 2. SPALLED CONCRETE IS TYPICALLY PUNKY, ESPECIALLY AT FASCIAS.
 3. LAMINATED RUST ON EXPOSED BOTTOM FLANGES WITH SECTION LOSS UP TO 1/4"D UNLESS OTHERWISE NOTED.
 4. RANDOM SPALLS UP TO 1'DIA x 1-1/2"D AND AREAS OF LIGHT SCALE AND HONEYCOMBING ON SLAB UNDERSIDE.
 5. HEAVY EFFLORESCENCE AND STALACTITES UP TO 8"L ALONG CRACKS.
 6. DRAINS NOT SHOWN UNLESS DEFECTIVE.
 7. ENCASED BEAMS SPACED 3.5' APART.
 8. CONCRETE BELOW ENCASED BEAMS HAVE LONGITUDINAL CRACKS UP TO 1/8"W WITH HEAVY EFFLORESCENCE AND HOLLOW AREAS.
 9. SPALL LESS THAN 1'DIA. HAVE BEEN PARTIALLY PATCHED ON SLAB UNDERSIDE.

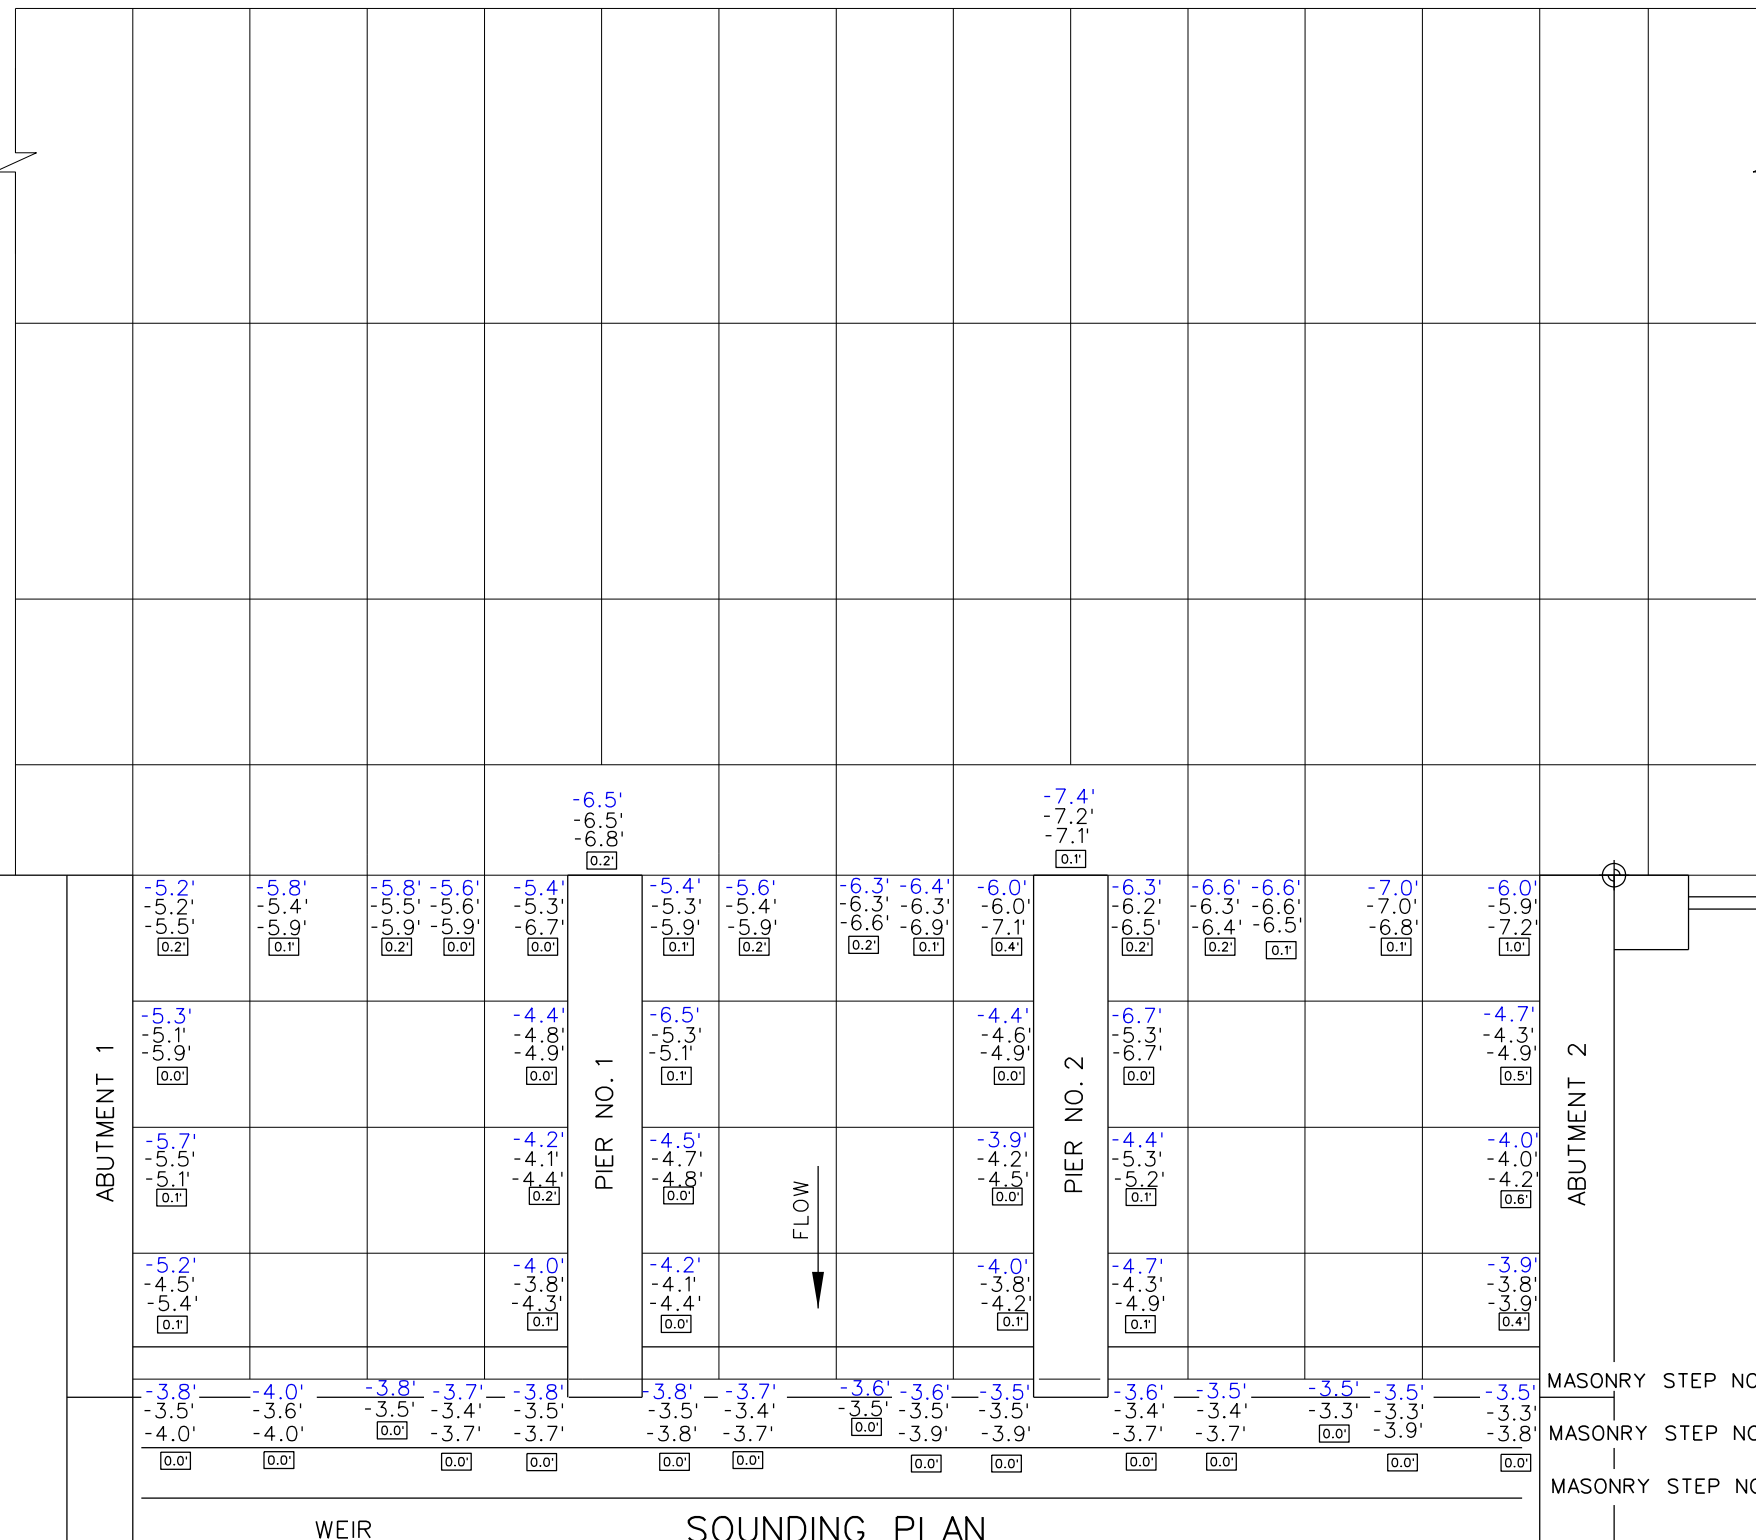
SOUNDING PLAN

- UPSTREAM (NORTH) CHANNEL EMBANKMENTS HAVE MINOR EROSION/UNDERCUTTING.
- DOWNSTREAM (SOUTH) CHANNEL EMBANKMENTS HAVE DRY-LAID STONE RETAINING WALLS.
- THERE IS A 15'L x 4'W ISLAND WITH TREES UP TO 1.5'φ IN THE DOWNSTREAM (SOUTH) CHANNEL DIRECTLY SOUTH OF THE DAM/SPILLWAY.
- MINOR TIMBER AND MAN-MADE DEBRIS WAS OBSERVED IN THE CHANNEL.

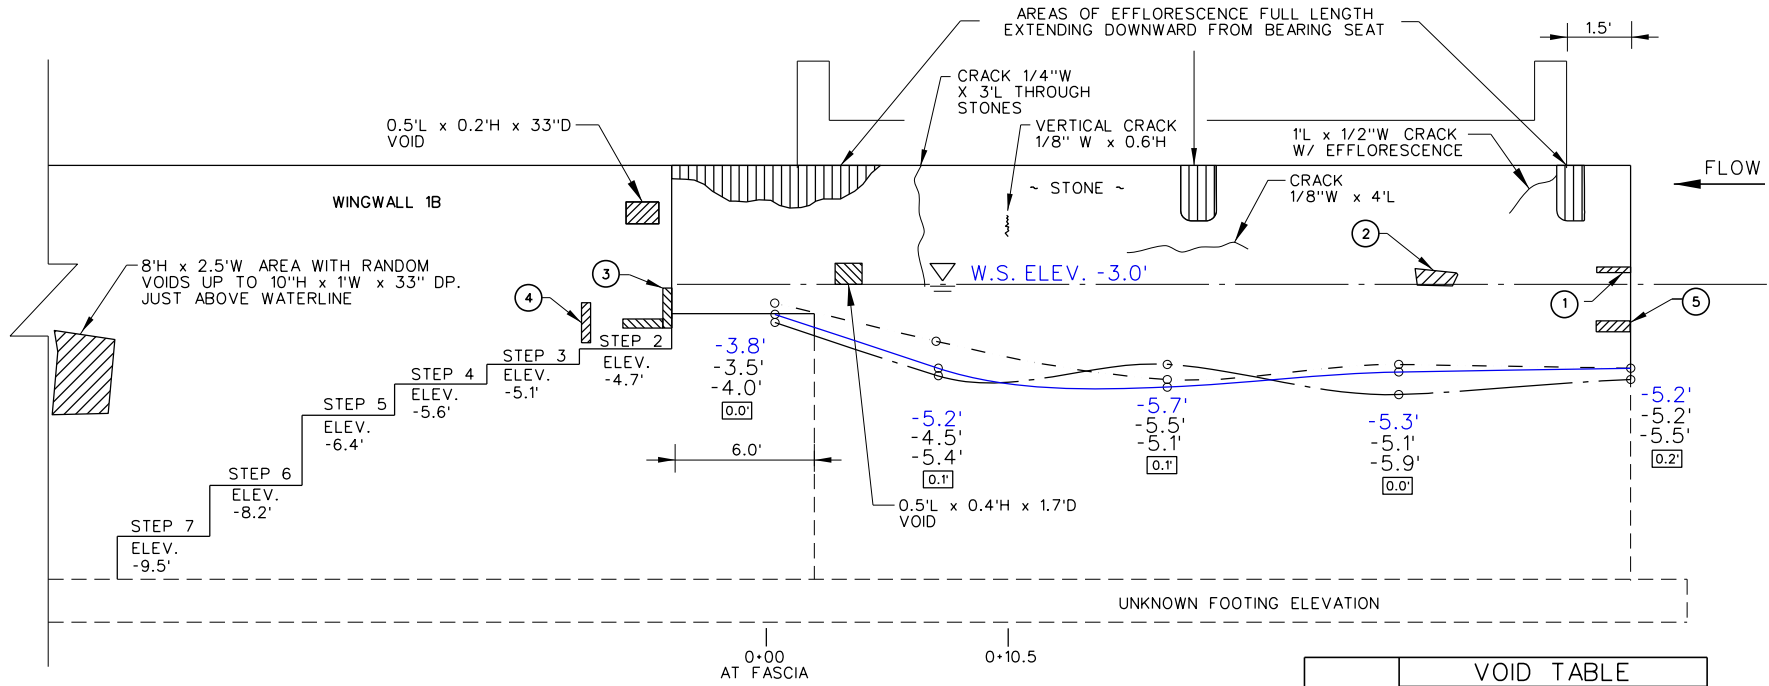
ABUTMENT 1
N.T.S.

- MISSING CRACKED MORTAR AND CHINKING STONES, UP TO 50% EXTENDING FROM 1.0' ABOVE THE WATERLINE TO THE CHANNEL BOTTOM. PENETRATION UP TO 30".
- MASONRY JOINT AT WATER SURFACE AT NORTH END OF ABUTMENT IS OPEN 8"L.
- RANDOM VOIDS AT WINGWALL 1A UP TO 8"L x 8"H x 2'D.
- TREE UP TO 10" DIAMETER GROWING OUT OF WINGWALL 1B.
- SEVERAL VOIDS HAVE BEEN PATCHED AND SOME MASONRY HAS BEEN REPOINTED.
- RANDOM CRACKS UP TO 3'L x 1/4"W.

VOID NO.	VOID TABLE		
	ENGLISH DIMENSIONS		
	LENGTH	VERTICAL HEIGHT	PENETRATION
①	2.3'	0.4'	1.3'
②	0.5'	0.8'	3.3'
③	1.7'	1.5'	2.1'
④	0.3'	0.8'	2.5'
⑤	3.0'	1.0'	2.0'

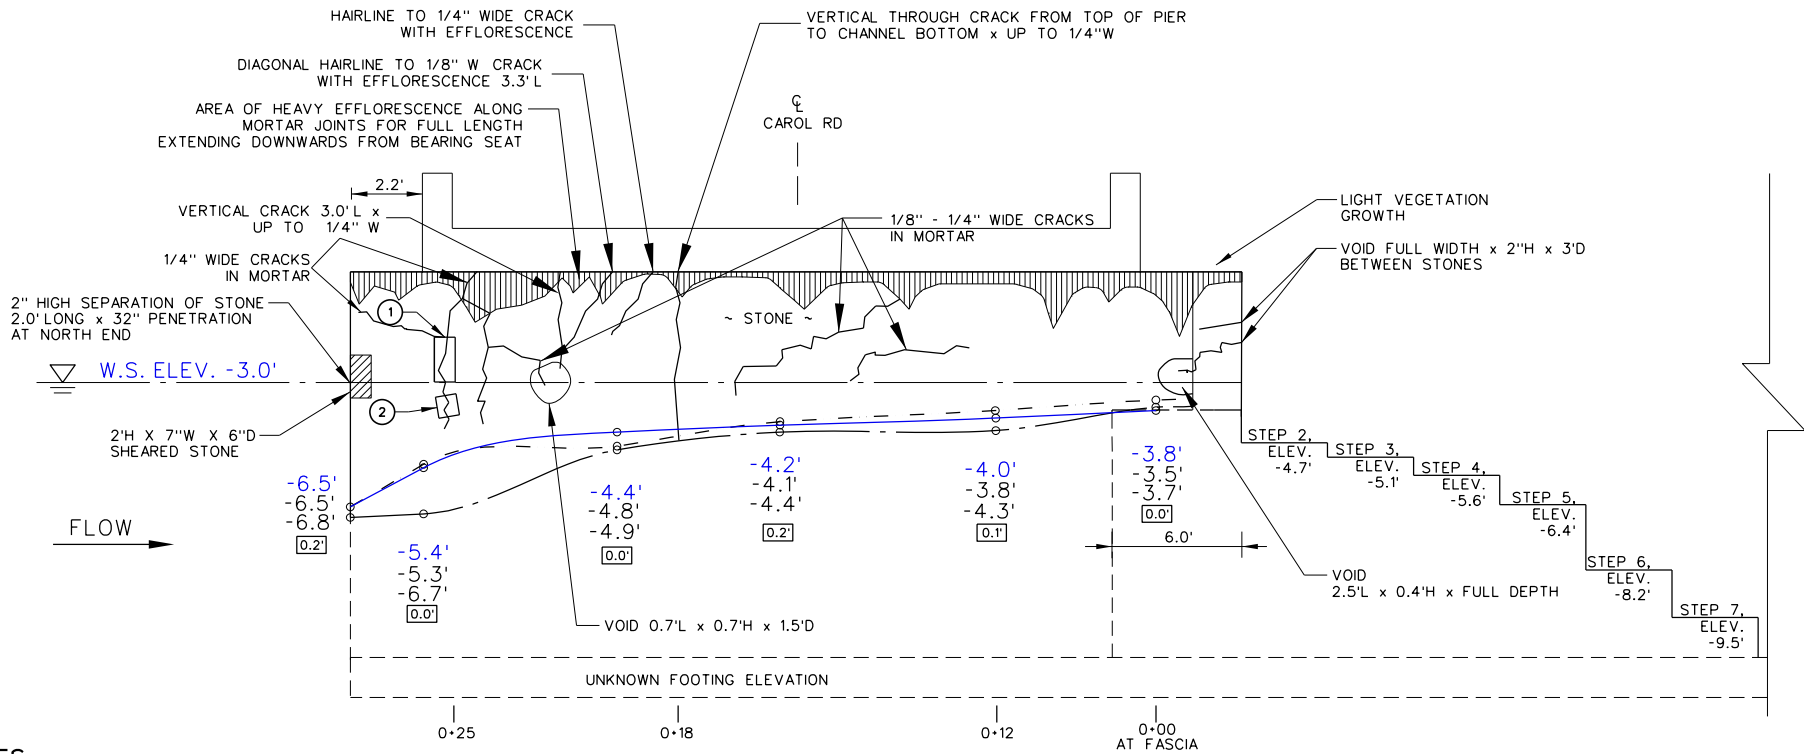
PIER NO. 1 (WEST) ELEVATION
N.T.S.

- INTERMITTENT CRACKING OF MORTAR UP TO 1/4"W WAS OBSERVED FROM 1.0' ABOVE THE WATERLINE TO THE BEARING SEAT.
- MORTAR LOSS, UP TO 95%, EXTENDING FROM WATERLINE TO THE CHANNEL BOTTOM ON THE SOUTH, EAST AND WEST FACES.
- LOOSE AND MISSING CHINKING STONES, UP TO 30%, BELOW THE WATERLINE.
- MISSING MORTAR, UP TO 100%, WITH UP TO 4.6' PENETRATION INTO THE STRUCTURE, FROM 1.0' ABOVE THE WATERLINE TO THE CHANNEL BOTTOM, ON THE NORTH FACE.
- STONES ARE 6" WIDER AT N,E & W FACES STARTING 0.5' BELOW WATER SURFACE.
- SEVERAL VOIDS HAVE BEEN PATCHED AND MASONRY HAS BEEN REPOINTED.

VOID NO.	VOID TABLE		
	ENGLISH DIMENSIONS		
	LENGTH	VERTICAL HEIGHT	PENETRATION
①	0.8'	1.0'	FD
②	0.5'	0.5'	FD

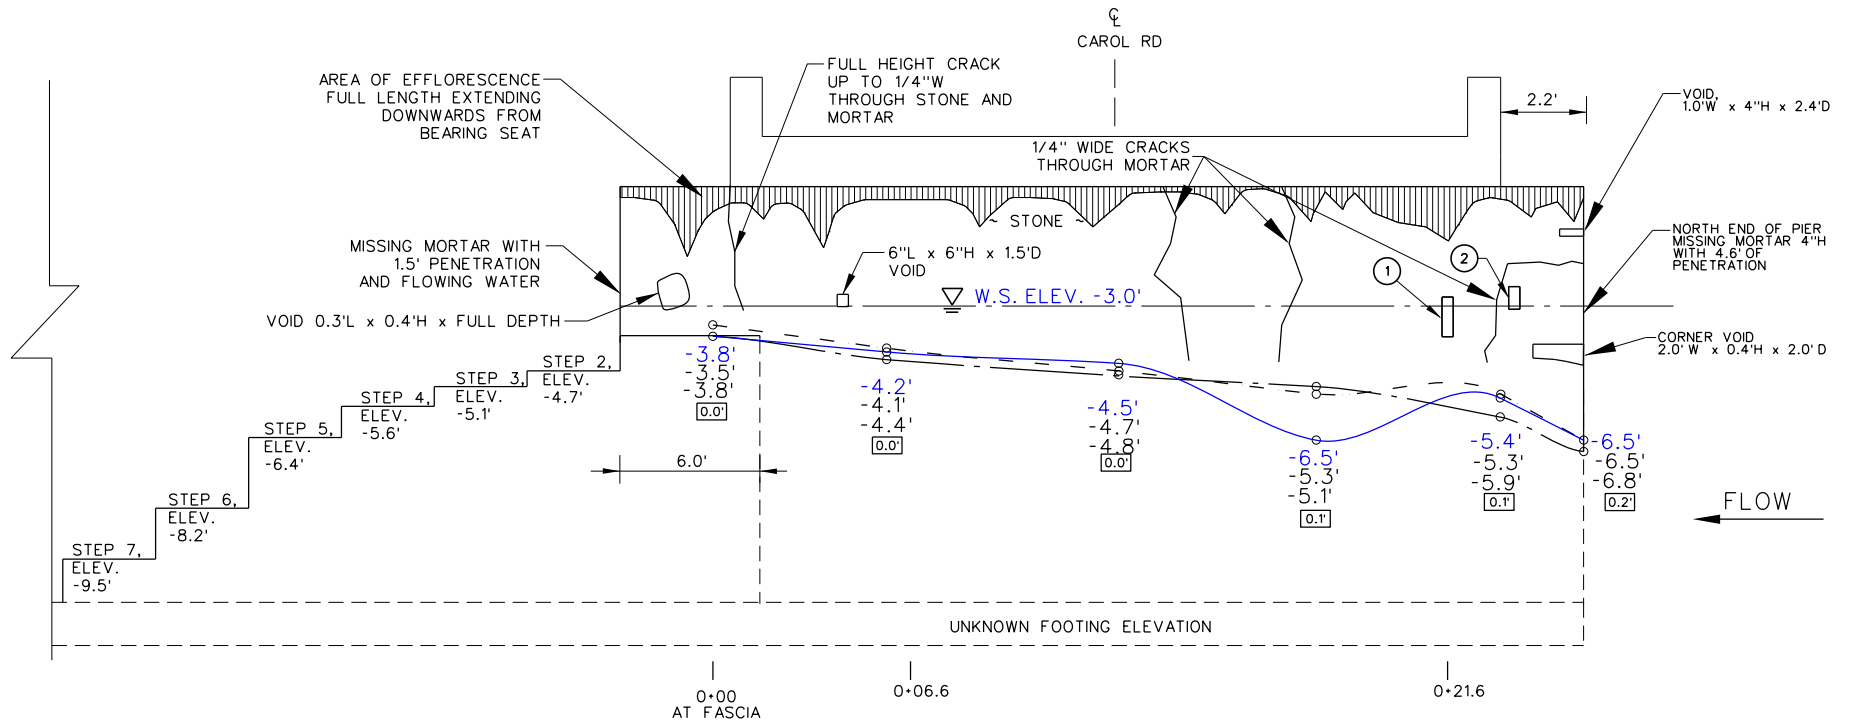
PIER NO. 1 (EAST) ELEVATION
N.T.S.

1. INTERMITTENT CRACKING OF MORTAR WAS OBSERVED FROM 1.0' ABOVE THE WATERLINE TO THE BEARING SEAT.
2. MORTAR LOSS, UP TO 95%, EXTENDING FROM THE WATERLINE TO THE CHANNEL BOTTOM WITH LESS THAN 15% MORTAR LOSS ABOVE THE WATER LINE WITH 10" TYPICAL PENETRATION AT ALL LOCATIONS.
3. LOOSE AND MISSING CHINKING STONES, UP TO 20%, BELOW THE WATERLINE WITH 1' PENETRATION.
4. STONES UP TO 12" WIDER AT N,E & W FACES STARTING 0.5' BELOW WATER SURFACE.
5. SEVERAL VOIDS HAVE BEEN PATCHED AND MASONRY HAS BEEN REPOINTED.

VOID TABLE				
ENGLISH DIMENSIONS				
VOID NO.	LENGTH	VERTICAL HEIGHT	PENETRATION	NOTES
①	0.2'	0.8'	1.7'	
②	0.2'	0.5'	3.0'	FD

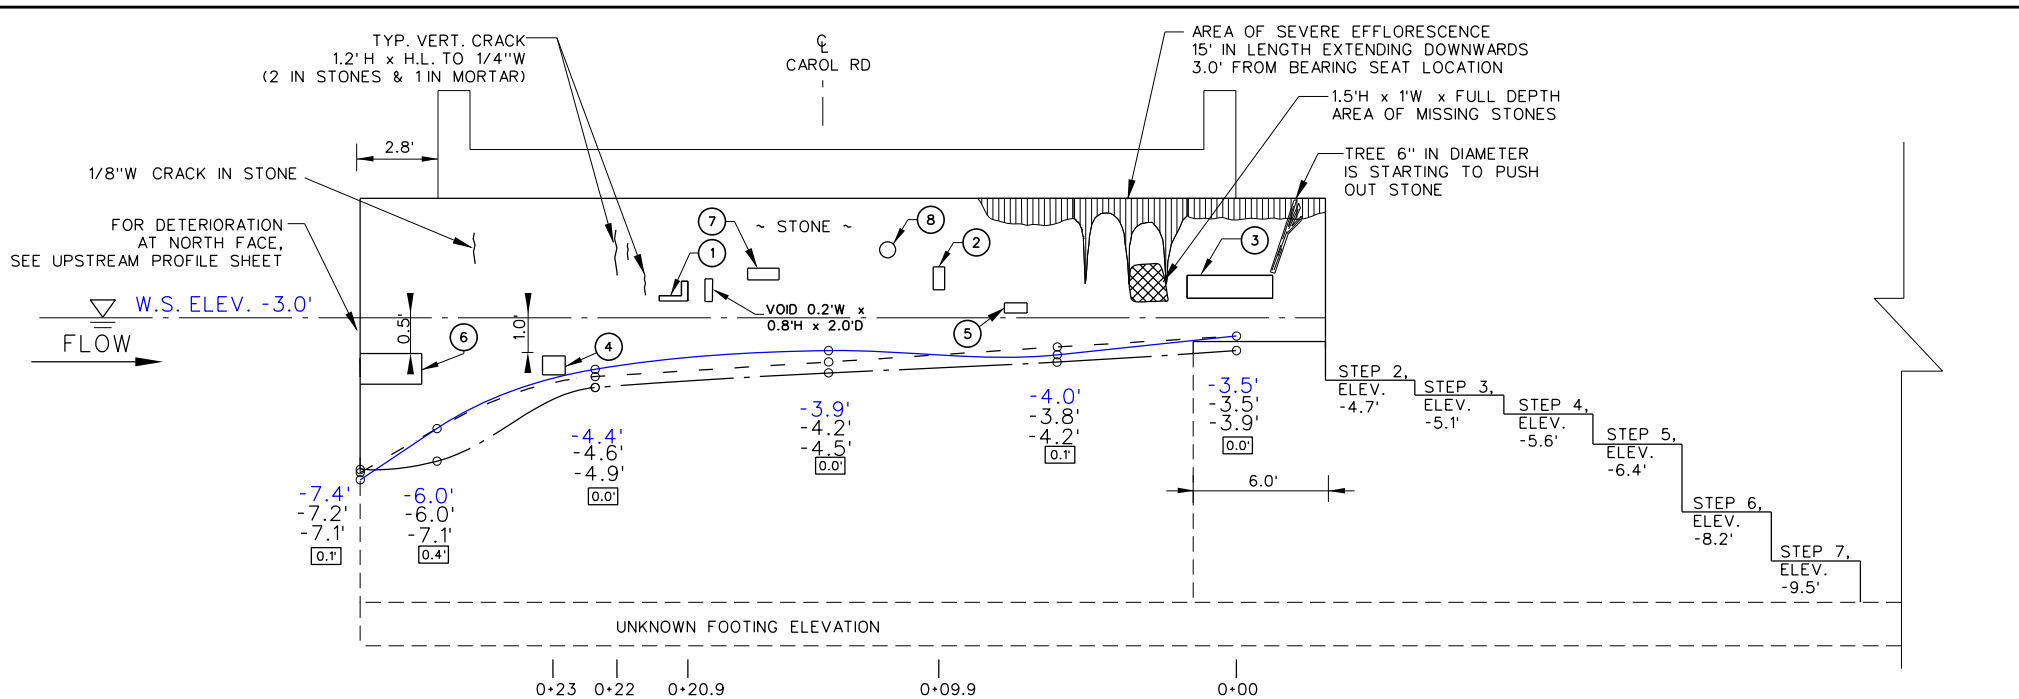
PIER NO. 2 (WEST) ELEVATION
N.T.S.

1. INTERMITTENT HAIRLINE CRACKING OF MORTAR IN JOINTS WAS OBSERVED.
2. MORTAR LOSS, UP TO 75%, EXTENDING FROM 1.0' ABOVE THE WATERLINE TO THE CHANNEL BOTTOM WITH LESS THAN 5% MORTAR LOSS ABOVE THE WATER LINE. 15" TYPICAL PENETRATION AT ALL LOCATIONS.
3. SEVERAL VOIDS HAVE BEEN PATCHED AND MASONRY HAS BEEN REPOINTED.
4. STONES ARE 6" WIDER AT N,E & W FACES STARTING 1.0' BELOW WATER SURFACE.

VOID NO.	VOID TABLE			NOTES
	ENGLISH DIMENSIONS			
	LENGTH	VERTICAL HEIGHT	PENETRATION	
①	1.3'	0.3'	3.0'	(FULL DEPTH) PROBE 1.5' BEHIND FASCIA STONE
②	0.5'	0.5'	3.0'	SURROUNDING STONE LOOSE
③	1.0'	0.5'	1.5'	
④	1.0'	0.3'	3.0'	(FULL DEPTH)
⑤	0.1'	0.1'	1.5'	
⑥	2.7'	0.7'	2.8'	
⑦	0.4'	0.3'	3.0'	(FULL DEPTH)
⑧	0.3'	0.8'	2.0'

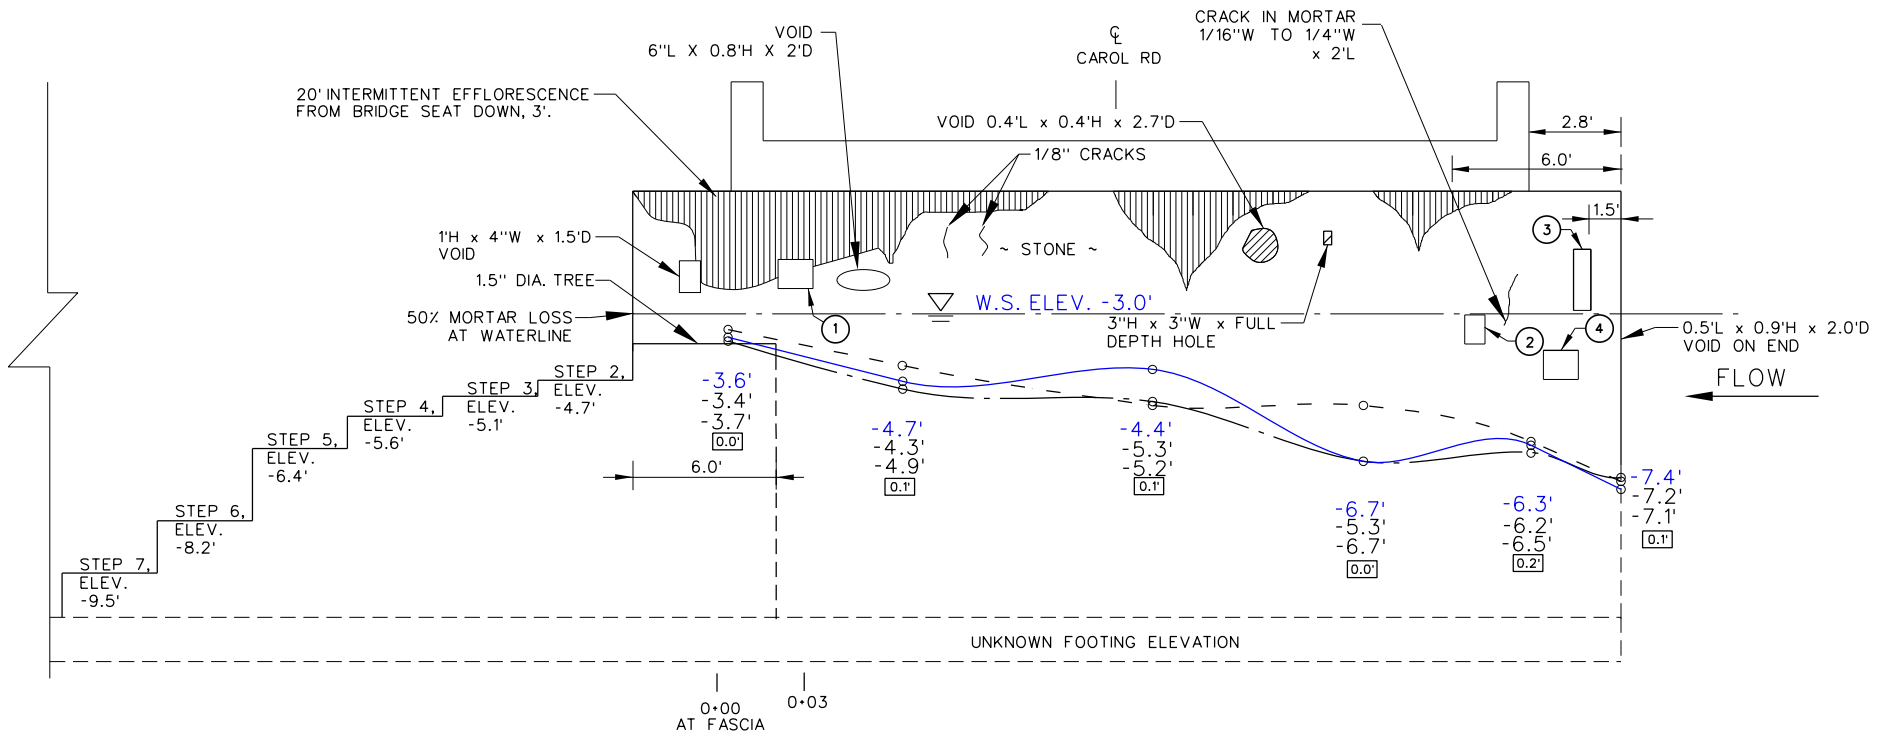
PIER NO. 2 (EAST) ELEVATION
N.T.S.

1. INTERMITTENT HAIRLINE UP TO 1/4" W CRACKING OF MORTAR IN JOINTS WAS OBSERVED.
2. MORTAR LOSS, UP TO 75%, EXTENDING FROM WATER SURFACE TO THE CHANNEL BOTTOM WITH LESS THAN 5% MORTAR LOSS ABOVE THE WATER LINE. 15" TYPICAL PENETRATION NOT AT ALL LOCATIONS. MISSING MORTAR, UP TO 50%, ON SOUTH FACE.
3. SEVERAL VOIDS HAVE BEEN PATCHED AND MASONRY HAS BEEN REPOINTED.
4. STONES ARE 6" WIDER AT N,E & W FACES STARTING 1.0' BELOW WATER SURFACE.

VOID NO.	VOID TABLE		
	ENGLISH DIMENSIONS		
	LENGTH	VERTICAL HEIGHT	PENETRATION
①	0.9'	1.0'	2.0'
②	0.1'	0.5'	2.0'
③	0.7'	0.8'	2.0'
④	0.8'	0.1'	2.0'

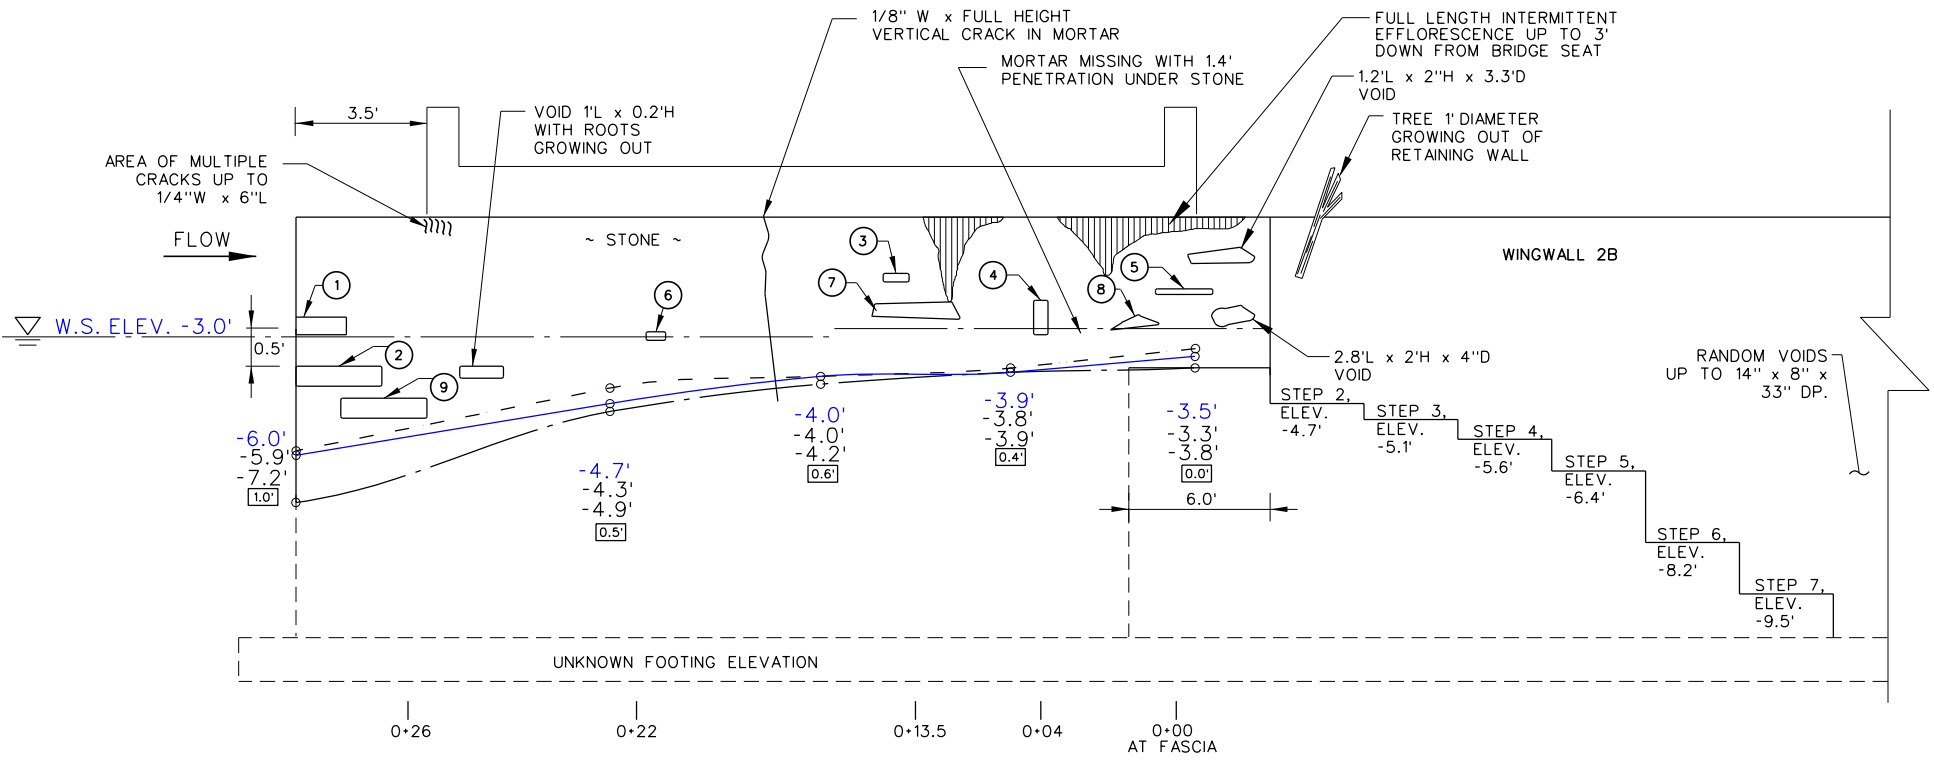
ABUTMENT 2
N.T.S.

VOID TABLE			
VOID NO.	ENGLISH DIMENSIONS		
	LENGTH	VERTICAL HEIGHT	PENETRATION
①	1.5'	0.3'	6.2'
②	1.5'	0.4'	1.5'
③	0.9'	0.3'	1.7'
④	1.5'	0.9'	1.0'
⑤	3.0'	0.5'	2.0'
⑥	0.5'	0.4'	2.9'
⑦	2.0'	0.4'	1.5'
⑧	0.5'	0.5'	2.5'
⑨	2.0'	0.7'	4.0'

(WITH LOSS OF FILL)

(WITH LOSS OF FILL, COARSE GRANULAR AND GRAVEL)

- UP TO 20% MORTAR LOSS ABOVE WATER LINE WITH UP TO 1.0' PENETRATION. BELOW THE WATER LINE, THERE IS 100% MORTAR LOSS WITH UP TO 1.0' PENETRATION.
- SEVERAL VOIDS HAVE BEEN PATCHED AND SOME MASONRY HAS BEEN REPOINTED.
