ADDENDUM NO. 4

LAWRENCE
Federal Aid Project No. CMQ-003S(733)X
Lawrence Manchester Rail Corridor (LMRC) Rail Trail

2023 INSPECTION OF THE ABANDONED B&M RAILROAD BRIDGE

OVER THE MERRIMACK RIVER

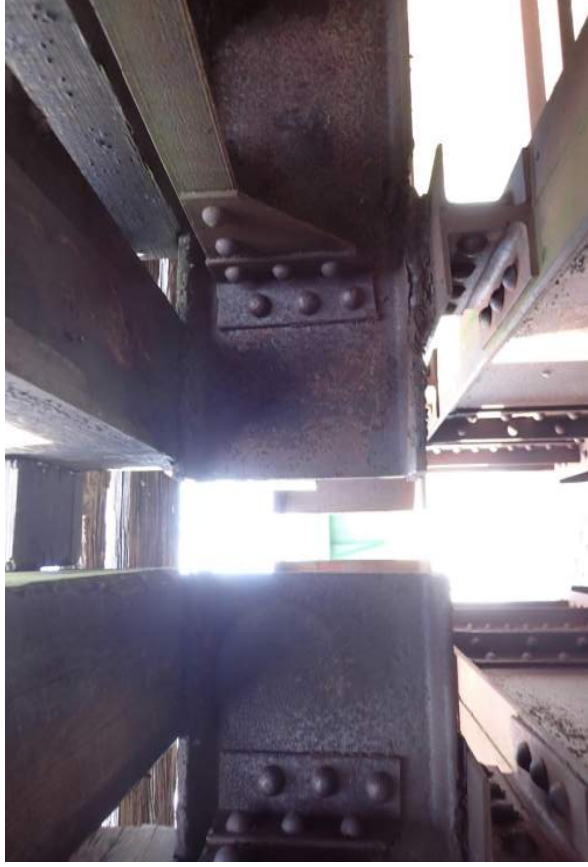
The stringer seat angles at the floorbeams typically have heavy pack rust between the outstanding legs of the angles and the stringer bottom flanges measuring up to 1" thick. Many of the stringers at the seat angles have heavy section loss and holes in the top and bottom flanges at the floorbeam connections. Isolated stringers have moderate to heavy section loss on the lower webs at the floorbeams with several locations exhibiting holes. In Span 6, at the North Abutment, all stringers have section loss along the lower web at the backwall measuring 1/8"-3/16" deep with scattered holes throughout. At Floorbeams FB1 and FB8 in each span, the stringers rest on bearings at the floorbeam top flanges. Scattered stringers at these floorbeams are floating or have pack rust between the bearing and stringer bottom flange (**Photo 1**). Specific locations of these deficiencies are as follows:

- Span 4, Stringer S8 at Floorbeam FB1: There is pack rust between the bearing and stringer bottom flange measuring 1/8" thick.
- Span 4, Stringers S2 and S5 at Floorbeam FB8: The stringers have pack rust between the bottom flange and bearing measuring 3/8" thick and 1-1/2" thick, respectively **(Photo 1)**.
- Span 5, Stringers S2 and S5 at Floorbeam FB1: The stringers have pack rust between the bottom flange and the bearing measuring up to 1-3/16" thick **(Photo 1)**.

<p style="text-align: center;">Photo 1</p> <p>Description: (Looking West) Stringer S2 at Floorbeam 8 of Span 4 and Floorbeam 1 of Span 5; View of heavy pack rust between the stringer bottom flanges and the bearings.</p> <p style="text-align: right;">MG2-18</p>	<p style="text-align: center;">Photo 2</p> <p>Description: (Looking Northeast) Stringer S2, west face in Panel 6 of Span 5; View of typical heavy deterioration to the stringer top flange with full width holes throughout the panel.</p> <p style="text-align: right;">MG2-20</p>

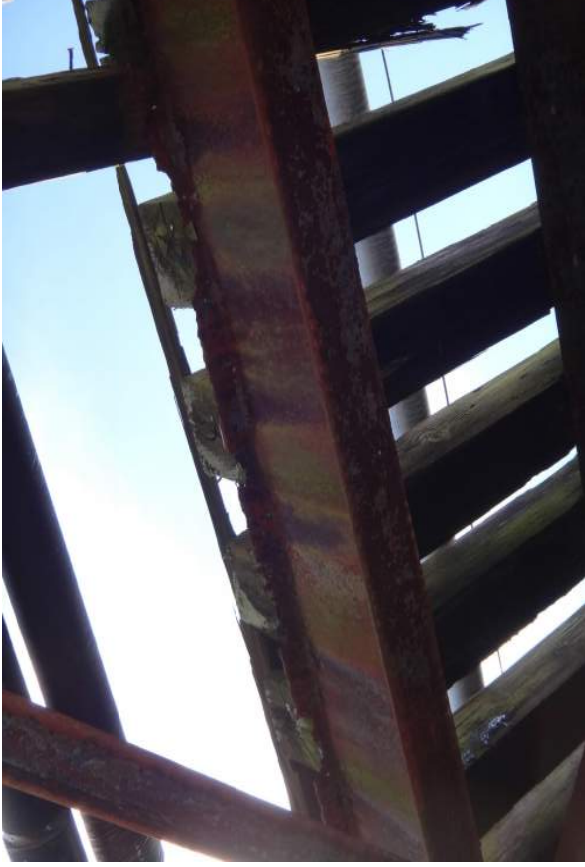
The rolled steel stringers are in **Fair** condition and exhibit heavy rust throughout. Many of the stringers exhibit severe deterioration to the top flanges with full width holes throughout (**Photos 1 to 5**). It appears large coupons were taken from the center of the web of three (3) stringers in Span 6 by torch cutting at approximately the center of the panel (**Photo 6**). The locations and sizes of the coupons removed are as follows:

<p style="text-align: center;">Photo 3</p> <p>Description: (Looking West) Stringer S8, east face in Panel 3 of Span 5; View of typical heavy deterioration to the stringer top flange with full width holes throughout the panel.</p> <p style="text-align: right;">JT2-25</p>	<p style="text-align: center;">Photo 4</p> <p>Description: (Looking Southeast) Stringer S2, top flange in Panel 5 near Floorbeam 5 in Span 6; View of heavy deterioration to the top flange with full width holes.</p> <p style="text-align: right;">MS1-44</p>

Refer to the table below outlining specific locations of severe deterioration to stringers where stringers will most likely need to be replaced. Additional stringers have been added to the table now that WSP has a better understanding of the proposed deck configuration and planned attachment to the superstructure.

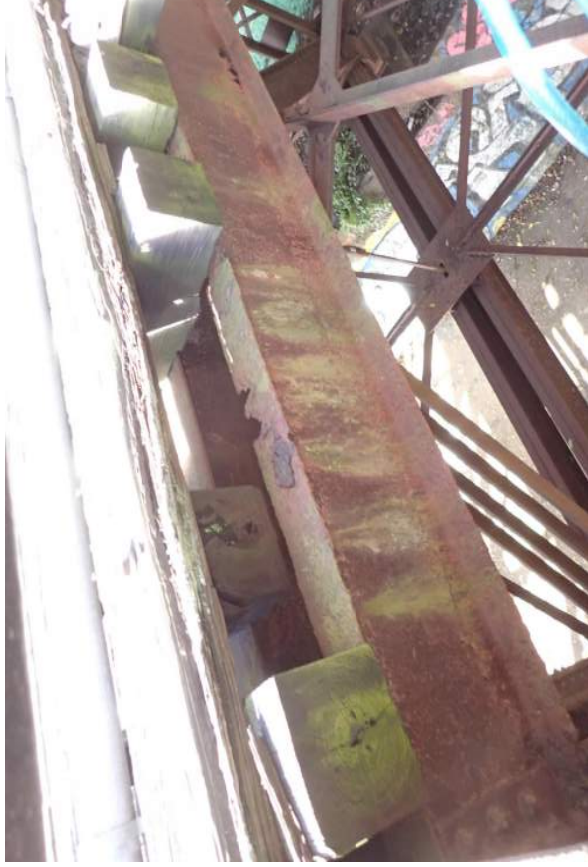
<p>Photo 5 Description: (Looking Northwest) Stringer S8, east face in Panel 7 of Span 6; View of heavy deterioration to the top flange and lower web with holes.</p> <p>MG1-37</p>

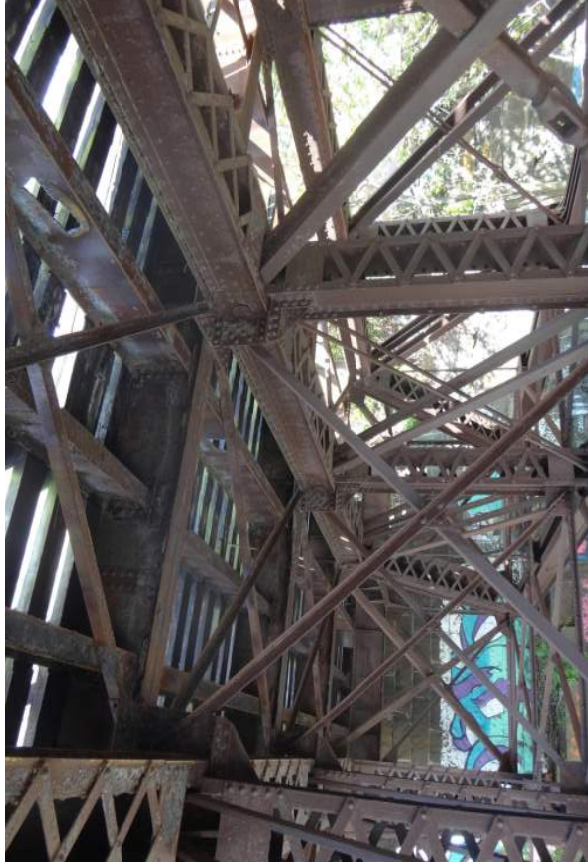
<p>Photo 6 Description: (Looking Northeast) Stringer S6, Panels 4, 5 & 7 in Span 6; View of torch-cut coupons taken from the center of the stringer webs in each panel.</p> <p>MS2-20</p>
--	--

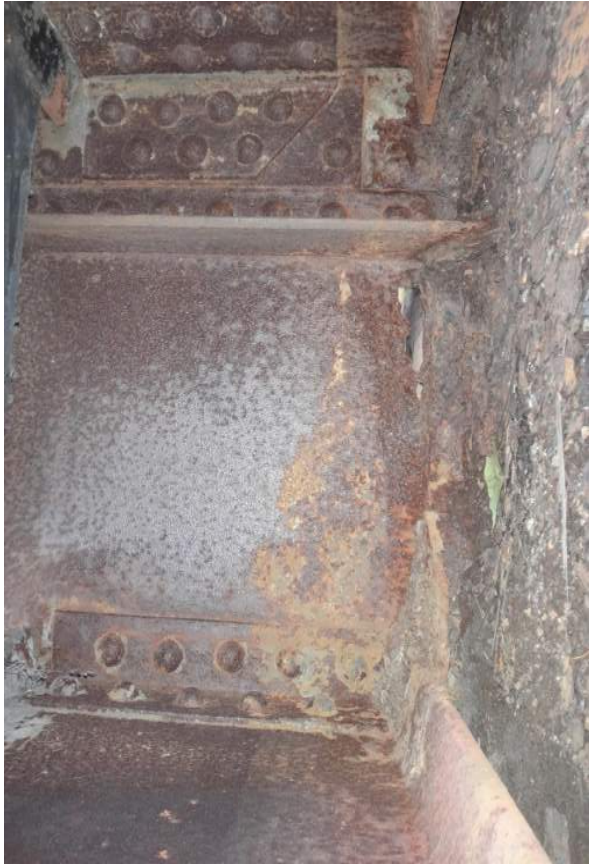
<p style="text-align: center;">Photo 7</p> <p>Description: (Looking North) South face of Floorbeam 3 in Span 6 at the west side of Truss 3; View of a lower web hole and adjacent section loss to the web. Note the debris on the bracing plate below.</p> <p style="text-align: right;">BG2-15</p>	<p style="text-align: center;">Photo 8</p> <p>Description: (Looking North) Span 2, Truss 1, L3-L4 at L4, Eyebars 1 and 2; View of heavy pack rust between the eyebars and section loss up to 1/4" deep beyond.</p> <p style="text-align: right;">MG2-11</p>

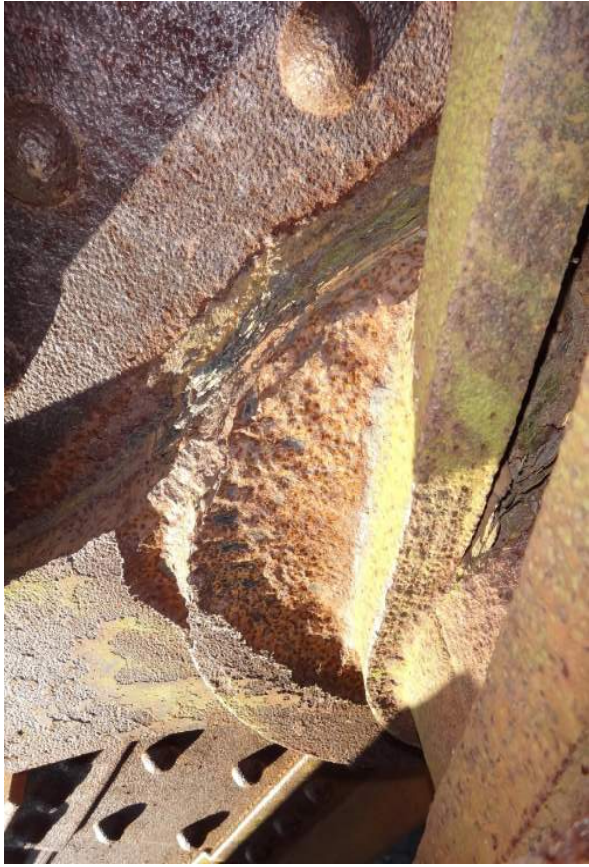
<p>Photo 9 Description: (Looking Southwest) Span 2, Truss 4, L3-L4 at L4, Eyebars 3; View of section loss around the top circumference up to 5/16" deep.</p> <p>JT2-14</p>

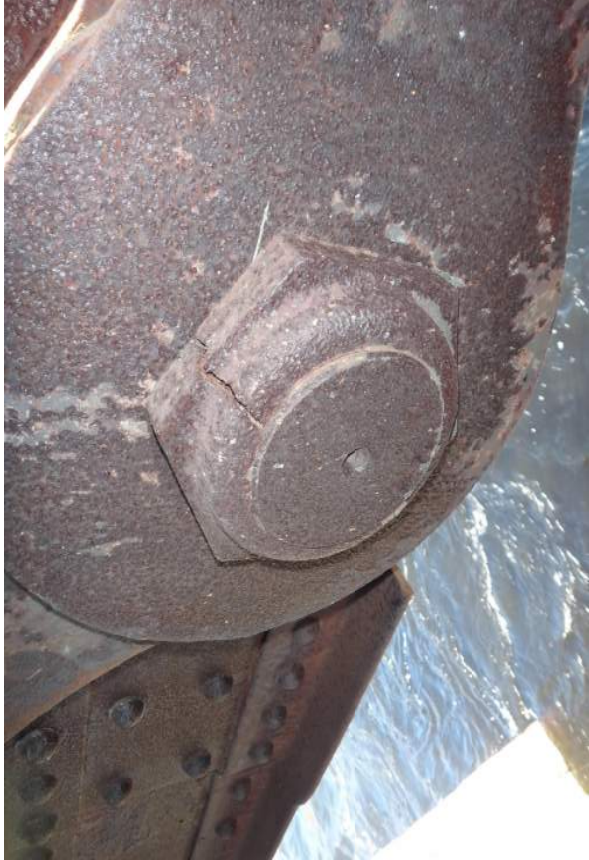
<p>Photo 10 Description: (Looking Northeast) Span 2, Truss 4, west pin nut at Panel Point L6; View of the pin nut cracked at the top.</p> <p>JT2-11</p>
--	--

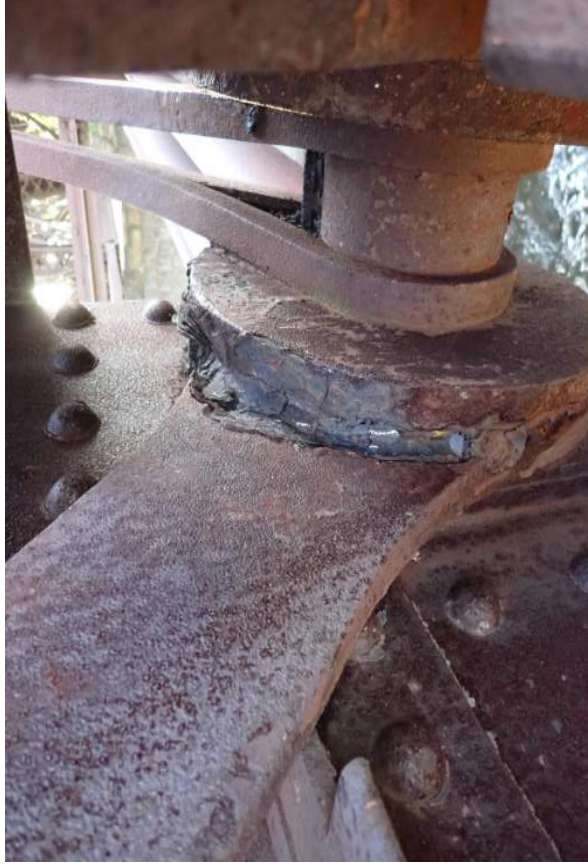
<p style="text-align: center;">Photo 11</p> <p>Description: (Looking Southeast) Span 3, Truss 1, L6-U7 at L6, Eyebars 3; View of section loss along the west face up to 1/2" deep.</p> <p style="text-align: right;">MG2-03</p>	<p style="text-align: center;">Photo 12</p> <p>Description: (Looking North) Span 4, Truss 1, U4-L5 at L5, Eyebars 1 & 2; View of pack rust and section loss between the eyebars.</p> <p style="text-align: right;">MG1-30</p>

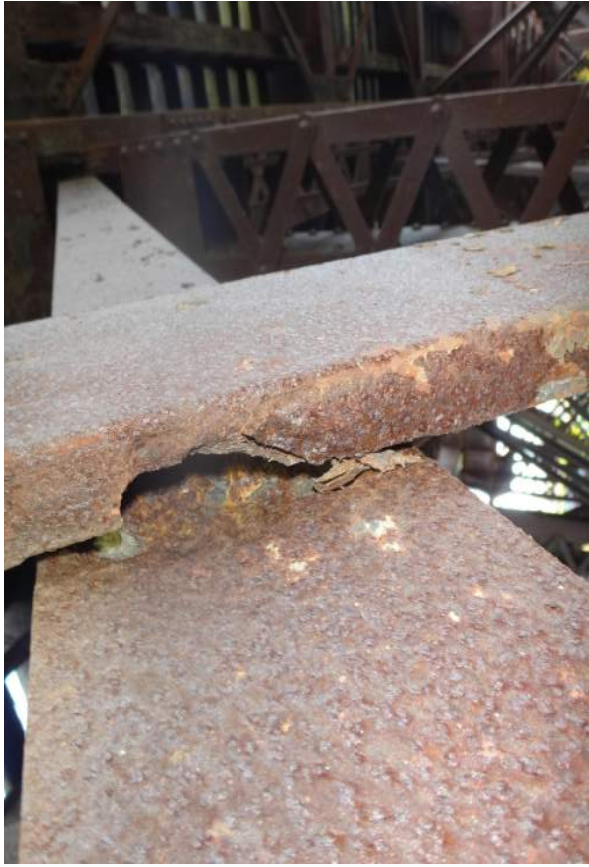
<p>Photo 13</p> <p>Description: (Looking Southeast) Span 4, Truss 2, L4-U5 & U4-L5 at midpanel; View of pack rust up to 1/4" thick and section loss up to 1/2" thick at each eyebar.</p> <p>MS1-40</p>

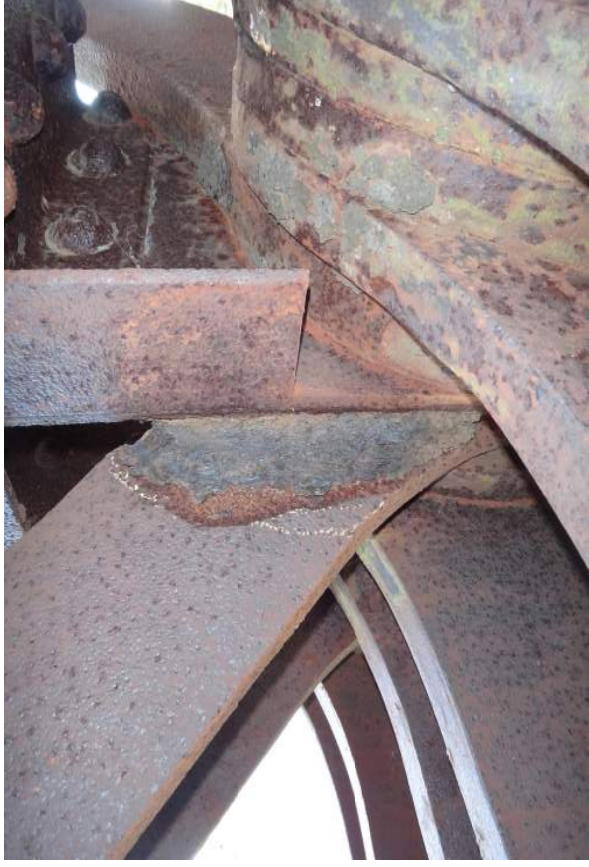
<p>Photo 14</p> <p>Description: (Looking Southeast) Span 4, Truss 4, L4-U5 at L4, Eyebars 1; View of pack rust and up to 5/16" deep section loss.</p> <p>JT1-20</p>
--	--

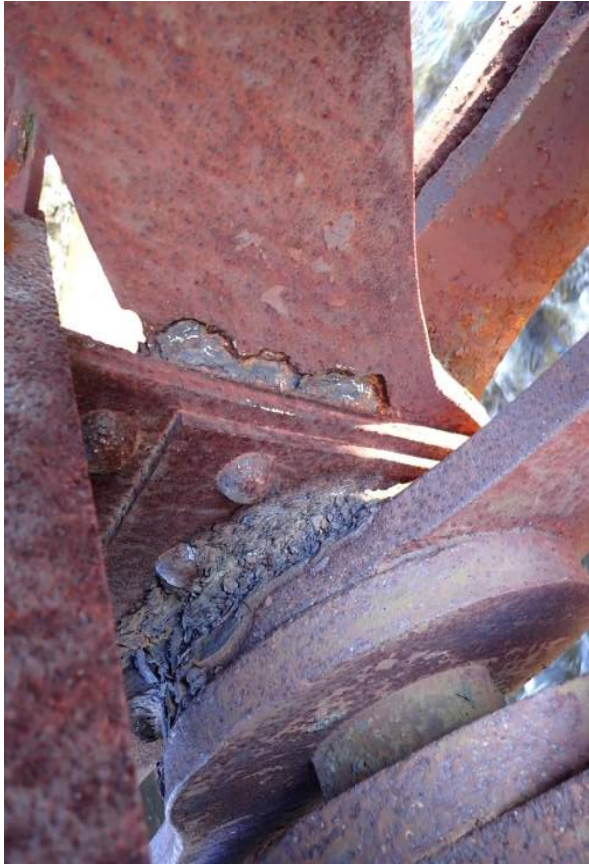
<p style="text-align: center;">Photo 15</p> <p>Description: (Looking Northeast) Span 5, Truss 1, U3-L4 at L4, Eyebars 2; View of section loss along the west face up to 3/8" deep.</p> <p style="text-align: right;">MG1-23</p>	<p style="text-align: center;">Photo 16</p> <p>Description: (Looking Northwest) Span 5, Truss 3, L6-U7 at U7, Eyebars 1; View of pack rust and section loss up to 3/8" deep.</p> <p style="text-align: right;">BG1 - (18)</p>

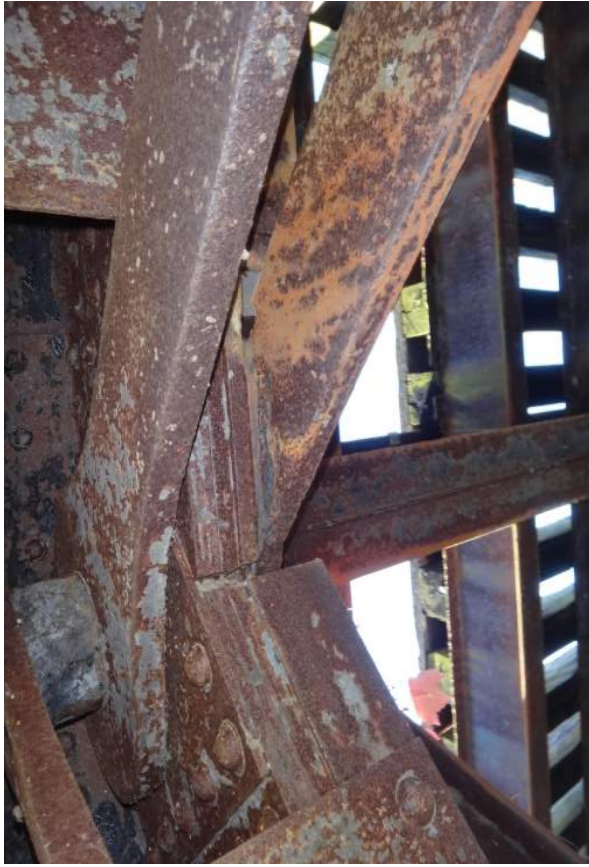
<p style="text-align: center;">Photo 17</p> <p>Description: (Looking Southwest) Span 5, Truss 4, U2-L3 at U2, Eyebars 1; View of 3/8" deep section loss along the underside of the bottom chord.</p> <p style="text-align: right;">JT1-17</p>	<p style="text-align: center;">Photo 18</p> <p>Description: (Looking Northwest) Span 5, Truss 4, L4-U5 & U4-L5 at midpanel; View of section loss at the intersection up to 1/2" deep.</p> <p style="text-align: right;">JT1-15</p>

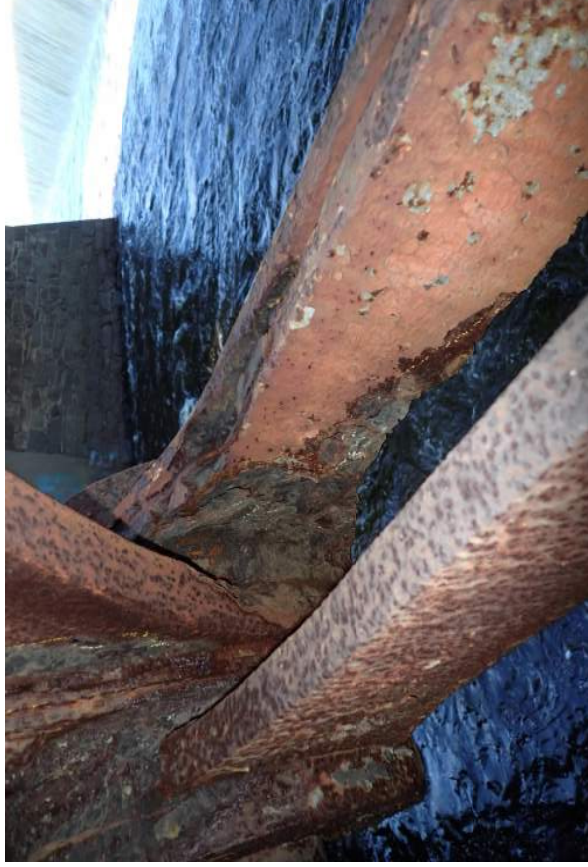
<p style="text-align: center;">Photo 21</p> <p>Description: (Looking Southwest) Span 6, Truss 1, L5-L6 at L5, Eyebar 2; View of the east face with heavy section loss up to 1/2" deep.</p> <p style="text-align: right;">MG1-09</p>	<p style="text-align: center;">Photo 22</p> <p>Description: (Looking North) Span 6, Truss 1, L7-L8; View of the bottom chord with the west built-up member bent east.</p> <p style="text-align: right;">MG1-04</p>

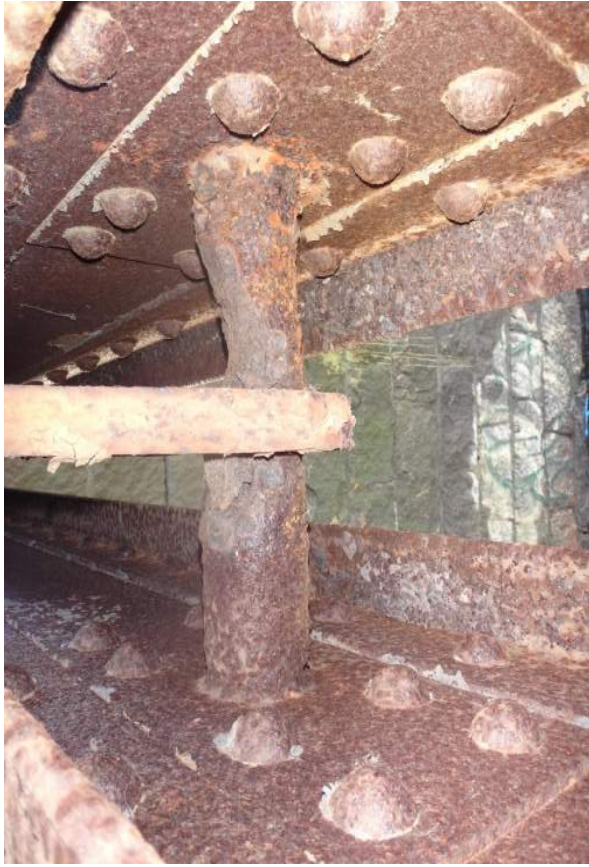
<p style="text-align: center;">Photo 23</p> <p>Description: (Looking South) Span 6, Truss 2, Pin at L2; View of missing pin spacers and heavy section loss to the west side of the pin.</p> <p style="text-align: right;">MS1-22</p>	<p style="text-align: center;">Photo 24</p> <p>Description: (Looking Southeast) Span 6, Truss 2, L4-U5 Eyebar 1 and L4-L5 Eyebars 2 & 3 at L4; View of up to 5/16" deep section loss along the west face of the eyebars.</p> <p style="text-align: right;">MS1-18</p>

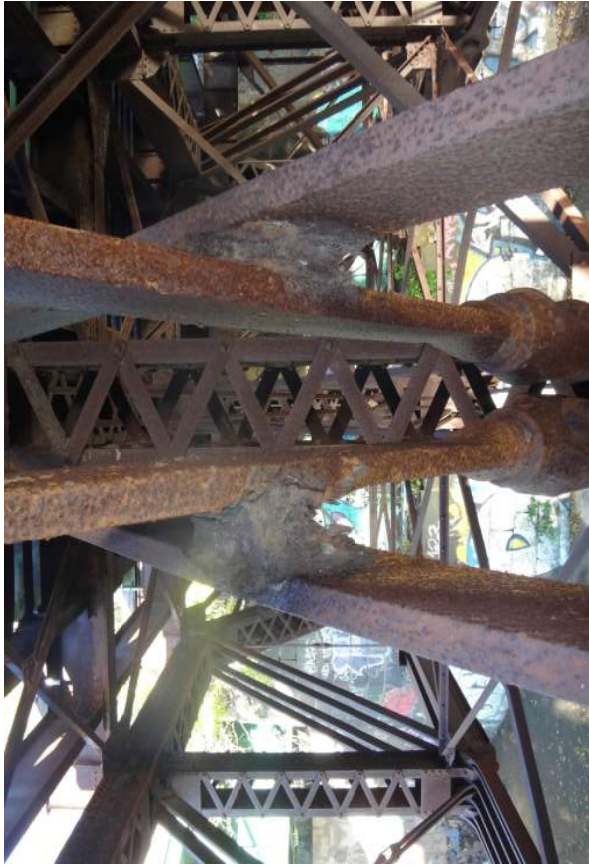
<p style="text-align: center;">Photo 25</p> <p>Description: (Looking North) Span 6, Truss 2, L4-U5 & U4-L5 at midpanel; View of up to 2" thick pack rust and up to 3/4" deep section loss at the intersection of the eyebars.</p> <p style="text-align: right;">MS1-17</p>	<p style="text-align: center;">Photo 26</p> <p>Description: (Looking Northwest) Span 6, Truss 2, L4-L5 at L5, Eyebars 1, 2 & 4; View of section loss along the east face of the eyebars up to 5/16" deep.</p> <p style="text-align: right;">MS1-15</p>

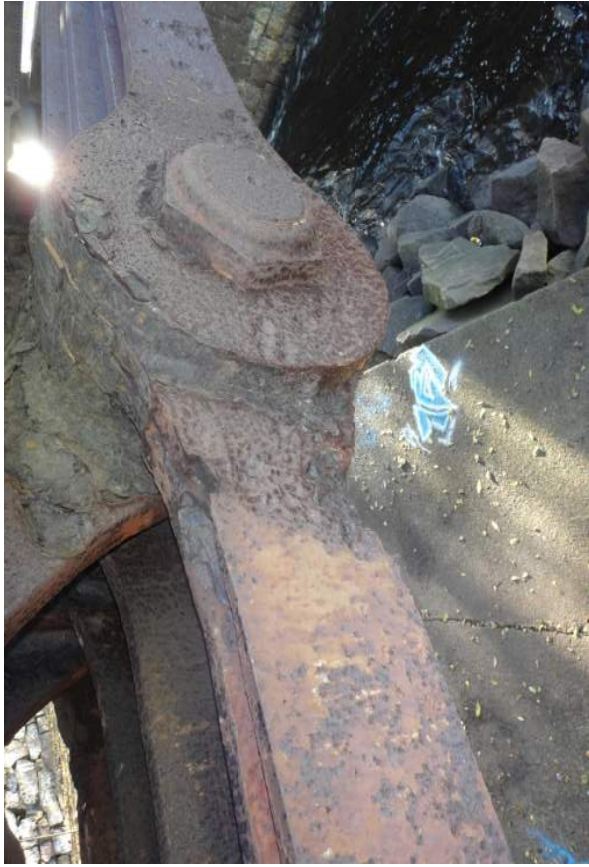
<p style="text-align: center;">Photo 27</p> <p>Description: (Looking Southeast) Span 6, Truss 2, L5-L6 Eyebar 1 and L5-U6 Eyebar 1 at L5; View of heavy section loss to the west face of the eyebars and 100% section loss along the base of L5-L6 Eyebar 1 up to 1/2" high.</p> <p style="text-align: right;">MS1-12</p>	<p style="text-align: center;">Photo 28</p> <p>Description: (Looking Northwest) Span 6, Truss 2, L5-L6 at L6, Eyebars 1 to 4; View of heavy section loss along the east face of the eyebars up to 7/16" deep.</p> <p style="text-align: right;">MS1-10</p>

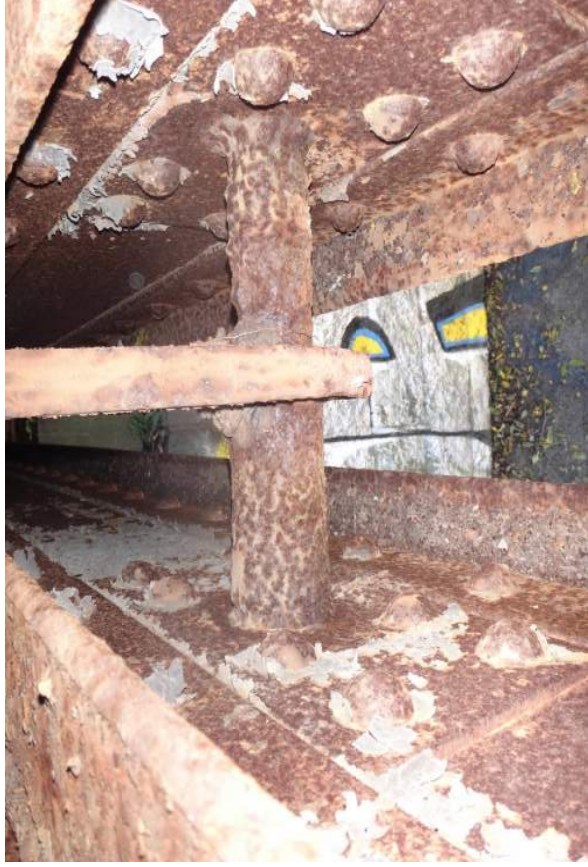
<p style="text-align: center;">Photo 29</p> <p>Description: (Looking North) Span 6, Truss 2, Pin at L6; View of missing pin spacers and heavy pitting/section loss to the pin.</p> <p style="text-align: right;">MS1-06</p>

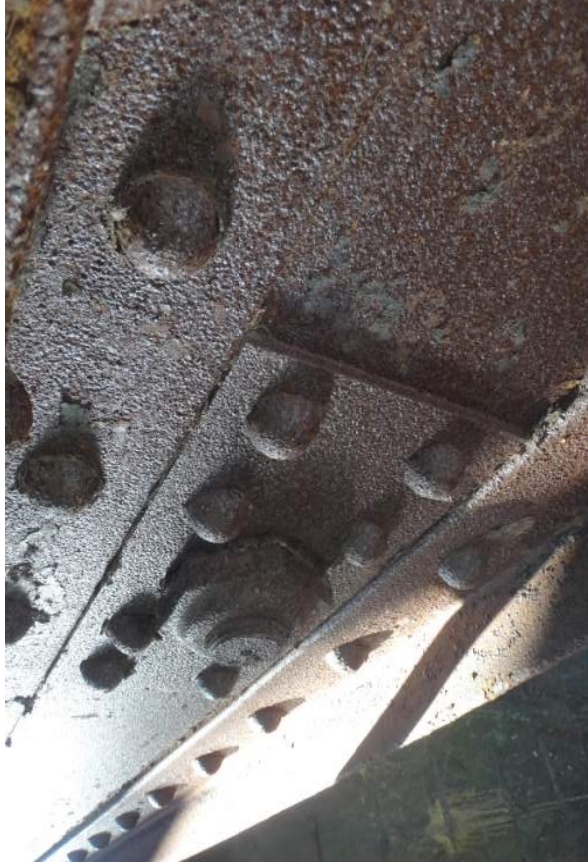
<p style="text-align: center;">Photo 30</p> <p>Description: (Looking Southwest) Span 6, Truss 3, west pin nut at L2; View of pack rust and a gap at the pin nut.</p> <p style="text-align: right;">BG1 - (13)</p>
---	--

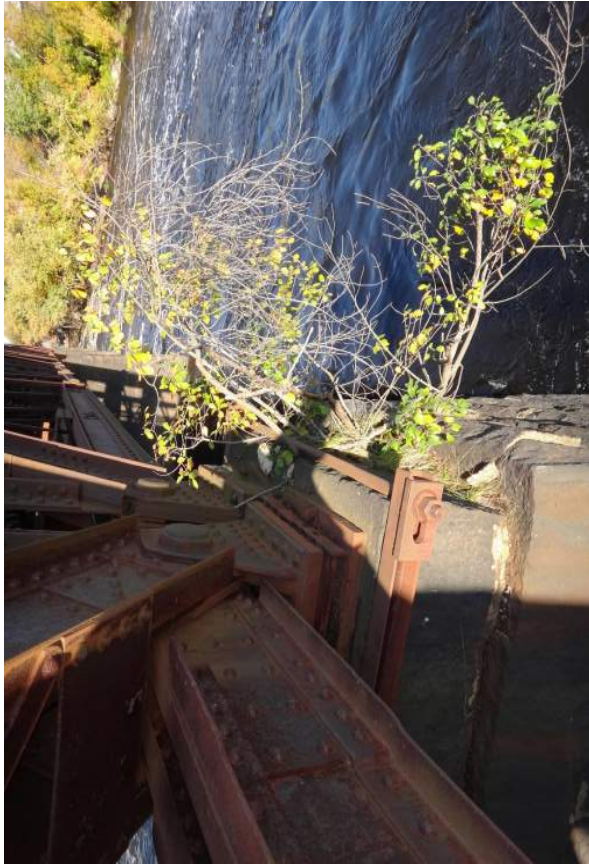
<p style="text-align: center;">Photo 39</p> <p>Description: (Looking North) Truss 4, Spans 1 & 2 bearings at Pier 1: View of vegetation growing between the pedestal stones and the east retrofit rod.</p> <p style="text-align: right;">JT2-22</p>	<p style="text-align: center;">Photo 40</p> <p>Description: (Looking West) Truss 2, Spans 2 & 3 bearings at Pier 2; View of typical pack rust between the truss bottom chord members and the bearing gusset plates.</p> <p style="text-align: right;">MS2-08</p>

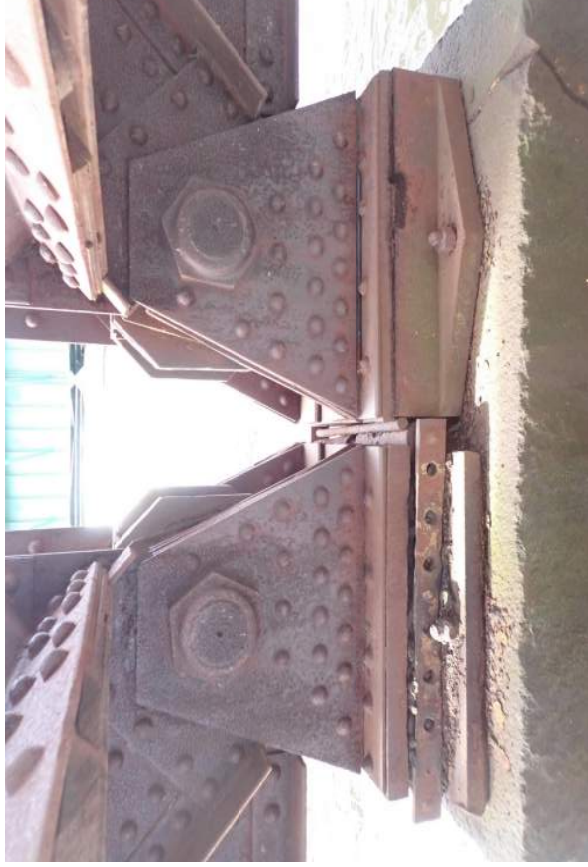
<p style="text-align: center;">Photo 41</p> <p>Description: (Looking West) Truss 1, Spans 3 & 4 bearings at Pier 3; View of the the Span 3 roller keeper plate detached at the north end.</p> <p style="text-align: right;">MG1-34</p>	<p style="text-align: center;">Photo 42</p> <p>Description: (Looking West) Truss 1, Spans 4 & 5 bearings at Pier 4; View of a typical missing anchor bolt at the Span 5 bearing and improper movement of the rollers.</p> <p style="text-align: right;">MG1-26</p>

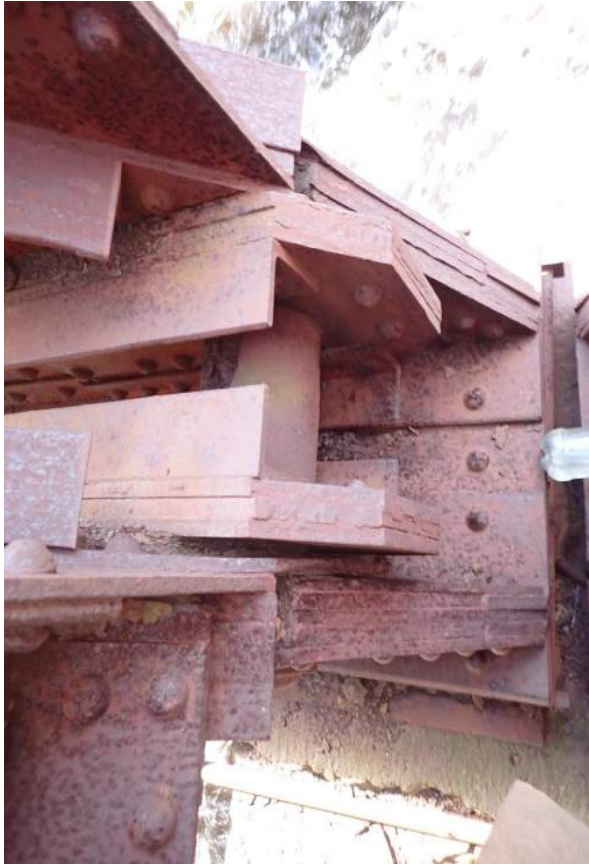
<p style="text-align: center;">Photo 43</p> <p>Description: (Looking South) Truss 1, Span 5 bearing at Pier 5; View of up to 1" thick pack rust between the bearing plates and bottom chord.</p> <p style="text-align: right;">MG2-21</p>

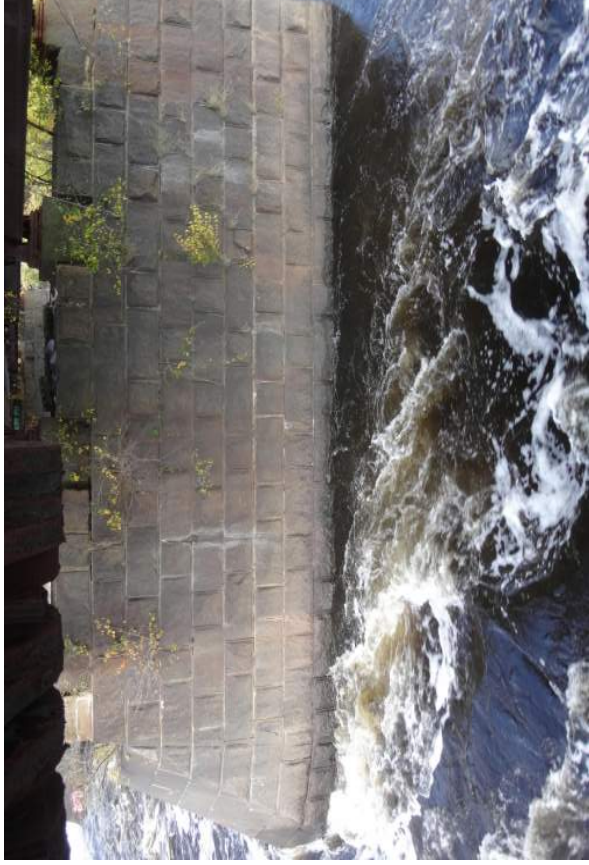
<p style="text-align: center;">Photo 44</p> <p>Description: (Looking North) South face of Pier 3; View of typical vegetation growth between the stones with cracked and missing mortar throughout.</p> <p style="text-align: right;">MS2-17</p>

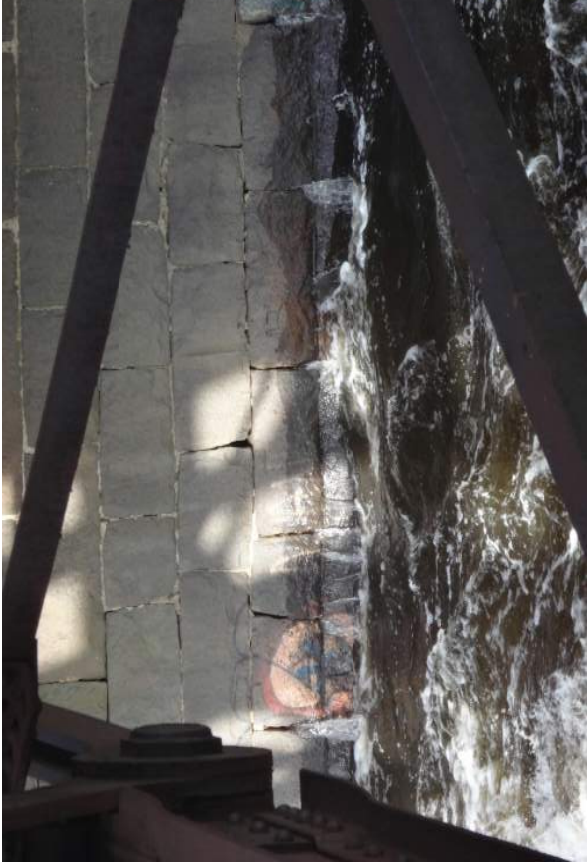
- At the west end, the south face at the lower horizontal masonry joint located just above the waterline has several locations with water flowing through the stones from the opposite face due to high water flow at this location (**Photo 45**).
- The Truss 1 bearing pedestal stones have retrofit rods installed.
- At the northwest corner, the 3rd, 4th and 5th row of stones from the top are broken and spalled for the full height below Truss 1 with several previous retrofit rods in place.
- The north face has graffiti at the base.

<p>Photo 45</p> <p>Description: (Looking North) South face of Pier 5 below Truss Bay 2; View of water flowing between the lower row of stones.</p> <p>MS2-19</p>	<p>Photo 46</p> <p>Description:</p> <p>0</p>
--	--
