Subject: On-Call Asbestos, Lead, Air Quality & Demolition Compliance  
Agreement No.: 8.07-01 (18)  
HazMat Inspection - Bridge Nos. 00388 & 00389, Route 17 & New London Turnpike  
Interchange, Glastonbury, CT  
ConnDOT Assignment No. 519-6097  
ConnDOT Project No. 53-189  
TRC Project No. 289951.6097.0710

TRC performed a limited survey for hazardous building materials associated with the replacement of Bridge Nos. 00388 & 00389, Route 17 & New London Turnpike Interchange in Glastonbury, Connecticut. Results of the survey identified lead paint to be present on the structural steel/metal bridge railing components and concrete abutments of Bridge Nos. 00388 & 00389. Results obtained from TCLP waste stream sampling and analysis for leachable lead from the paint on the structural steel characterized the paint waste stream at Bridge No. 00388 as CTDEEP/RCRA hazardous waste. At Bridge No. 00389, results obtained from TCLP waste stream sampling and analysis for leachable lead from the paint on the structural steel and metal bridge railing characterized the paint waste stream as CTDEEP/RCRA hazardous waste. Results obtained from TCLP waste stream sampling and analysis for leachable lead f

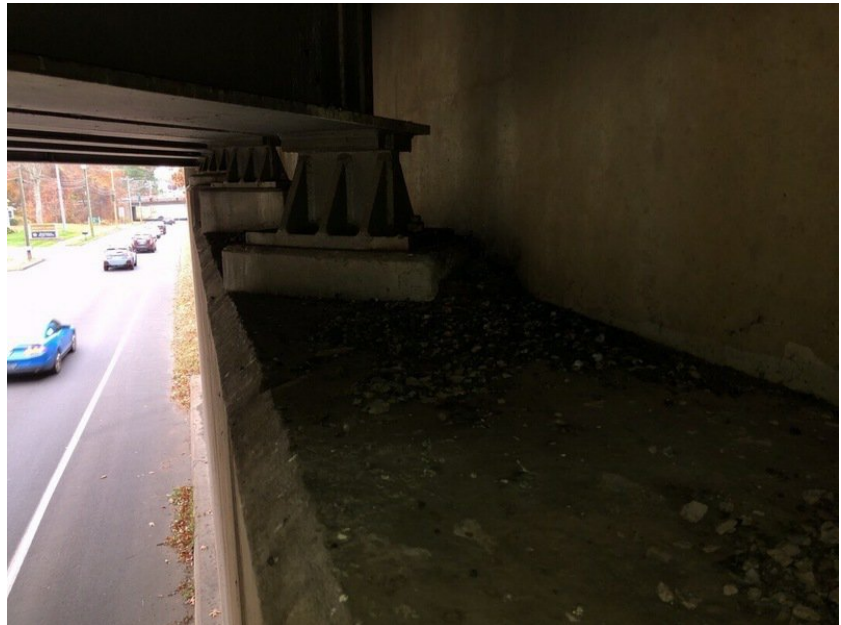
Bridge/Sign/Light Pole/Traffic Signal No.	00389
Accessibility	Accessible
Paint on Structure (s)?	Yes
Paint on what Components/Structure(s)?	Painted railings
Suspect Asbestos Containing Materials Identified on Structure	Yes
Guano Present?	Yes
Guano Locations	Underside abutments
Guano Square Footage	75
