Maura Healey, Governor
Kimberley Driscoll, Lieutenant Governor
Monica Tibbits-Nutt, Secretary & CEO
Jonathan L. Gulliver, Highway Administrator

January 15, 2025

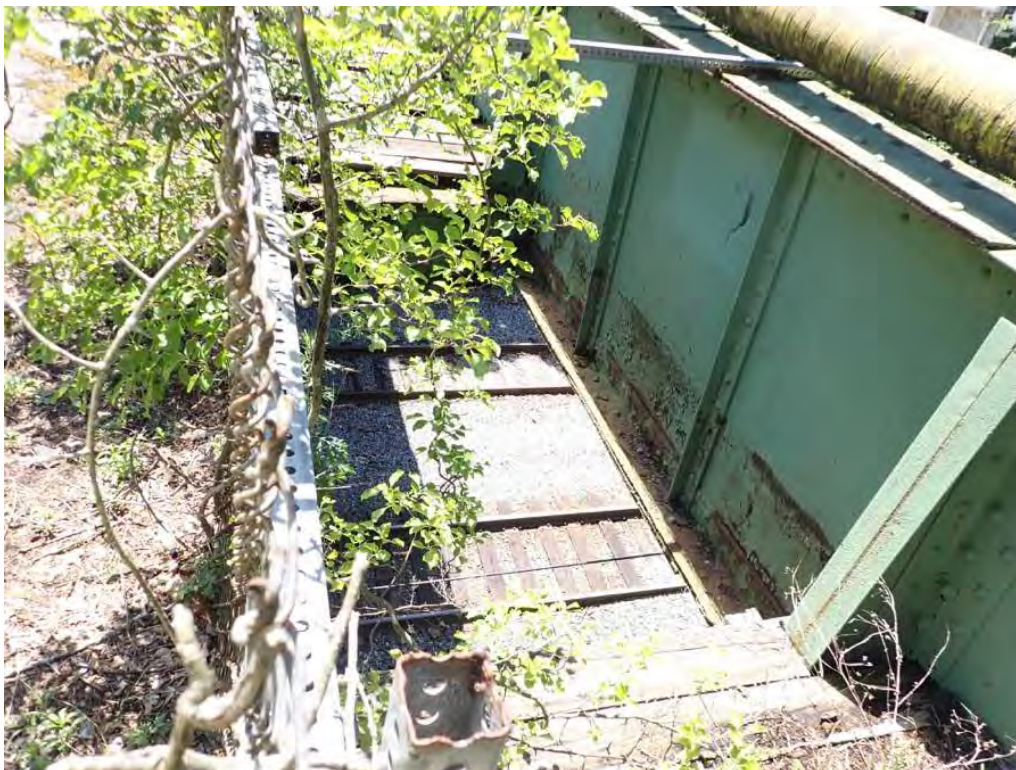
Photo 5: West sidewalk, missing section.

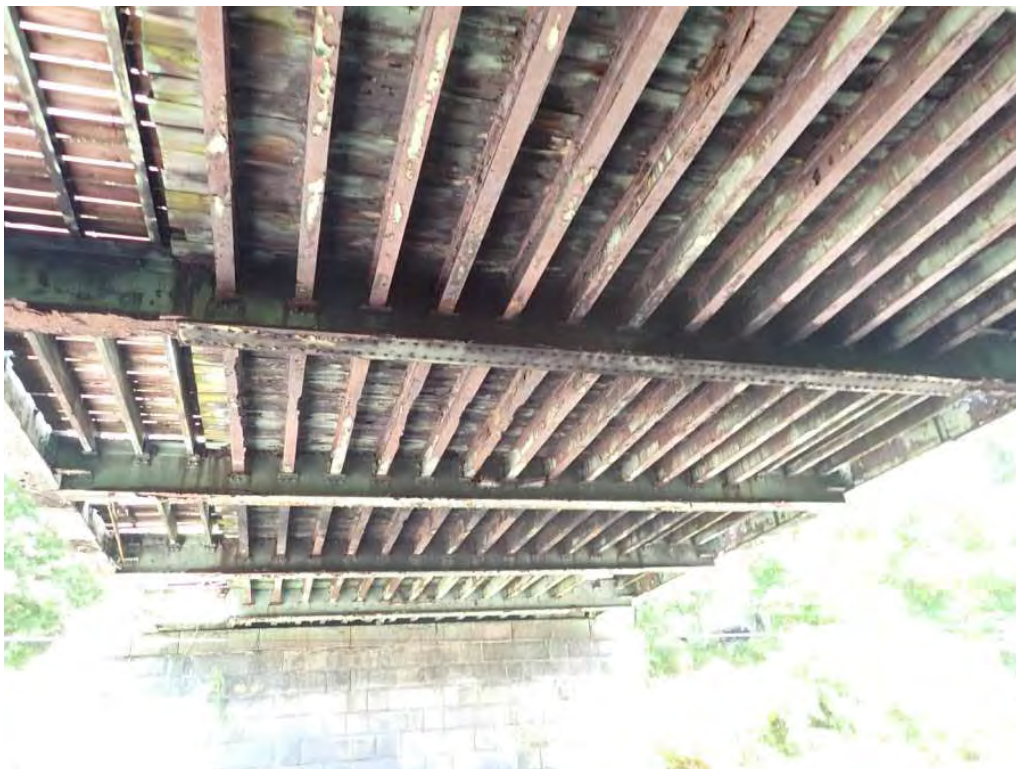
Photo 6: Underside, looking north.

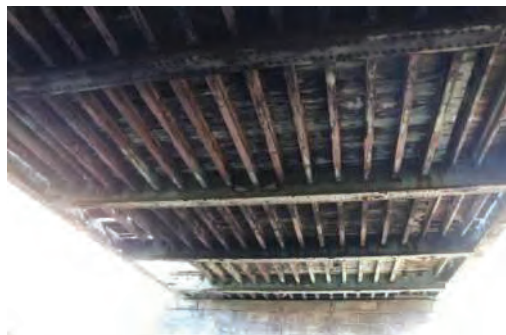
View of the underside of the bridge.

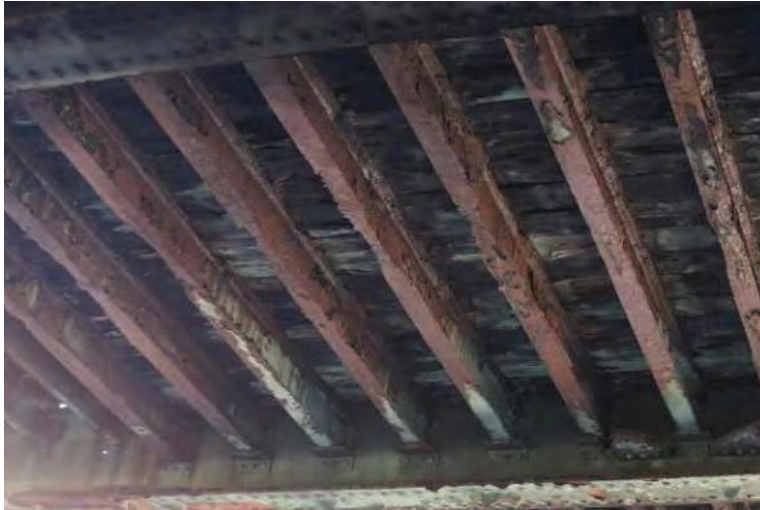
Typical condition of the stringers, showing significant section loss to the bottom flanges.

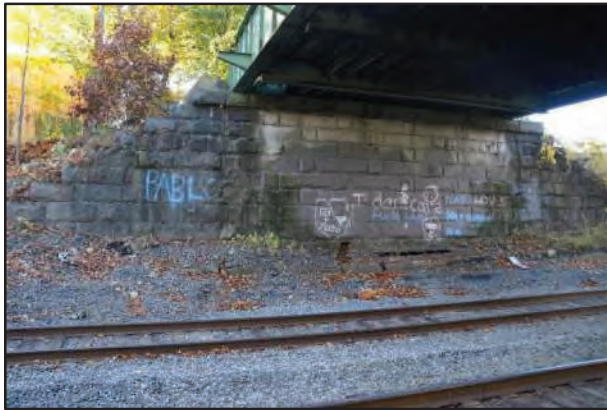
South Abutment, showing general condition of the abutment and wingwalls.

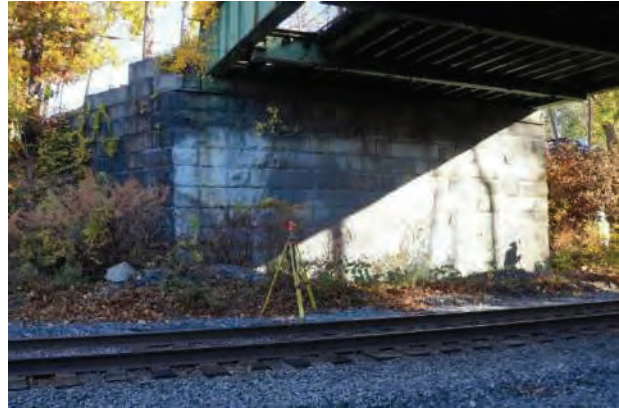
North Abutment, showing general condition of the abutment.

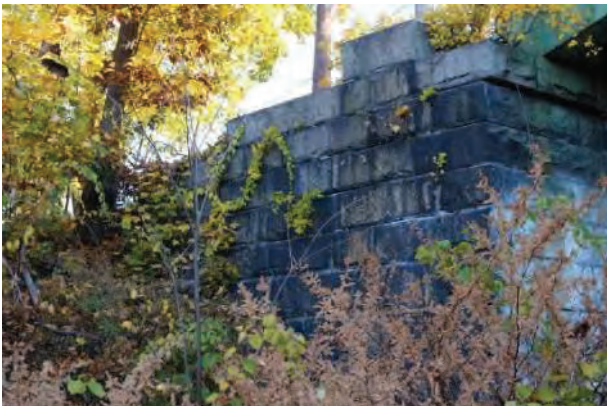
Typical condition of the North Abutment Wingwalls.

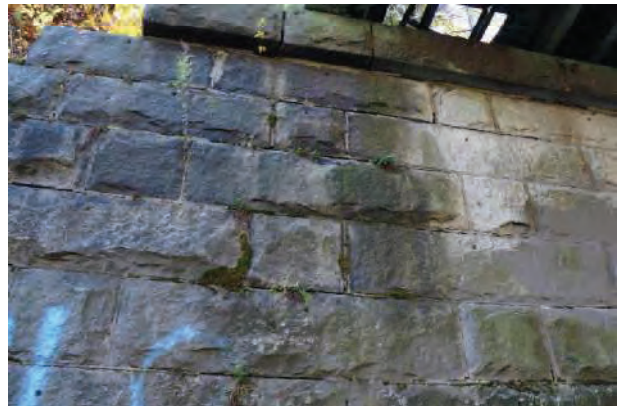
Typical example of area of deteriorated or missing mortar (South Abutment, near bridge seat, shown).

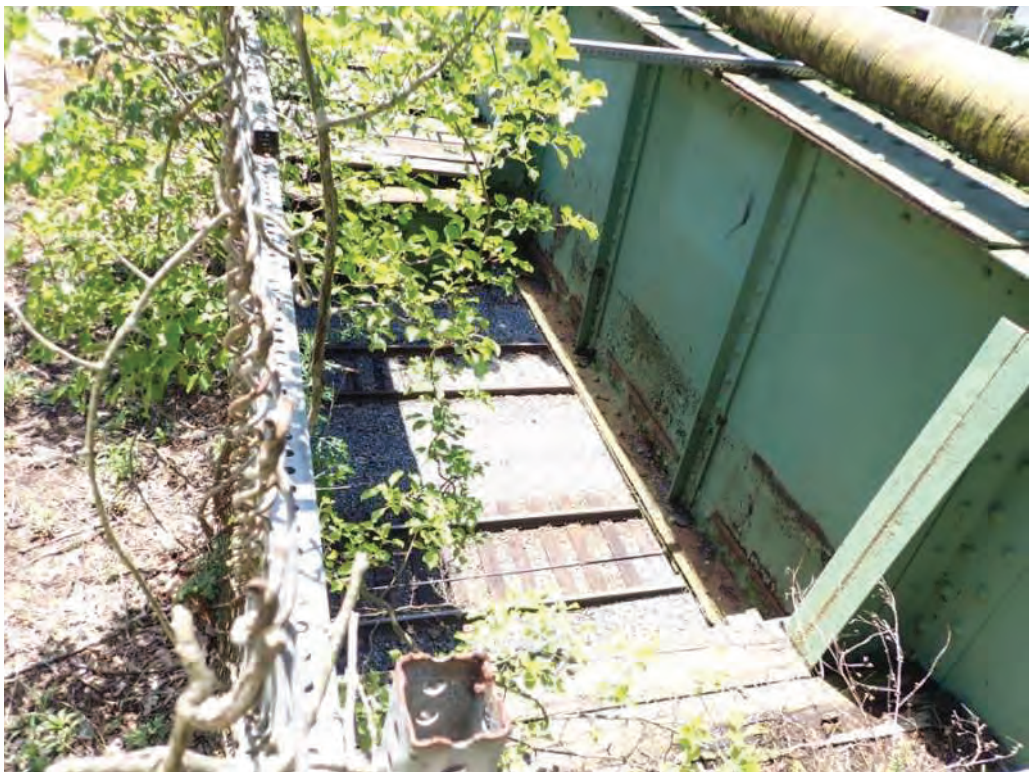
Photo 5: West sidewalk, missing section.

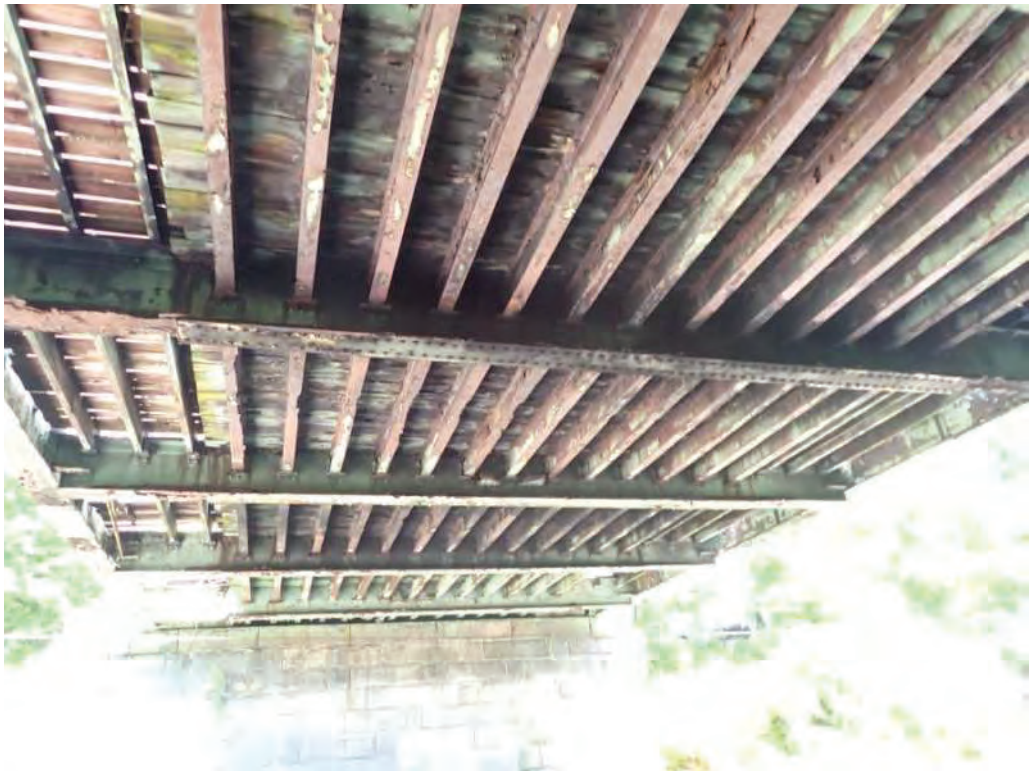
Photo 6: Underside, looking north.

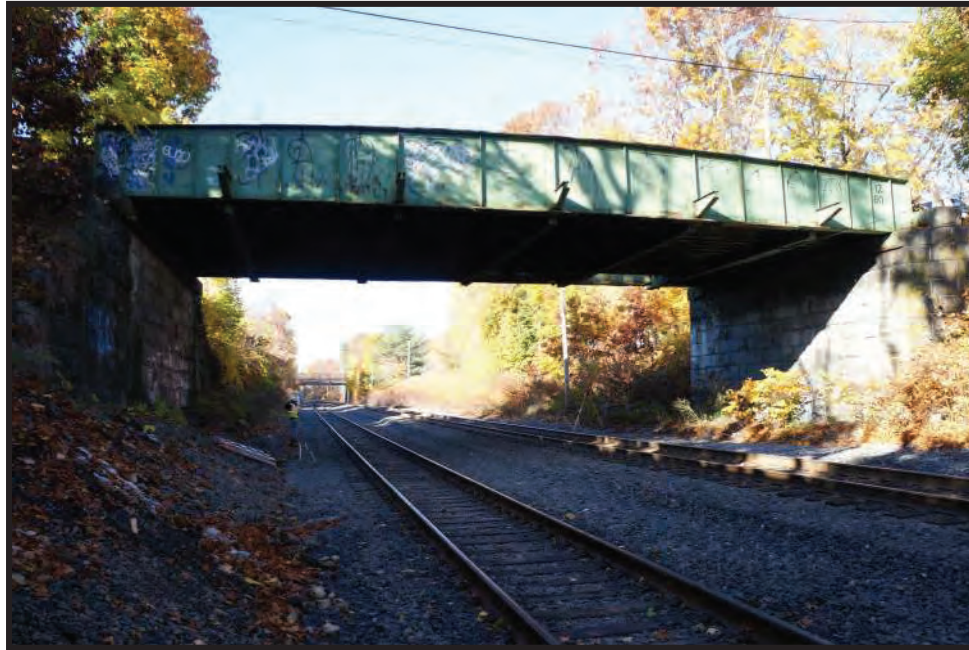
Photo 1: East elevation of the bridge, looking West.

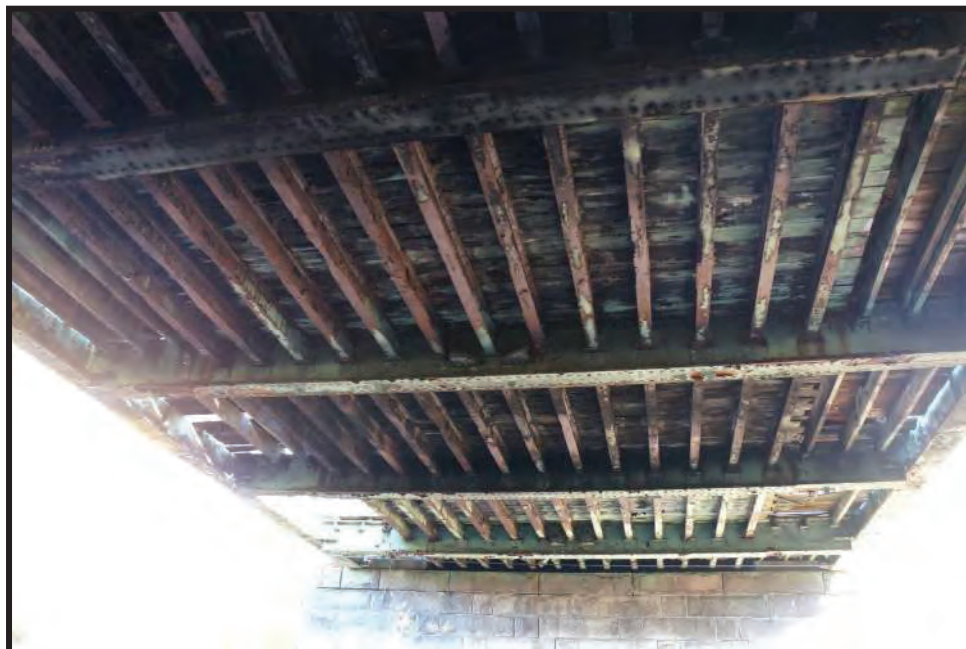
Photo 5: Typical condition of the underside of the bridge, looking North

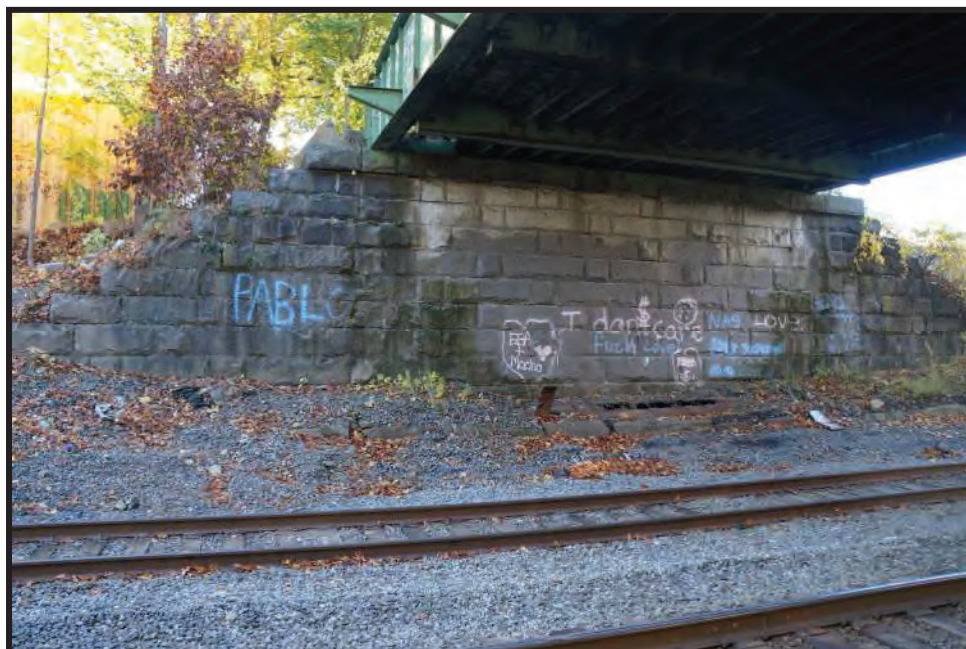
Photo 6: Typical condition of the abutments (South Abutment shown), looking South.

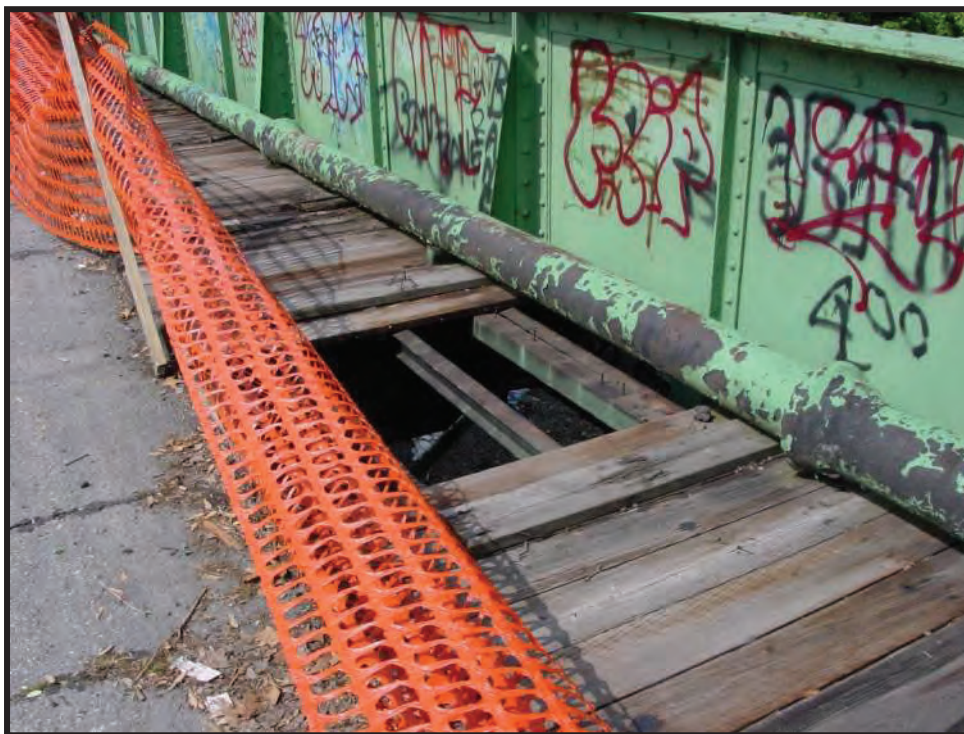
Photo 7: Water utility attached to the top of the East sidewalk (photo from 2001), looking Northeast.

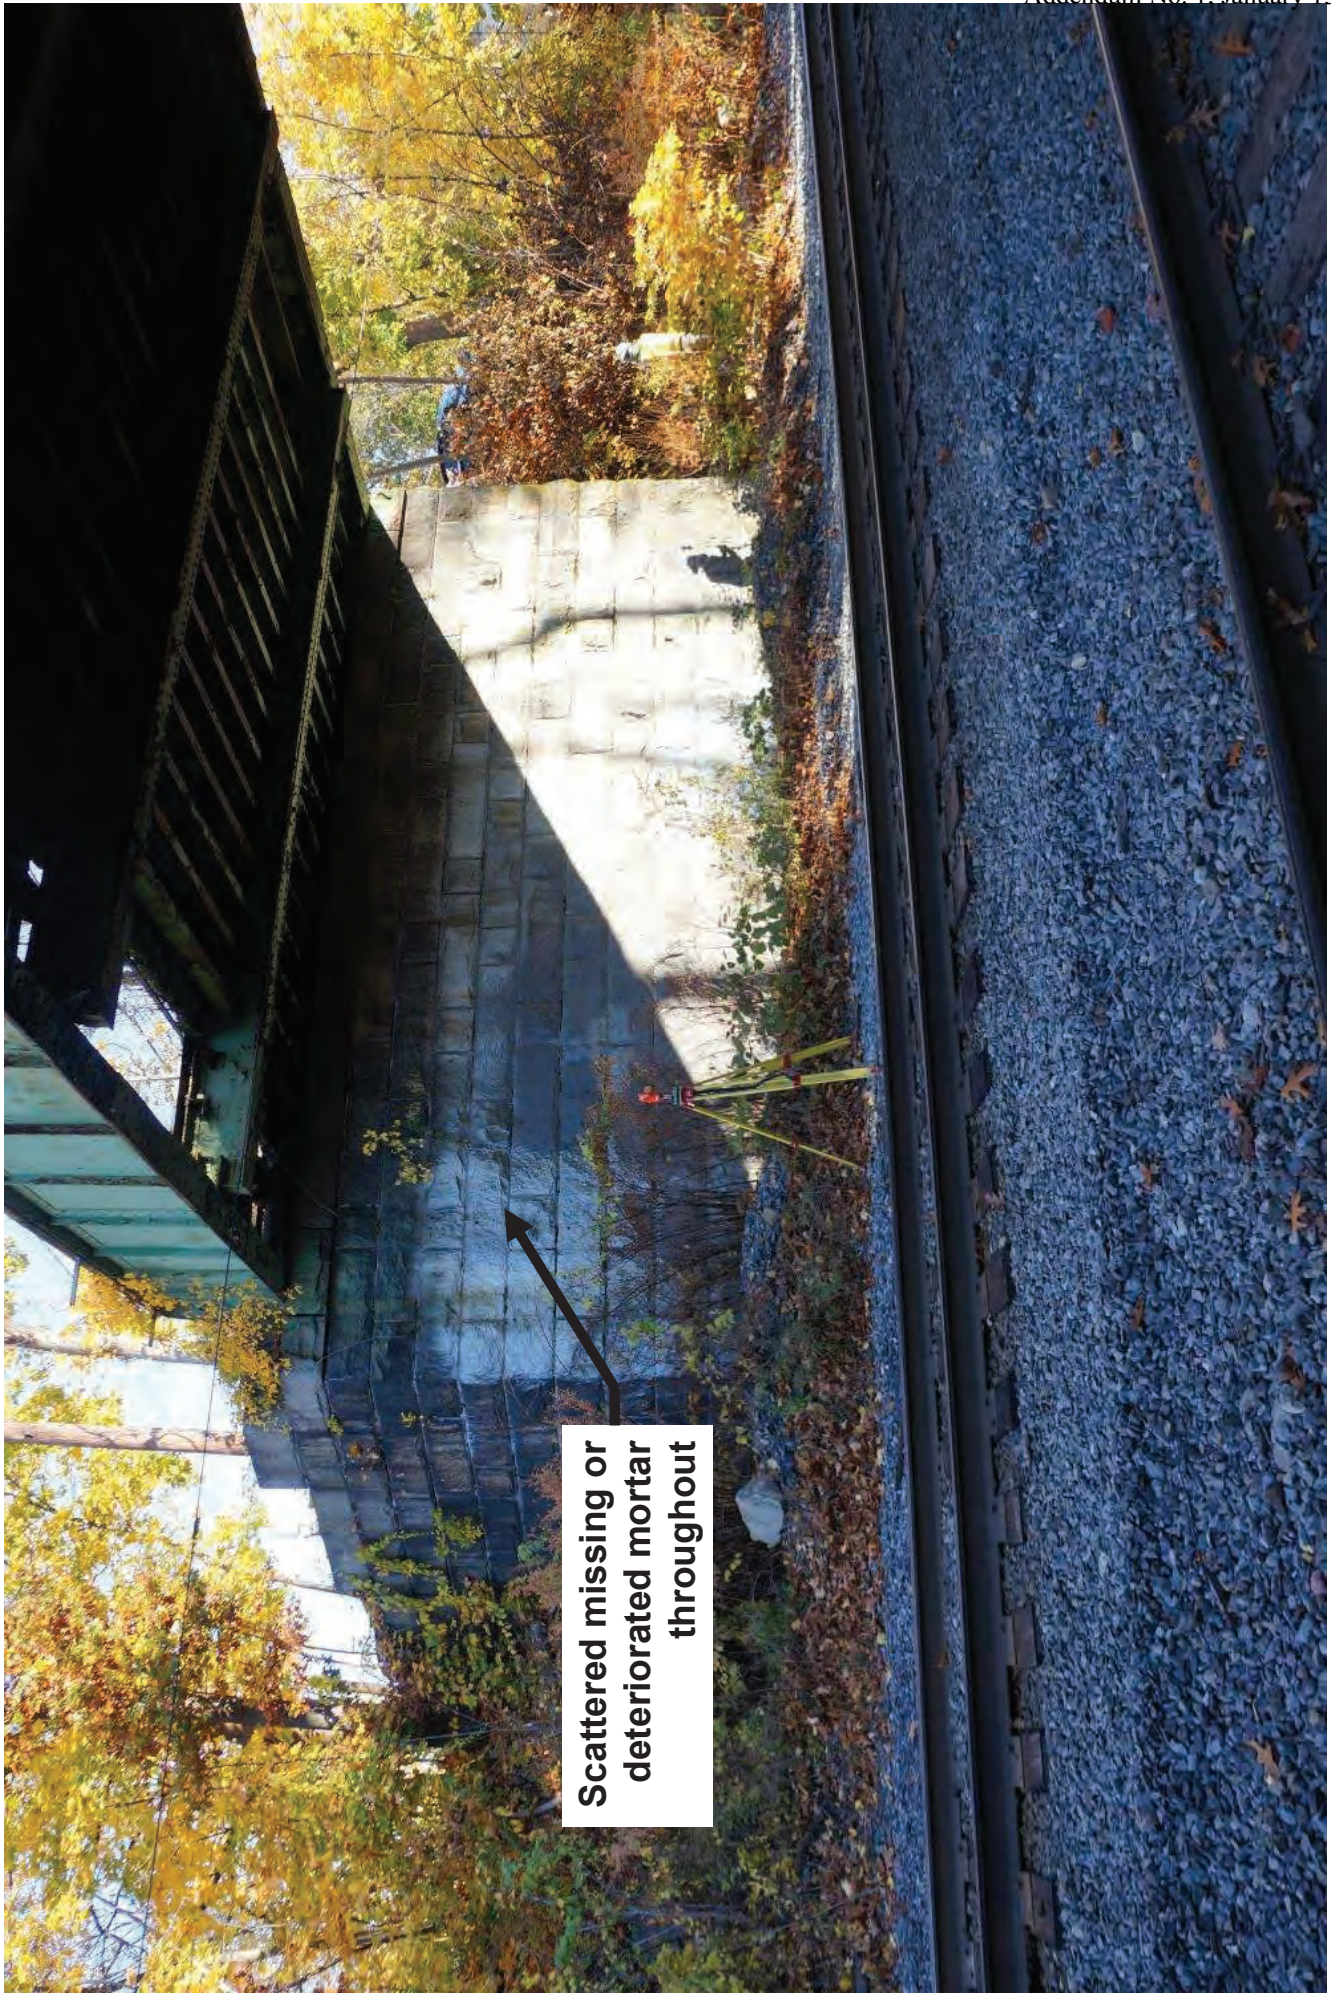
Scattered missing or deteriorated mortar throughout

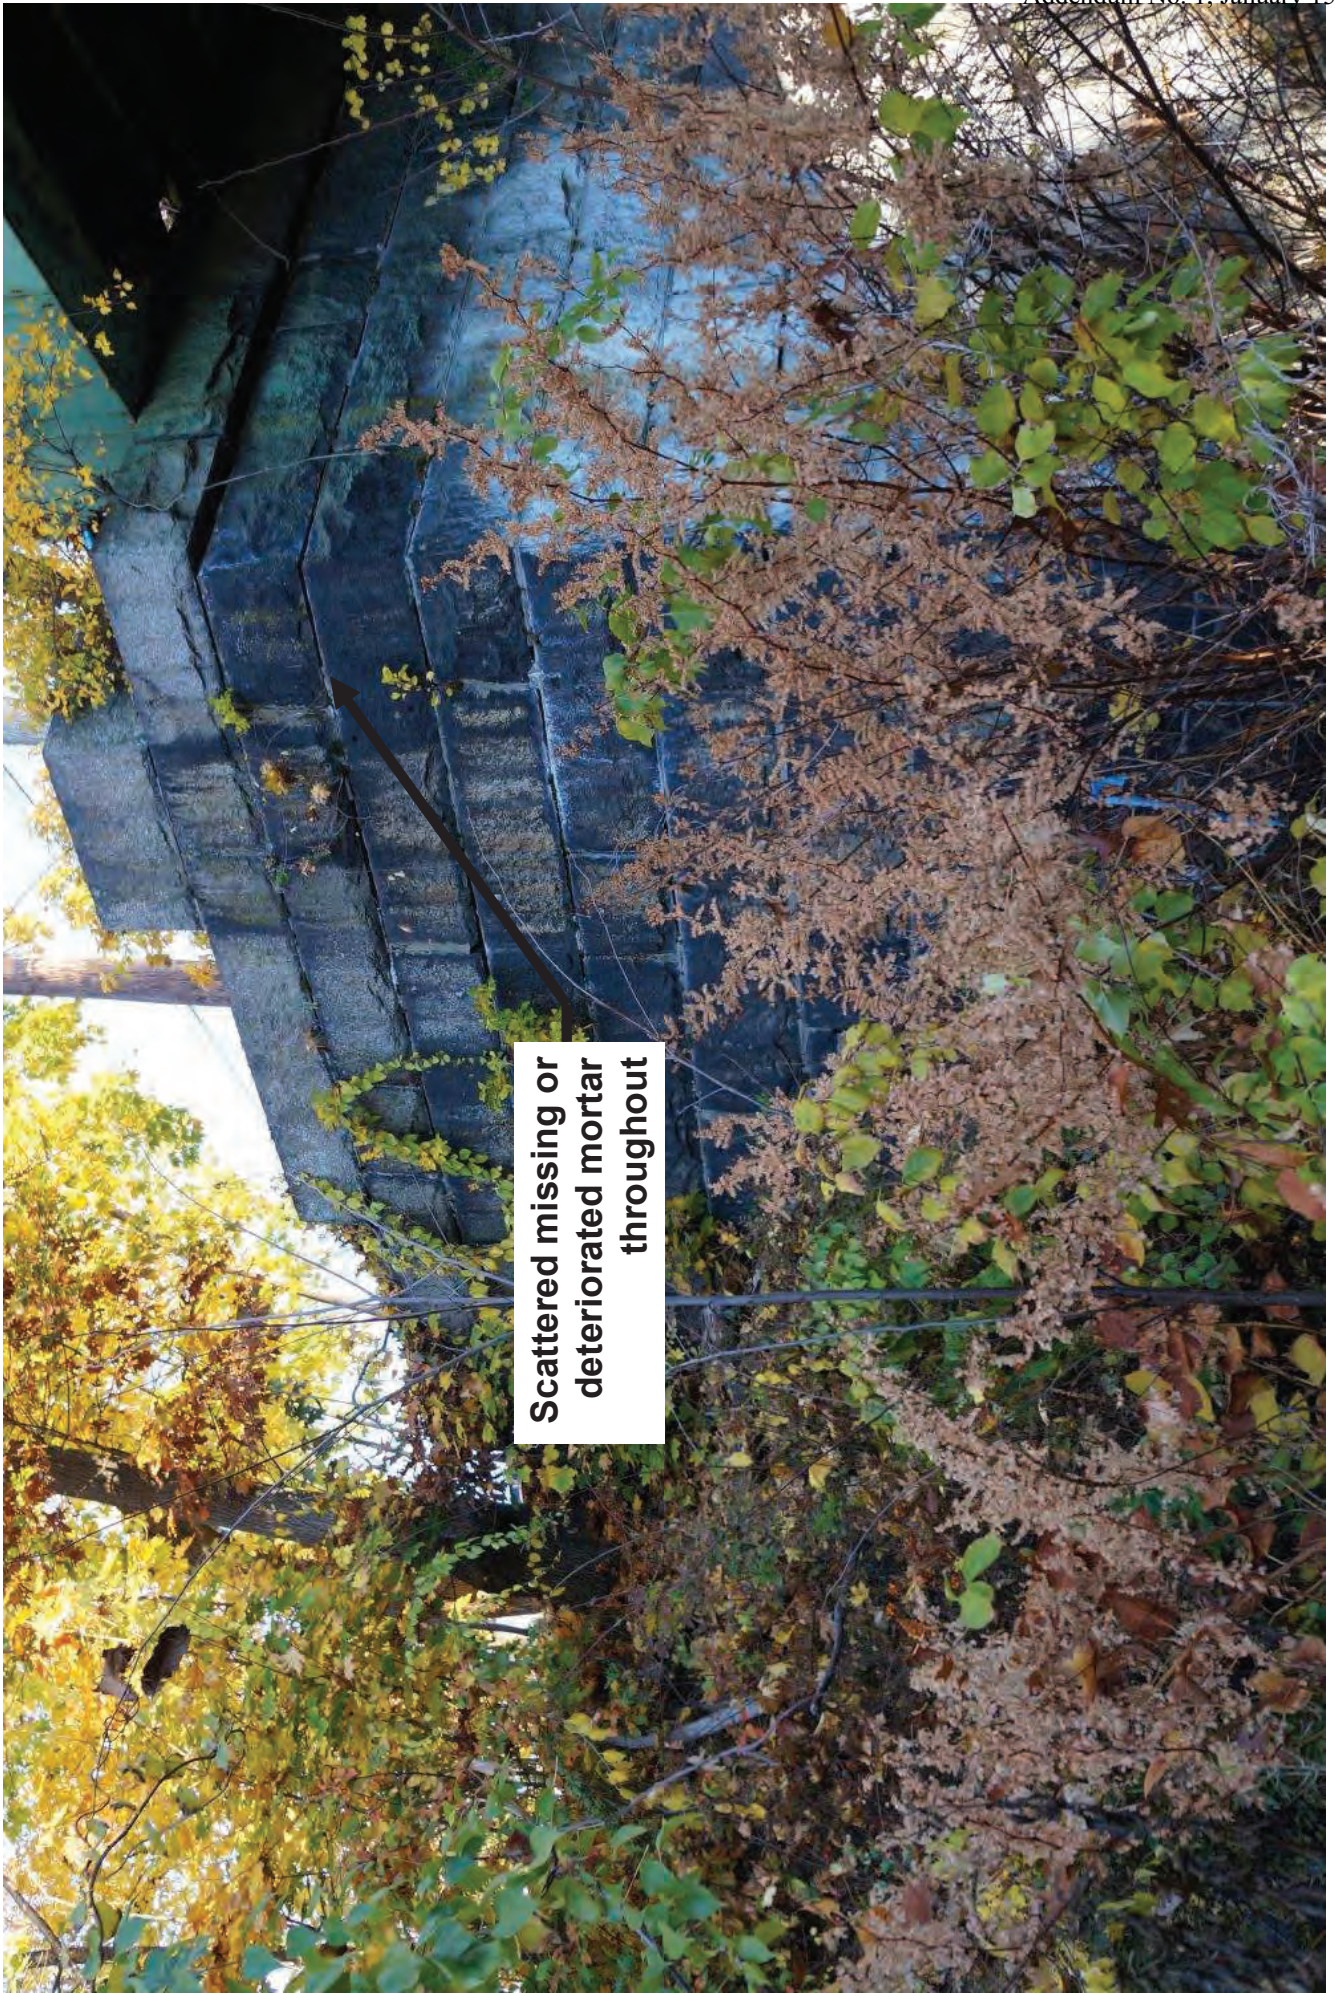
Scattered missing or
deteriorated mortar
throughout

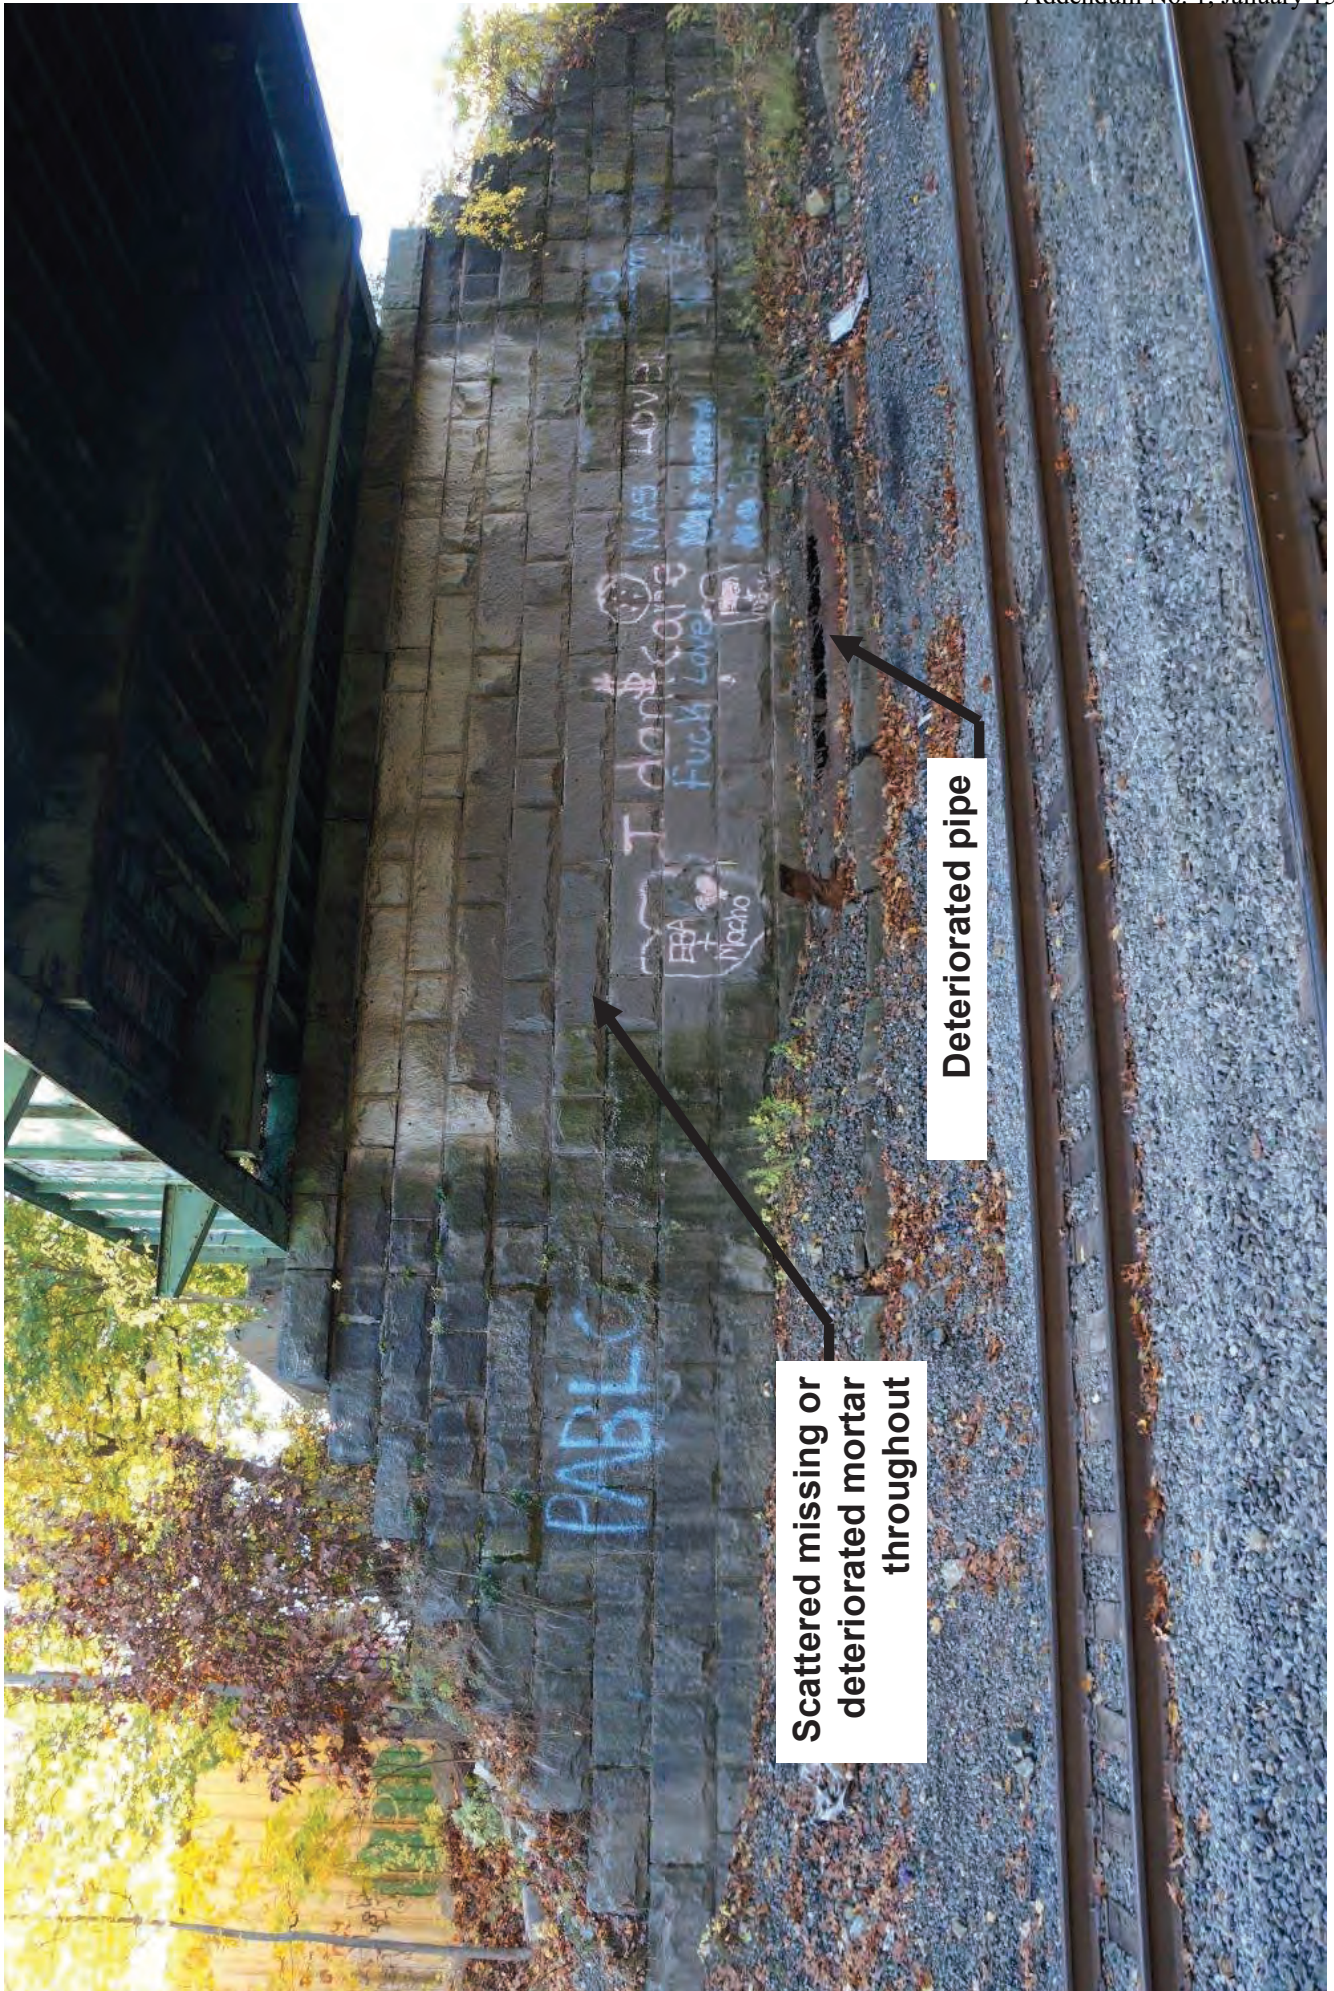
Scattered missing or deteriorated mortar throughout

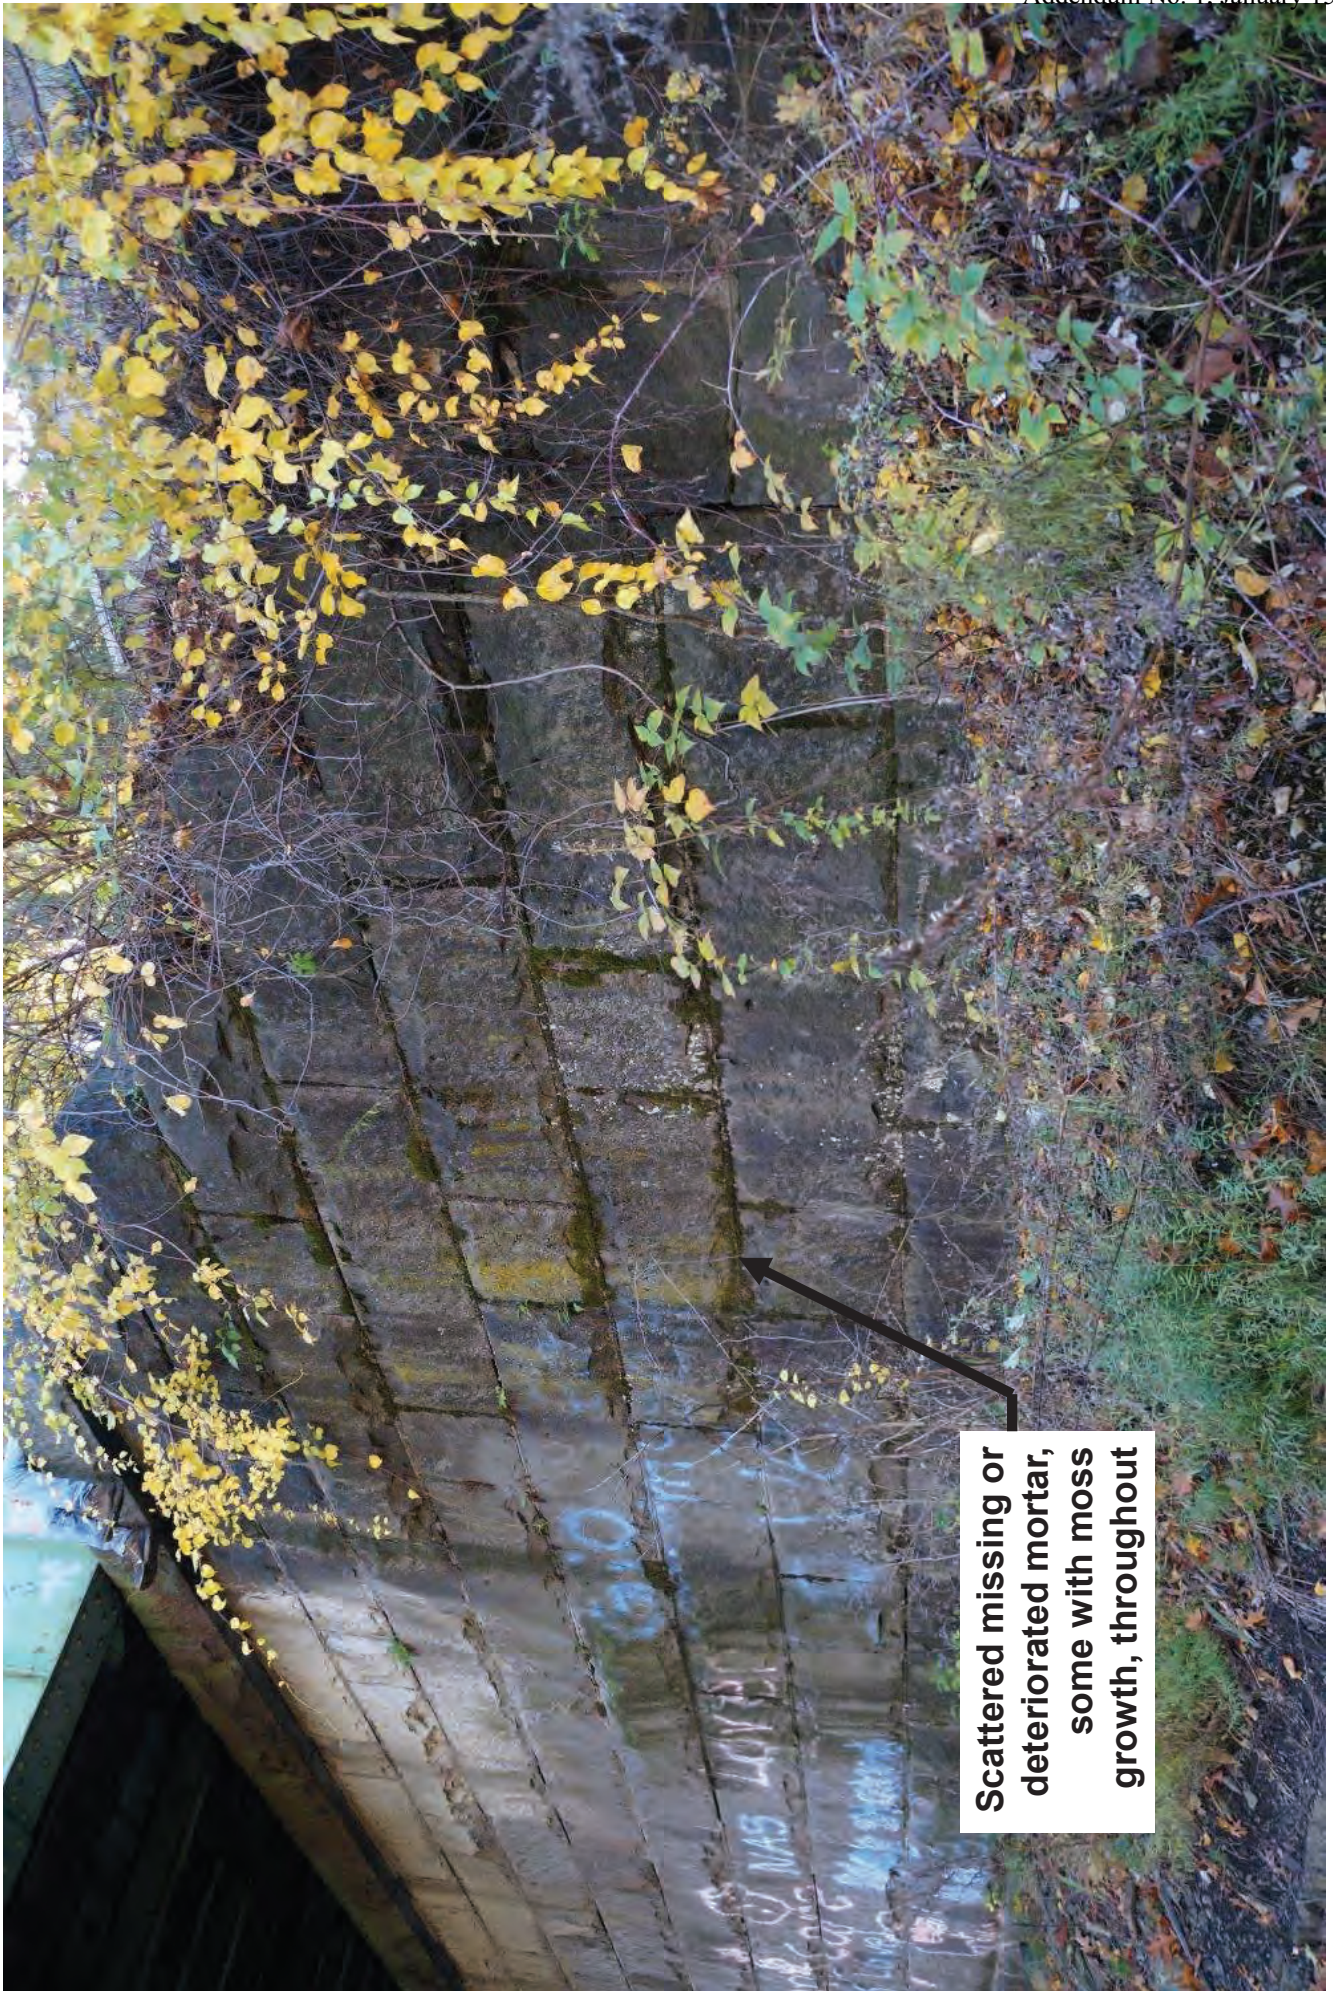
Scattered missing or
deteriorated mortar,
some with moss
growth, throughout

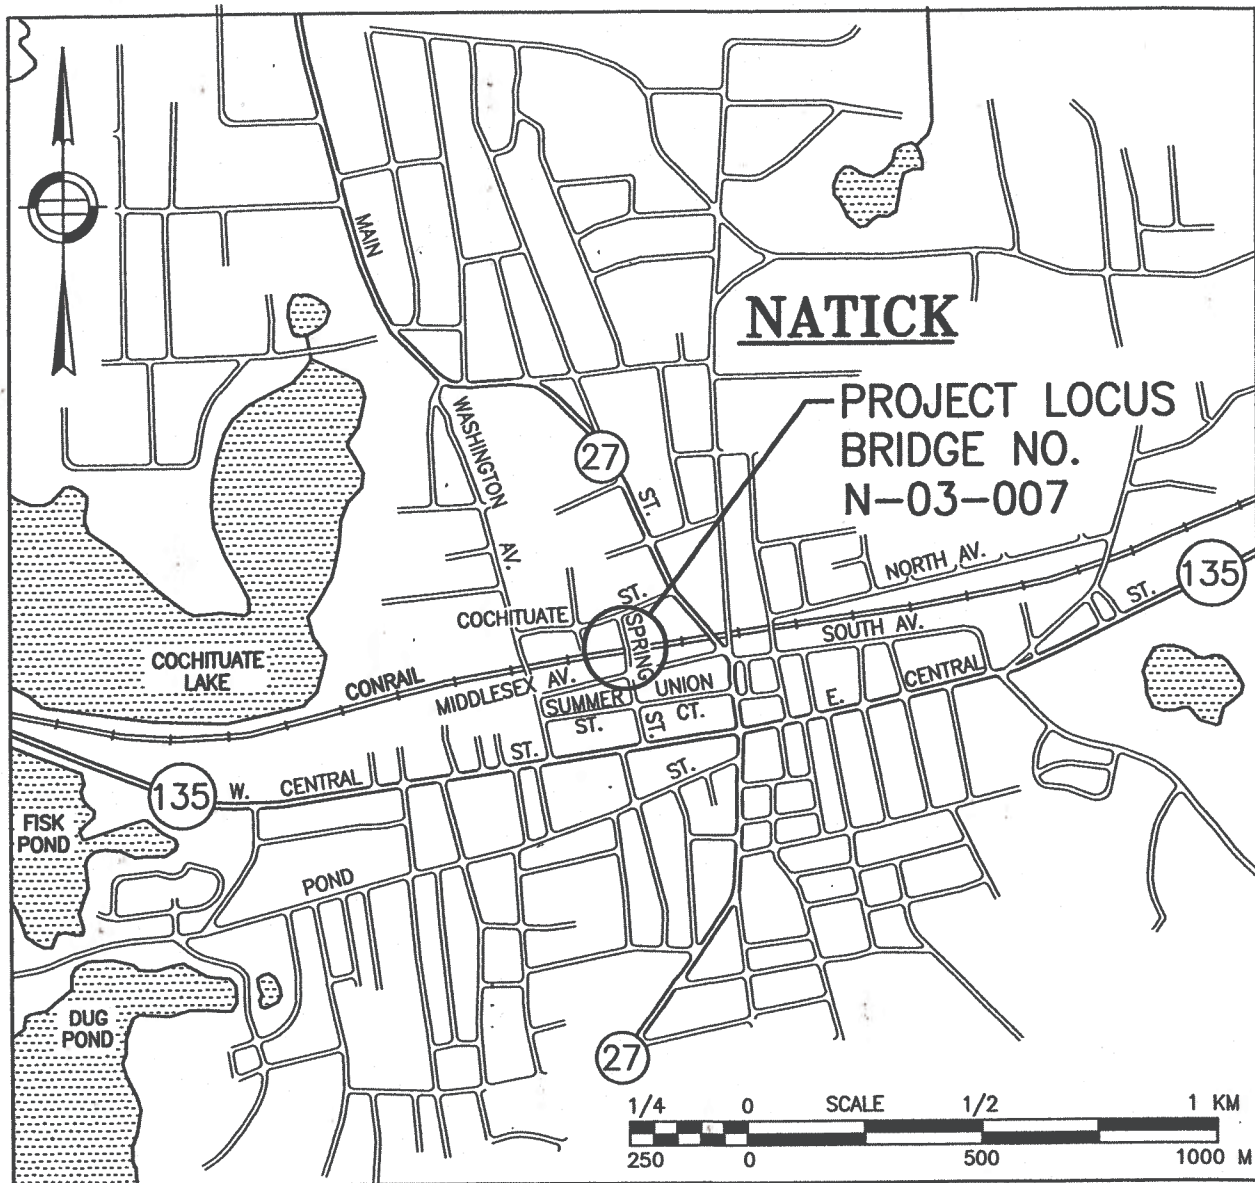
Based on the MHD Bridge Section's interpretation of the AASHTO recommended seismic design map, the design horizontal acceleration is 0.17g. The project has Soil Profile Type I, and Site Coefficient (S) = 1.0. The soil at the project location is judged to be not susceptible to liquefaction.
