Subject: On-Call Asbestos, Lead, Air Quality & Demolition Compliance
Agreement No. 10.04-02 (23)
HazMat Inspection – Removal of Bridge No. 04671, Carroll Road over the
Patchaug River, Griswold, CT
ConnDOT Assignment No. 524-7974
ConnDOT Project No. 57-121
TRC Project No. 501871.7974.0710

TRC performed a limited hazardous materials site investigation associated with the removal of Bridge No. 04671, Carroll Road over the Patchaug River in Griswold, Connecticut. Results of the survey identified lead paint on the railing support, cable guardrail and guardrail metal bridge components to be impacted at Bridge No. 04671. Results obtained from TCLP waste stream sampling and analysis for leachable lead from the paint on the railing support, cable guardrail and guardrail metal bridge components characterized the paint waste stream as **CTDEEP/RCRA hazardous waste**. No detectable amounts of lead in paint were identified on the concrete parapet wall/curb paint, therefore any paint waste generated from those bridge components would be non-hazardous, non-RCRA lead waste. Off-white remnant railing support caulk, tan stone abutment mortar, and grey textured parapet wall skim coat were sampled an

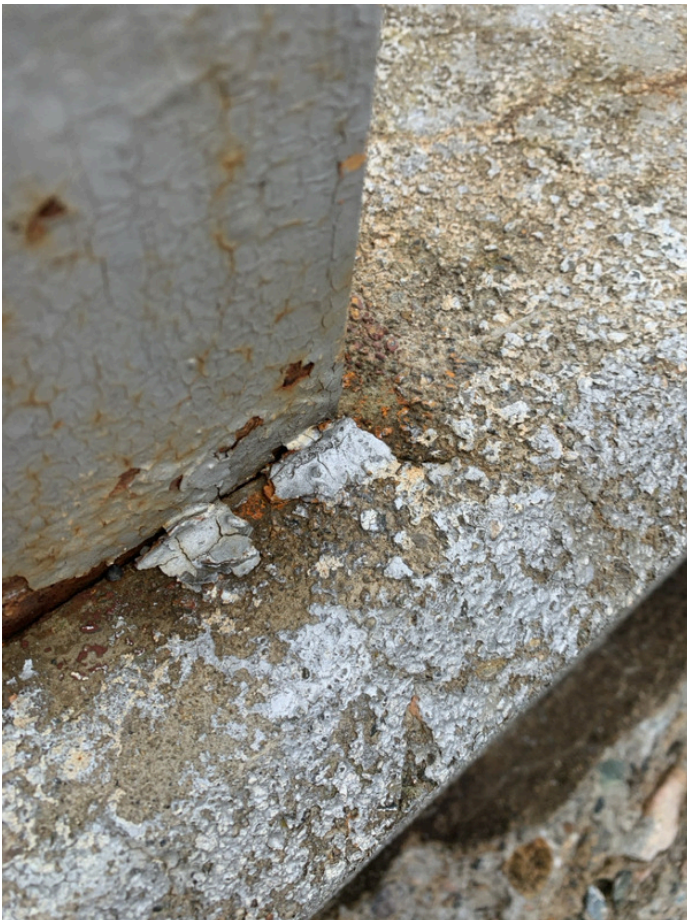
Representative Photos

Sampled or Assumed?	Sampled
Material Acronym	C ▶ 1
Material Description	Remnant off-white railing support caulk
Material Color

Is material non-friable organically bound (NOB)?	Yes
--	-----

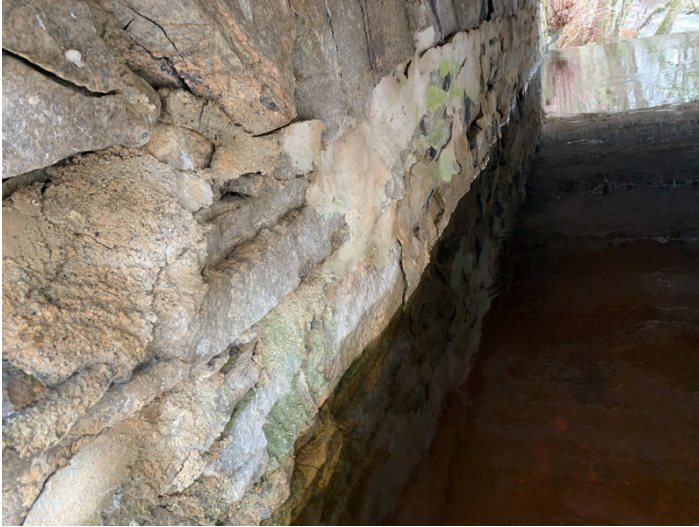
Representative Photos

Material Description | Tan stone abutment mortar

Is material non-friable organically bound (NOB)? | No

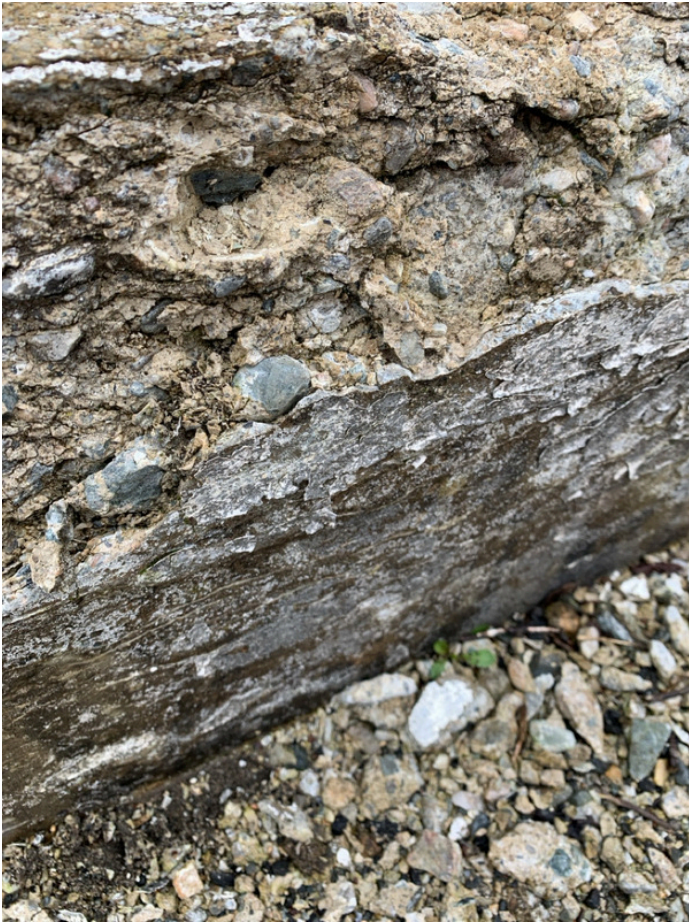
Representative Photos

Sampled or Assumed?	Sampled
Material Acronym	SK 1
Material Description	Textured parapet wall skim coat
Material Color

Analyze by layer?	No
Is material non-friable organically bound (NOB)?	No
Homogeneous Area	
Total Approximate Quantity	
Notes

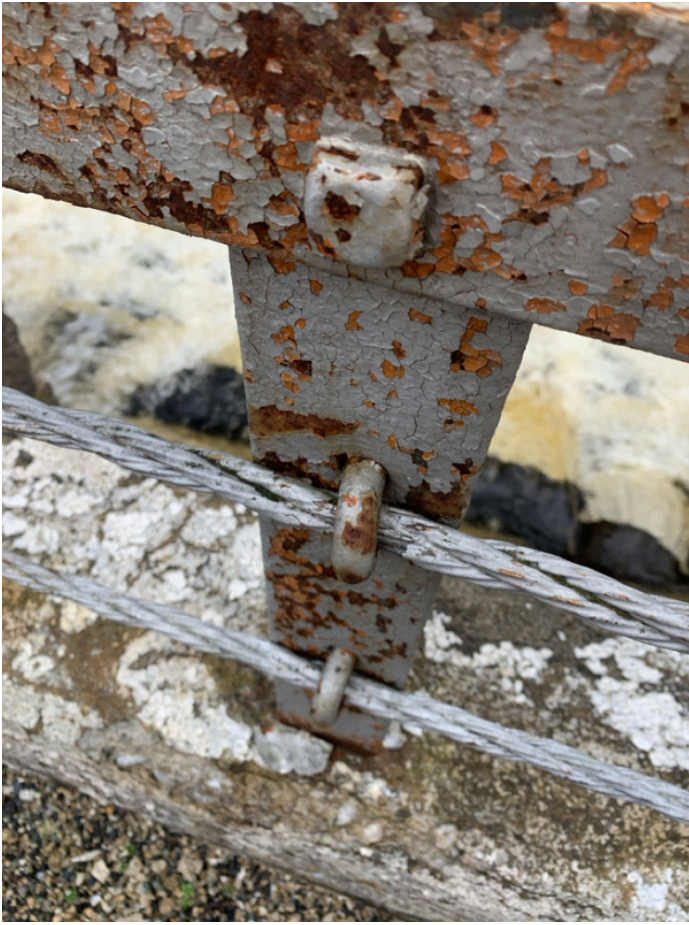
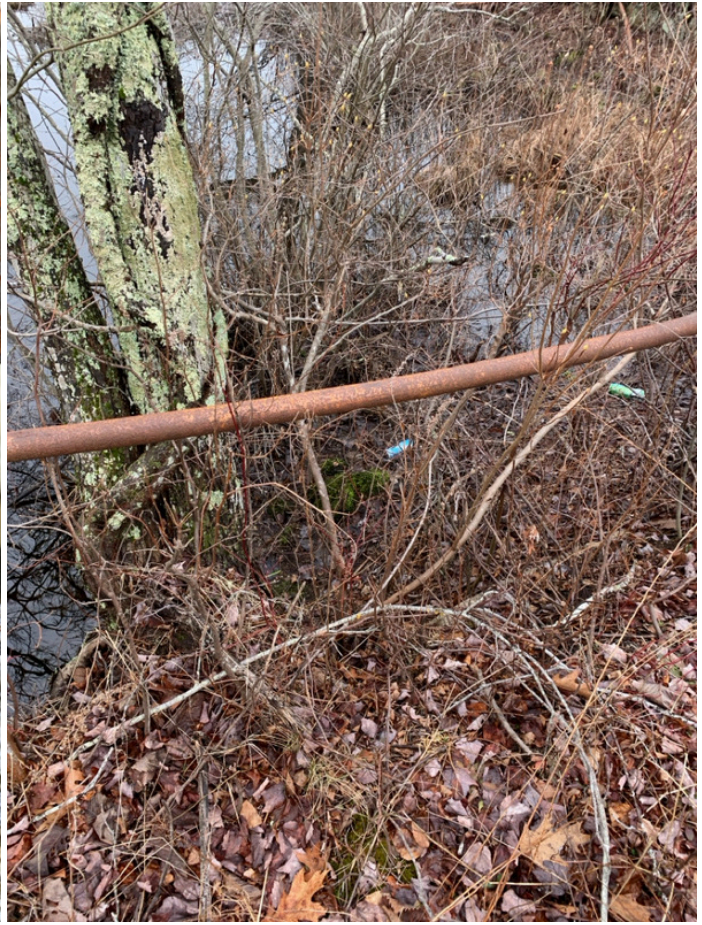
TCLP/SPLP/Total Lead Photos

TCLP/SPLP/Total Lead Sample Description	Silver/orange railing, railing support, cable guardrail paint
---	---

Material	Paint Chips
Square Footage	
Type of Analysis	TCLP Lead
Sample Number	01
Grab or Composite	Grab
Date	March 6, 2024
Time	09:43
TCLP/SPLP/Total Lead Notes

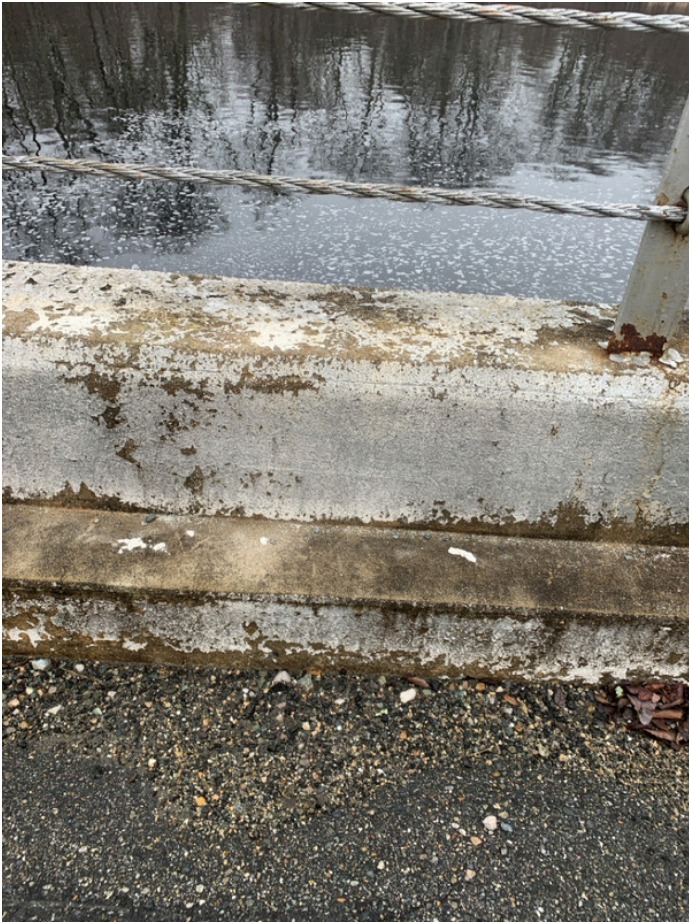
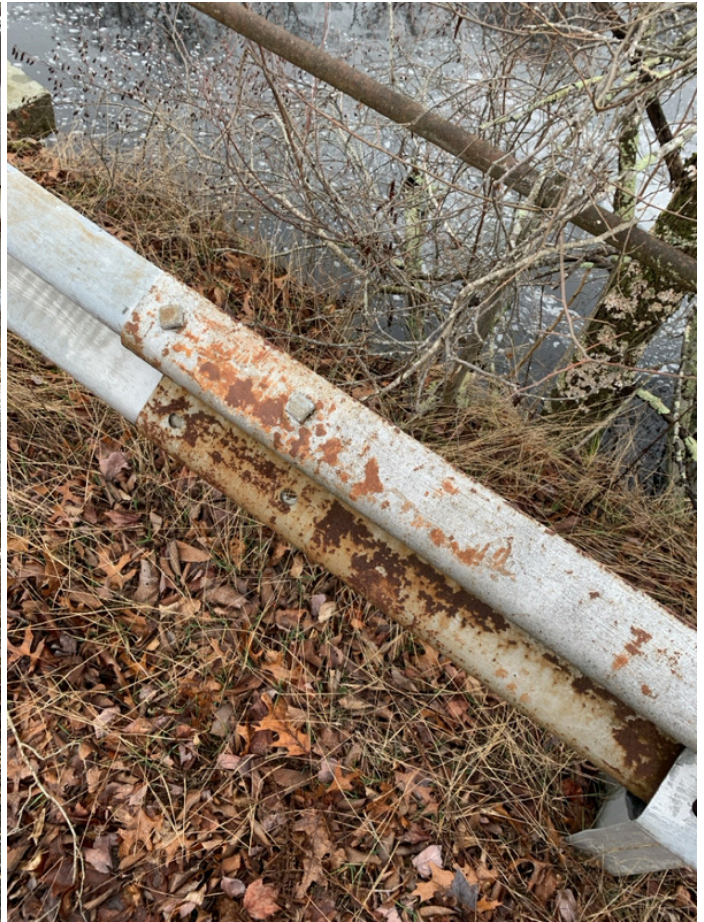
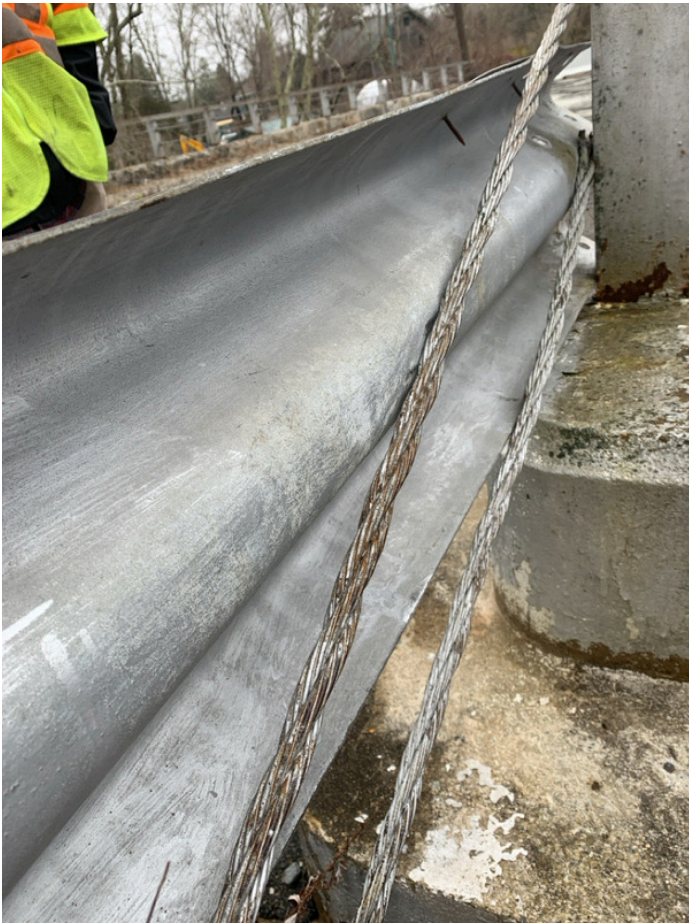
TCLP/SPLP/Total Lead Photos

TCLP/SPLP/Total Lead Sample Description	Silver/white parapet wall, curb, guardrail paint
---	--
