Subject: On-Call Asbestos, Lead, Air Quality & Demolition Compliance
Agreement No. 8.07-01 (18)
HazMat Inspection – Replacements of Bridge Nos. 06896 & 02713, Old Lyme &
East Lyme, CT
ConnDOT Assignment No. 519-6541
ConnDOT Project No. 104-175
TRC Project No. 289951.6541.0710

TRC performed a limited hazardous materials site investigation associated with the planned replacements of Bridge Nos. 06896 & 02713 in Old Lyme & East Lyme, CT, Connecticut. No painted surfaces were identified at Bridge Nos. 06896 & 02713, therefore no lead paint was identified at either bridge. Suspect asbestos asphalt coatings inside the corrugated metal pipes at both Bridge Nos. 06896 & 02713 were sampled and found to contain no detectable amounts of asbestos. No other hazmat/regulated items were identified at Bridge Nos. 06896 & 02713. Laboratory results, TRC Mobile Data Solutions reports, and site maps are attached.

ConnDOT, Bridge/Culvert #06896

ConnDOT, Bridge/Culvert #02713

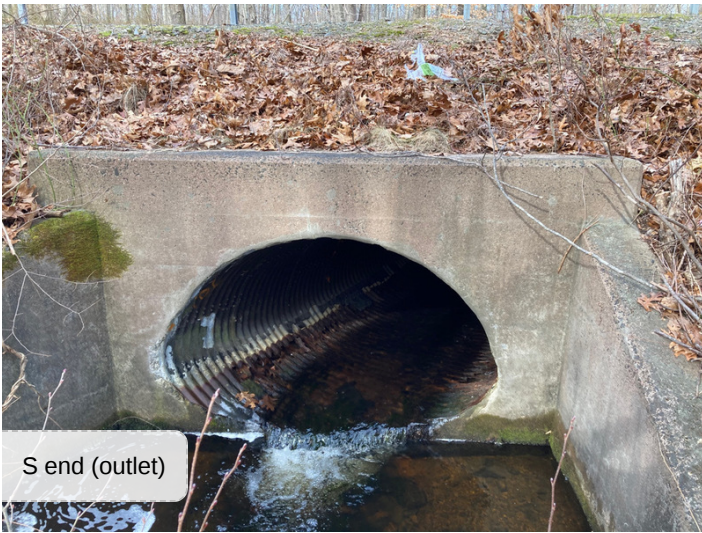
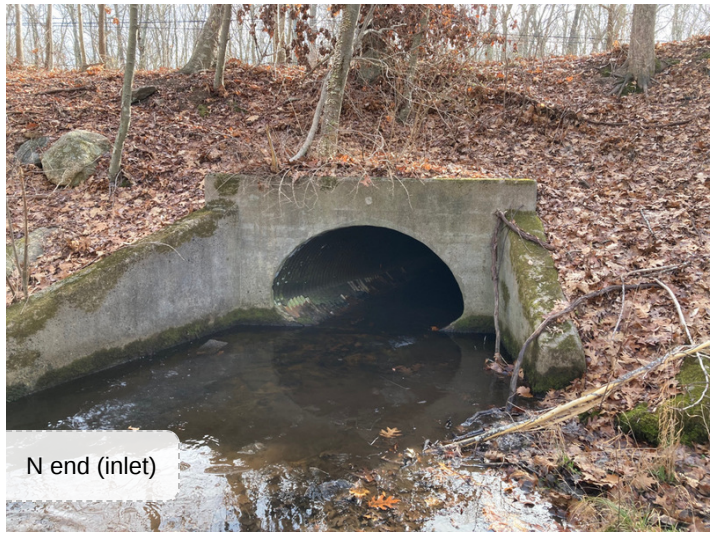
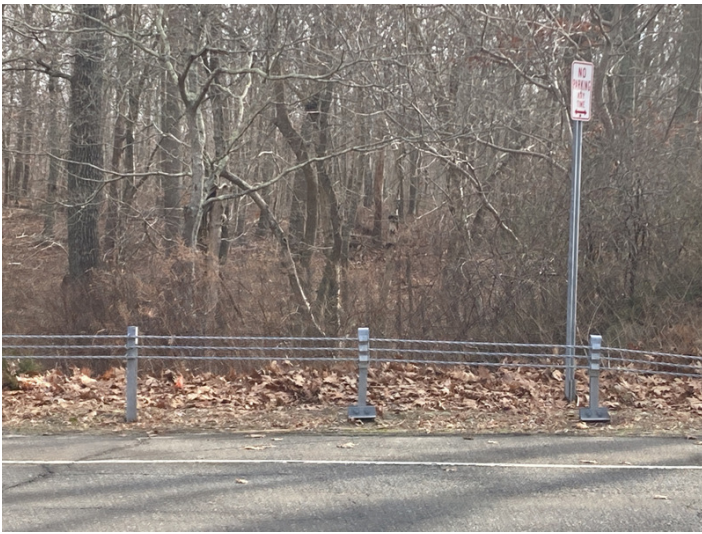
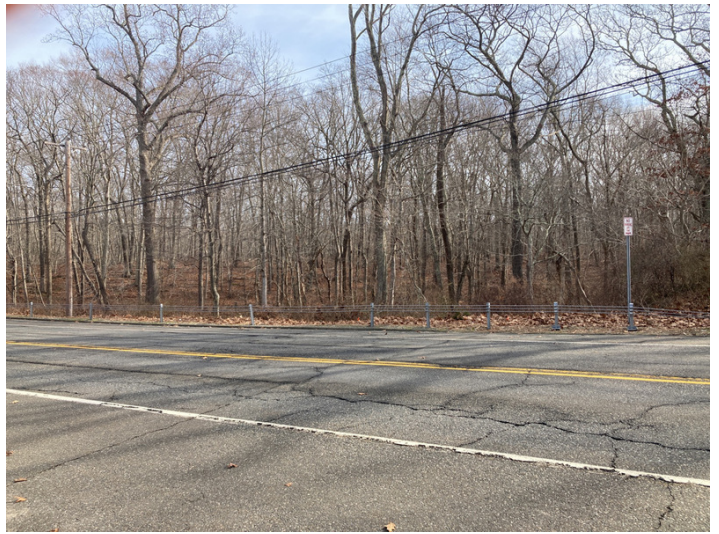
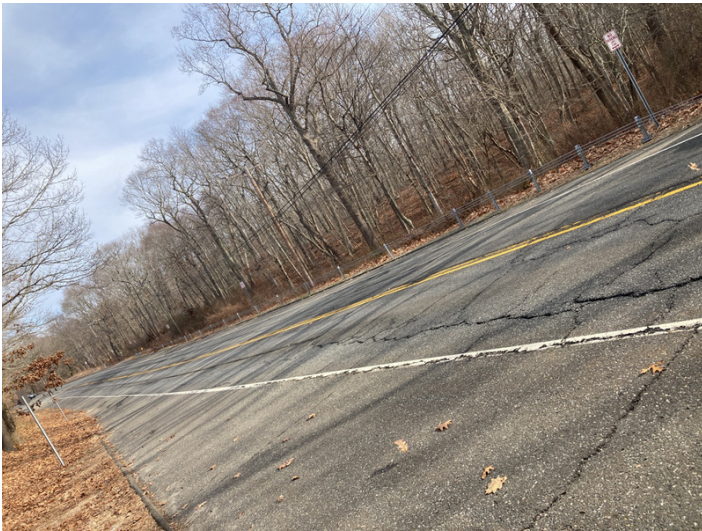
Overview Photo

Site Name	Bridge/Culvert #06896
Address	
TRC Project Number	289951.6541.0710
Project Manager	Erik Plimpton, Stephen Arienti
Inspector(s)	Alan Fortin
Client	ConnDOT
Type of Asbestos Survey	Reno/Demo
Site Sketch Diagrams	
Additional Analysis for NOB Materials (Calc)	TEM NY NOB 198.4
PLM Turnaround Time (TAT)	
TEM Turnaround Time (TAT)	3-day
Date	January 19, 2022
General Notes	No painted materials. Culvert pipe is rusted throughout. No visible caulking. No guano present. Black shiny tar present in culvert pipe.

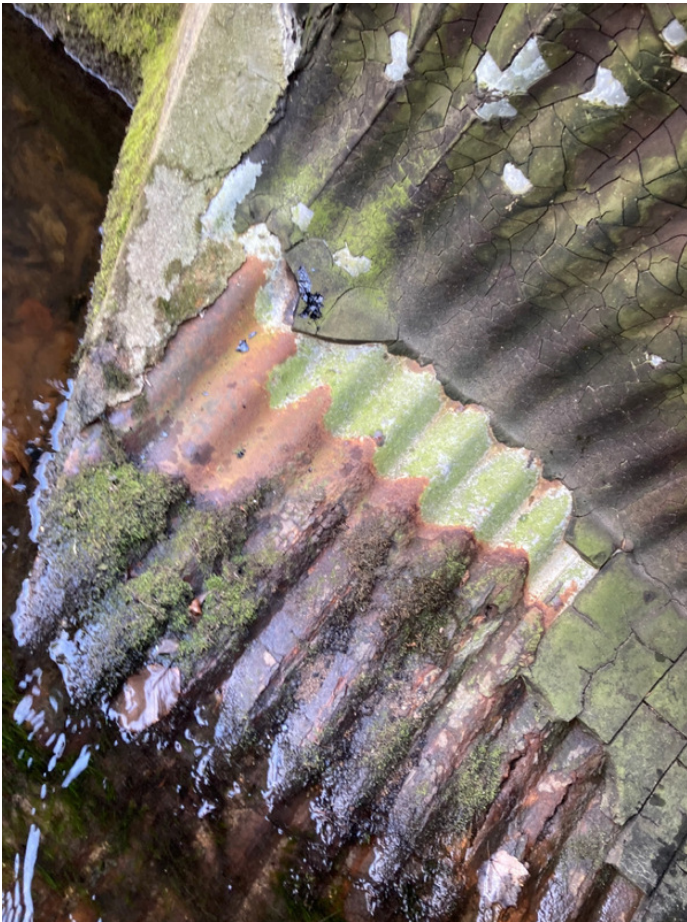
Representative Photos

Material Description | Black shiny tar coating on inside of culvert

Is material non-friable organically bound (NOB)? | Yes

Homogeneous Area | Entirety of culvert

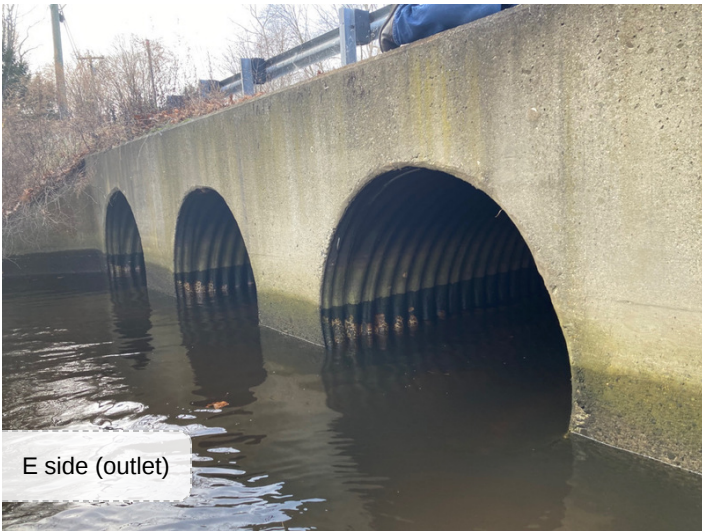
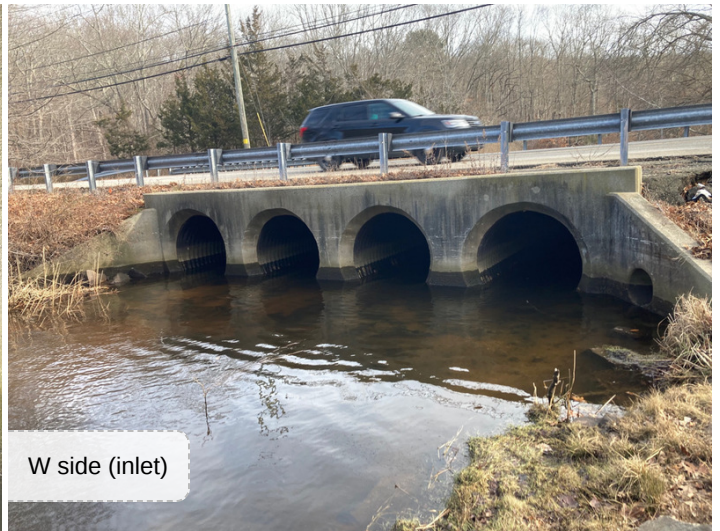
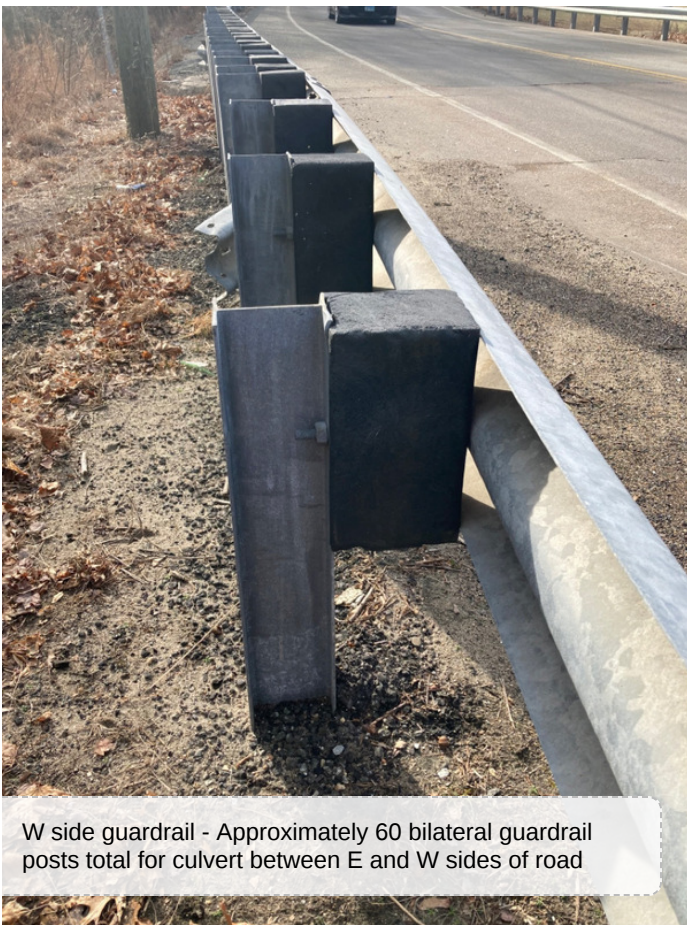
Overview Photo

Site Name	Bridge/Culvert #02713
Address	
TRC Project Number	279951.6541.0710
Project Manager	Erik Plimpton, Stephen Arienti
Inspector(s)	Alan Fortin
Client	ConnDOT
Type of Asbestos Survey	Reno/Demo
Site Sketch Diagrams	
Additional Analysis for NOB Materials (Calc)	TEM NY NOB 198.4
PLM Turnaround Time (TAT)	
TEM Turnaround Time (TAT)	3-day
Date	January 19, 2022
General Notes	No guano or caulking present. Rusting throughout culvert pipe. No paint present. Rubber impact dampeners on guardrails. No tar on inside of flashing.

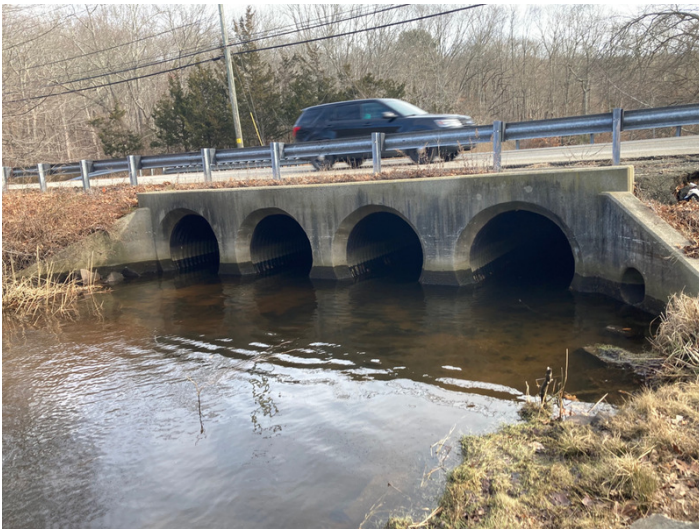
Sample Location Photo

Sample Number	01
Sample Location	West side (inlet)
Asbestos Bulk Analysis	PLM EPA 600/R93/116
Grab or Composite	Grab
Date	January 19, 2022
Time	14:21

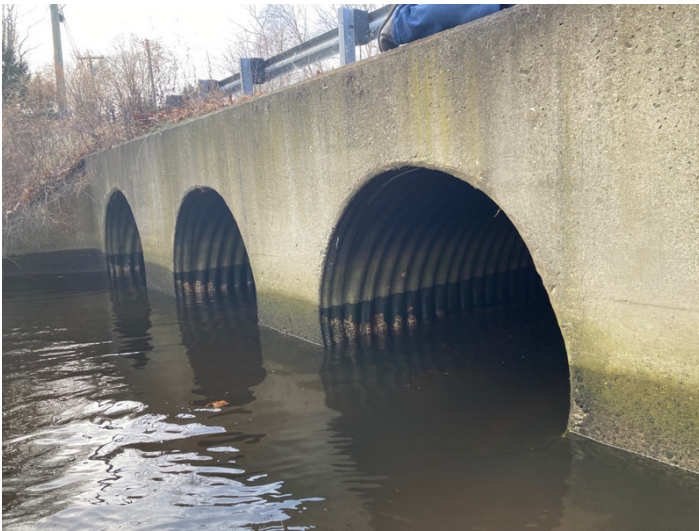
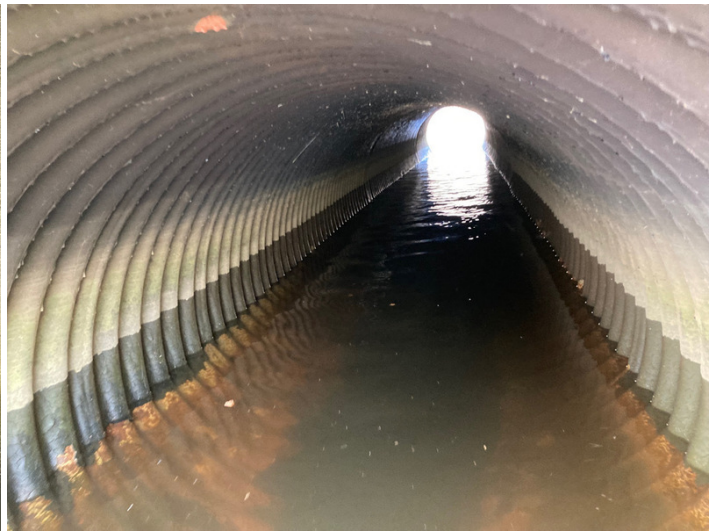
Sample Location Photo

Sample Number	02
Sample Location	East side (outlet)
Asbestos Bulk Analysis	PLM EPA 600/R93/116
Grab or Composite	Grab
Date	January 19, 2022
Time	14:22

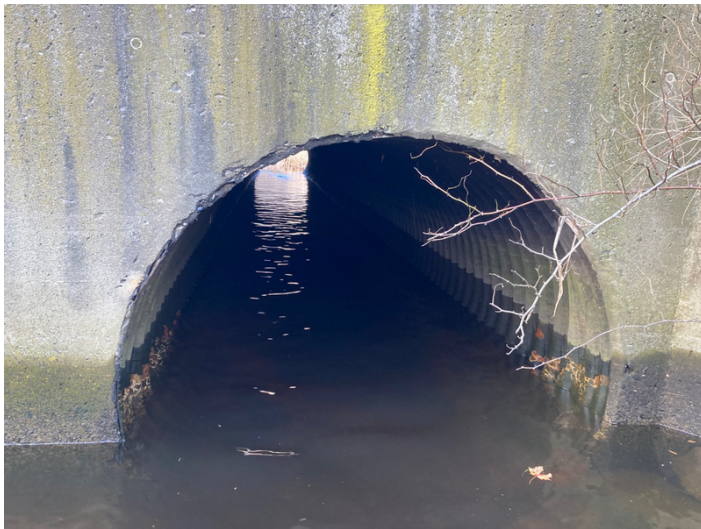
Representative Photos

Sampled or Assumed?	Sampled
Material Acronym	TC ▶ 1
Material Description	Black shiny tar coating on inside of culvert
Material Color	Black

Analyze by layer?	No
Is material non-friable organically bound (NOB)?	Yes
Homogeneous Area	
Total Approximate Quantity	
Notes
