ADDENDUM NO. 4

LAWRENCE
Federal Aid Project No. CMQ-003S(733)X
Lawrence Manchester Rail Corridor (LMRC) Rail Trail

2023 INSPECTION OF THE ABANDONED B&M RAILROAD BRIDGE

OVER THE MERRIMACK RIVER

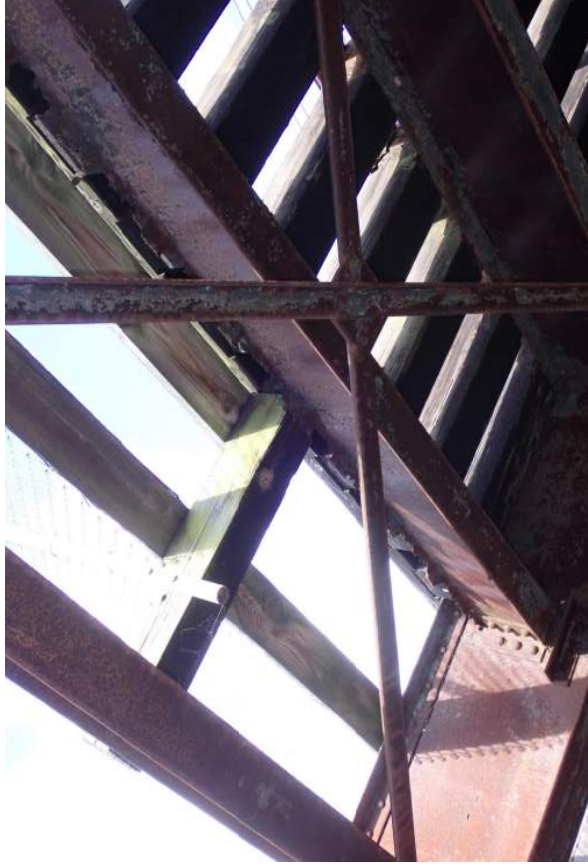
The stringer seat angles at the floorbeams typically have heavy pack rust between the outstanding legs of the angles and the stringer bottom flanges measuring up to 1" thick. Many of the stringers at the seat angles have heavy section loss and holes in the top and bottom flanges at the floorbeam connections. Isolated stringers have moderate to heavy section loss on the lower webs at the floorbeams with several locations exhibiting holes. In Span 6, at the North Abutment, all stringers have section loss along the lower web at the backwall measuring 1/8"-3/16" deep with scattered holes throughout. At Floorbeams FB1 and FB8 in each span, the stringers rest on bearings at the floorbeam top flanges. Scattered stringers at these floorbeams are floating or have pack rust between the bearing and stringer bottom flange (**Photo 1**). Specific locations of these deficiencies are as follows:

- Span 4, Stringer S8 at Floorbeam FB1: There is pack rust between the bearing and stringer bottom flange measuring 1/8" thick.
- Span 4, Stringers S2 and S5 at Floorbeam FB8: The stringers have pack rust between the bottom flange and bearing measuring 3/8" thick and 1-1/2" thick, respectively **(Photo 1)**.
- Span 5, Stringers S2 and S5 at Floorbeam FB1: The stringers have pack rust between the bottom flange and the bearing measuring up to 1-3/16" thick **(Photo 1)**.

<p style="text-align: center;">Photo 1</p> <p>Description: (Looking West) Stringer S2 at Floorbeam 8 of Span 4 and Floorbeam 1 of Span 5; View of heavy pack rust between the stringer bottom flanges and the bearings.</p> <p style="text-align: right;">MG2-18</p>	<p style="text-align: center;">Photo 2</p> <p>Description: (Looking Northeast) Stringer S2, west face in Panel 6 of Span 5; View of typical heavy deterioration to the stringer top flange with full width holes throughout the panel.</p> <p style="text-align: right;">MG2-20</p>

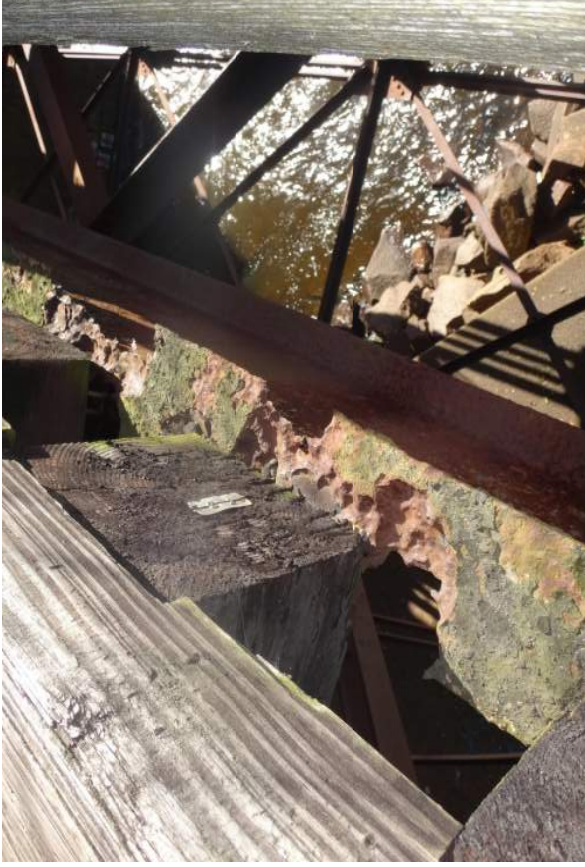
The rolled steel stringers are in **Fair** condition and exhibit heavy rust throughout. Many of the stringers exhibit severe deterioration to the top flanges with full width holes throughout (**Photos 1 to 5**). It appears large coupons were taken from the center of the web of three (3) stringers in Span 6 by torch cutting at approximately the center of the panel (**Photo 6**). The locations and sizes of the coupons removed are as follows:

<p style="text-align: center;">Photo 3</p> <p>Description: (Looking West) Stringer S8, east face in Panel 3 of Span 5; View of typical heavy deterioration to the stringer top flange with full width holes throughout the panel.</p> <p style="text-align: right;">JT2-25</p>	<p style="text-align: center;">Photo 4</p> <p>Description: (Looking Southeast) Stringer S2, top flange in Panel 5 near Floorbeam 5 in Span 6; View of heavy deterioration to the top flange with full width holes.</p> <p style="text-align: right;">MS1-44</p>

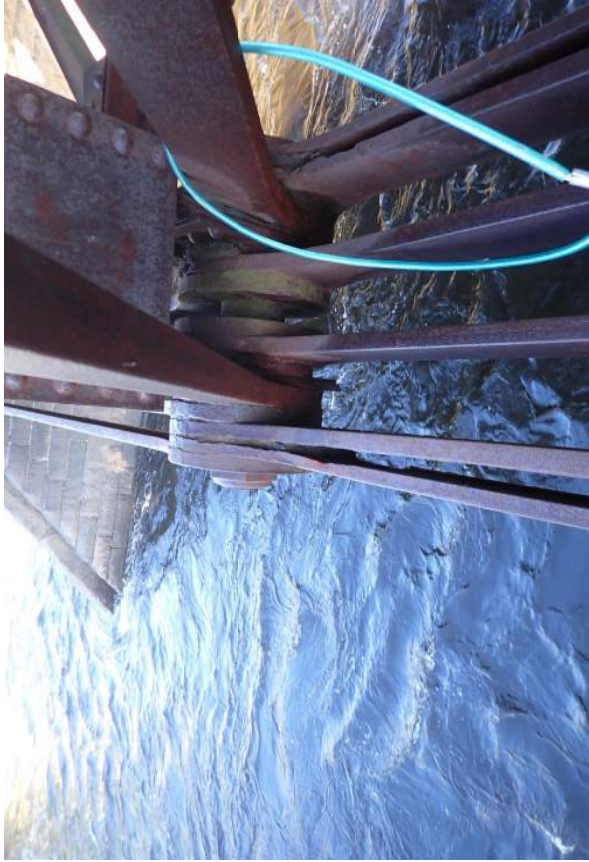
- Span 6, Floorbeam FB3: Above Truss 3 at the west side, there is a lower web hole measuring 6" wide x 1" high (**Photo 7**).
- Span 6, Floorbeam FB4: In Truss Bay 2, both faces of the lower web have pitting measuring up to 1/16" deep.

<p style="text-align: center;">Photo 7</p> <p>Description: (Looking North) South face of Floorbeam 3 in Span 6 at the west side of Truss 3; View of a lower web hole and adjacent section loss to the web. Note the debris on the bracing plate below.</p> <p style="text-align: right;">BG2-15</p>	<p style="text-align: center;">Photo 8</p> <p>Description: (Looking North) Span 2, Truss 1, L3-L4 at L4, Eyebars 1 and 2; View of heavy pack rust between the eyebars and section loss up to 1/4" deep beyond.</p> <p style="text-align: right;">MG2-11</p>

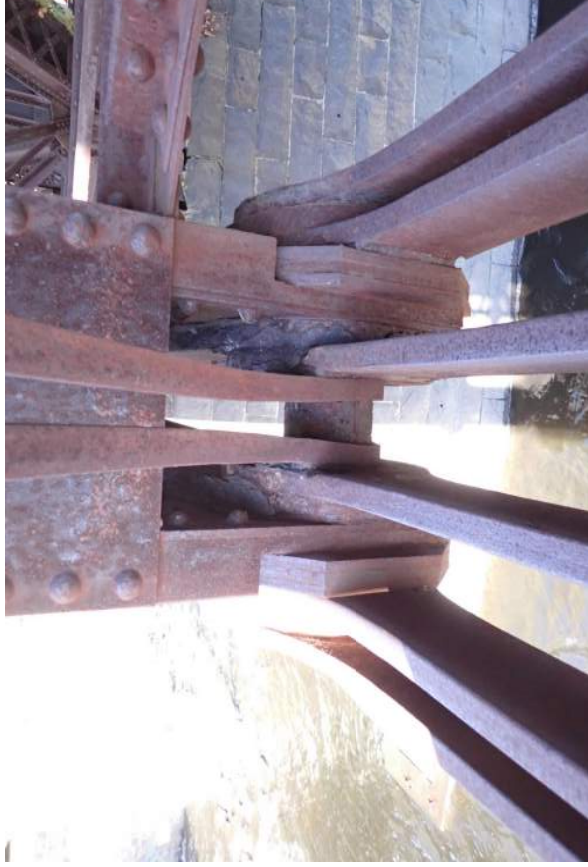
<p style="text-align: center;">Photo 11</p> <p>Description: (Looking Southeast) Span 3, Truss 1, L6-U7 at L6, Eyebars 3; View of section loss along the west face up to 1/2" deep.</p> <p style="text-align: right;">MG2-03</p>	<p style="text-align: center;">Photo 12</p> <p>Description: (Looking North) Span 4, Truss 1, U4-L5 at L5, Eyebars 1 & 2; View of pack rust and section loss between the eyebars.</p> <p style="text-align: right;">MG1-30</p>

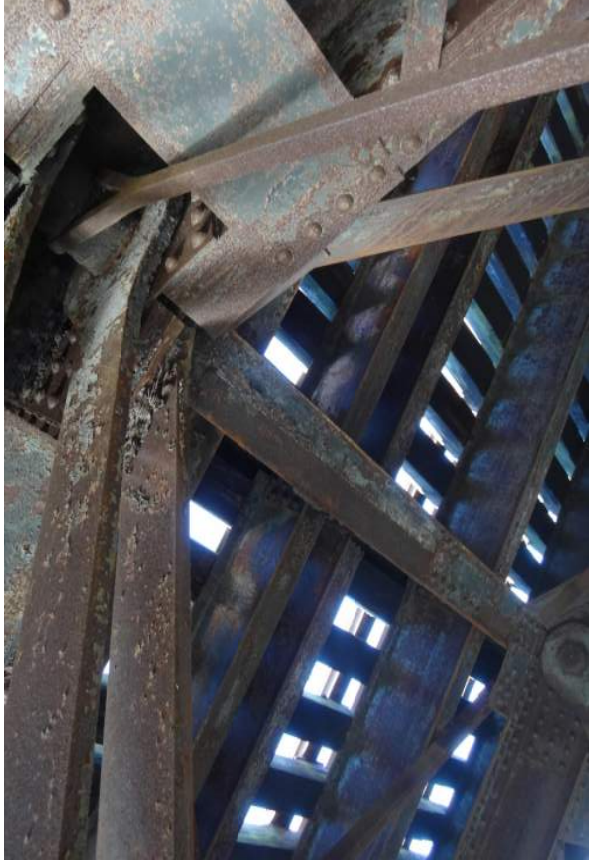
<p style="text-align: center;">Photo 15</p> <p>Description: (Looking Northeast) Span 5, Truss 1, U3-L4 at L4, Eyebars 2; View of section loss along the west face up to 3/8" deep.</p> <p style="text-align: right;">MG1-23</p>	<p style="text-align: center;">Photo 16</p> <p>Description: (Looking Northwest) Span 5, Truss 3, L6-U7 at U7, Eyebars 1; View of pack rust and section loss up to 3/8" deep.</p> <p style="text-align: right;">BG1 - (18)</p>

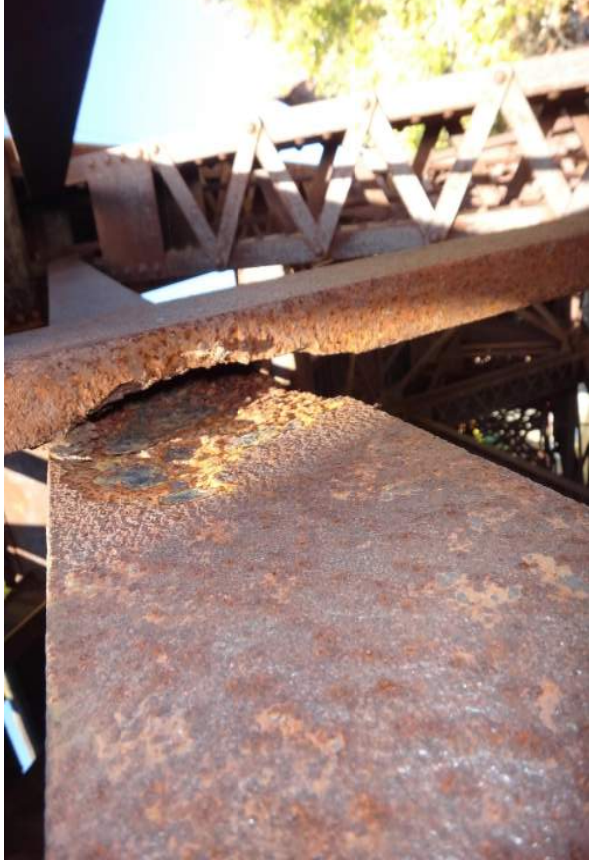
<p style="text-align: center;">Photo 17</p> <p>Description: (Looking Southwest) Span 5, Truss 4, U2-L3 at U2, Eyebars 1; View of 3/8" deep section loss along the underside of the bottom chord.</p> <p style="text-align: right;">JT1-17</p>	<p style="text-align: center;">Photo 18</p> <p>Description: (Looking Northwest) Span 5, Truss 4, L4-U5 & U4-L5 at midpanel; View of section loss at the intersection up to 1/2" deep.</p> <p style="text-align: right;">JT1-15</p>

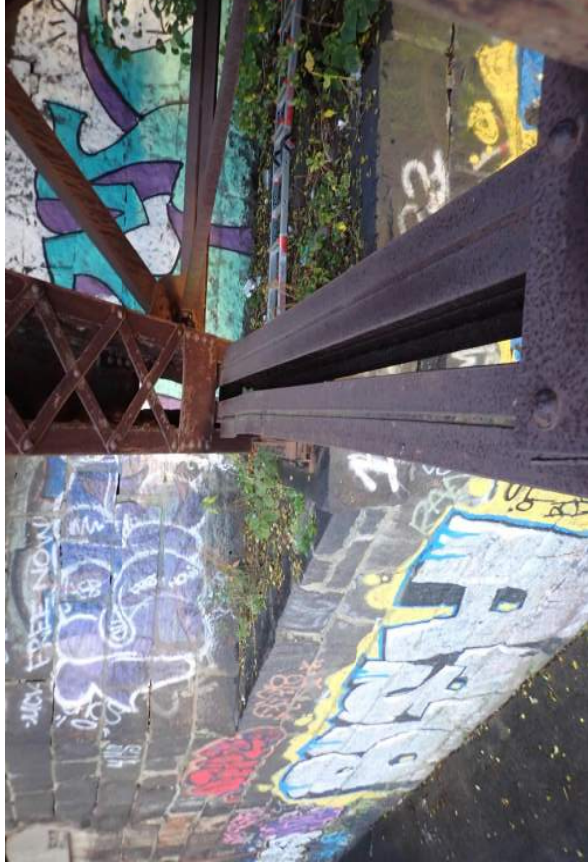
<p style="text-align: center;">Photo 21</p> <p>Description: (Looking Southwest) Span 6, Truss 1, L5-L6 at L5, Eyebar 2; View of the east face with heavy section loss up to 1/2" deep.</p> <p style="text-align: right;">MG1-09</p>	<p style="text-align: center;">Photo 22</p> <p>Description: (Looking North) Span 6, Truss 1, L7-L8; View of the bottom chord with the west built-up member bent east.</p> <p style="text-align: right;">MG1-04</p>

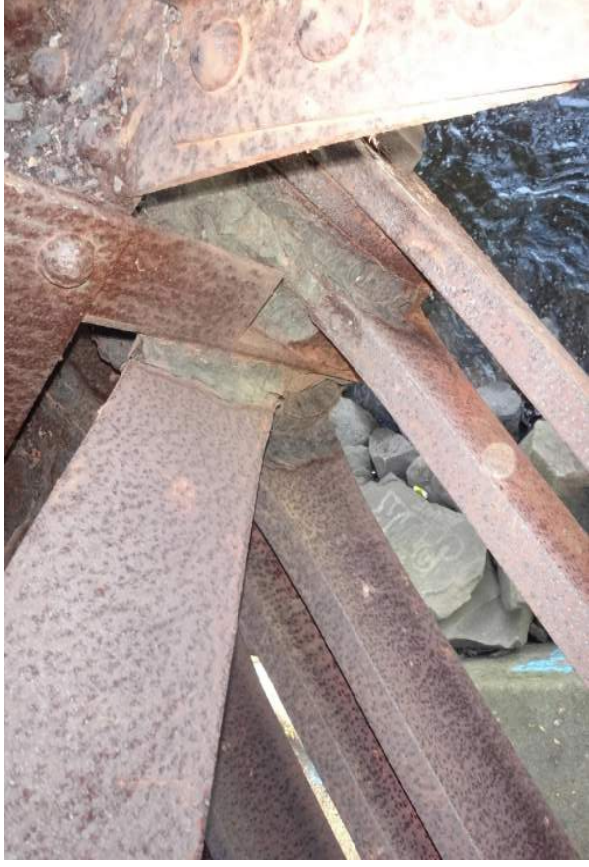
<p style="text-align: center;">Photo 23</p> <p>Description: (Looking South) Span 6, Truss 2, Pin at L2; View of missing pin spacers and heavy section loss to the west side of the pin.</p> <p style="text-align: right;">MS1-22</p>	<p style="text-align: center;">Photo 24</p> <p>Description: (Looking Southeast) Span 6, Truss 2, L4-U5 Eyebar 1 and L4-L5 Eyebars 2 & 3 at L4; View of up to 5/16" deep section loss along the west face of the eyebars.</p> <p style="text-align: right;">MS1-18</p>

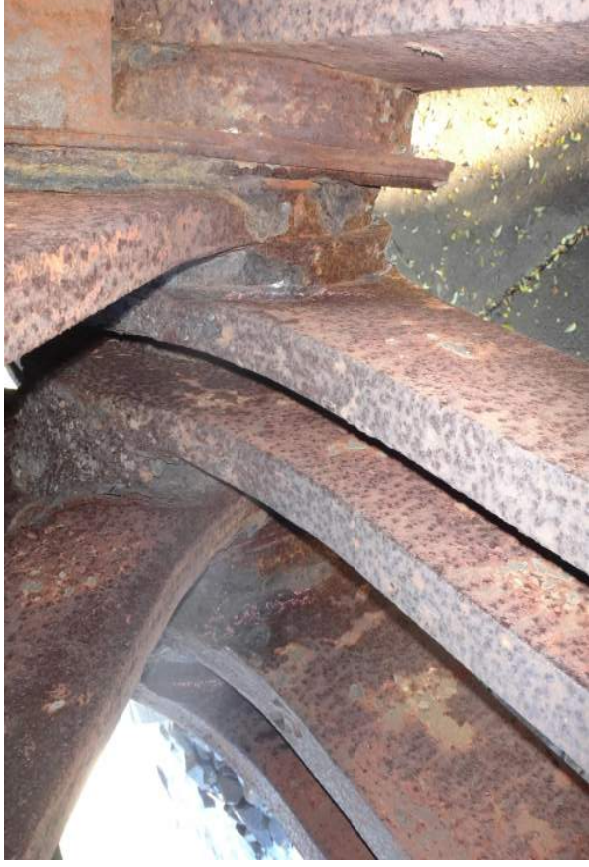
<p style="text-align: center;">Photo 25</p> <p>Description: (Looking North) Span 6, Truss 2, L4-U5 & U4-L5 at midpanel; View of up to 2" thick pack rust and up to 3/4" deep section loss at the intersection of the eyebars.</p> <p style="text-align: right;">MS1-17</p>	<p style="text-align: center;">Photo 26</p> <p>Description: (Looking Northwest) Span 6, Truss 2, L4-L5 at L5, Eyebars 1, 2 & 4; View of section loss along the east face of the eyebars up to 5/16" deep.</p> <p style="text-align: right;">MS1-15</p>

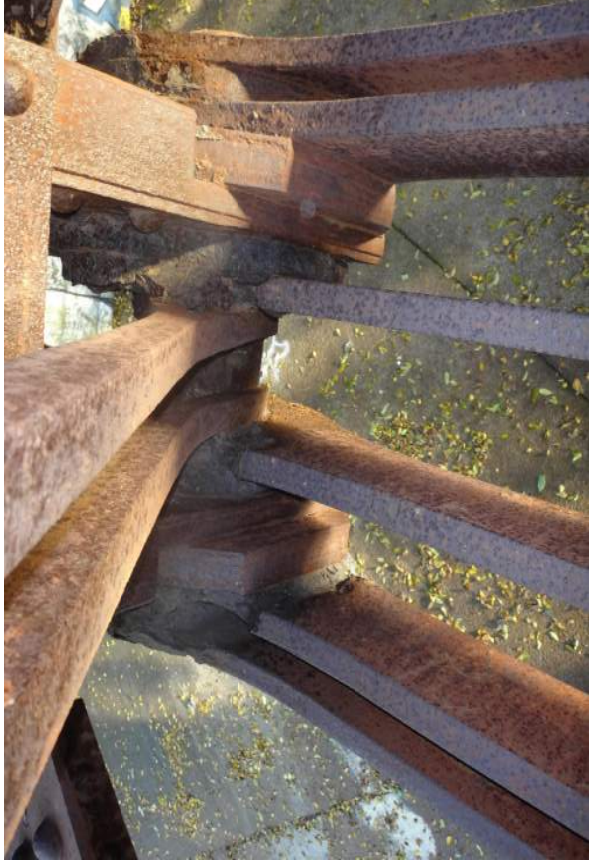
<p style="text-align: center;">Photo 27</p> <p>Description: (Looking Southeast) Span 6, Truss 2, L5-L6 Eyebar 1 and L5-U6 Eyebar 1 at L5; View of heavy section loss to the west face of the eyebars and 100% section loss along the base of L5-L6 Eyebar 1 up to 1/2" high.</p> <p style="text-align: right;">MS1-12</p>	<p style="text-align: center;">Photo 28</p> <p>Description: (Looking Northwest) Span 6, Truss 2, L5-L6 at L6, Eyebars 1 to 4; View of heavy section loss along the east face of the eyebars up to 7/16" deep.</p> <p style="text-align: right;">MS1-10</p>

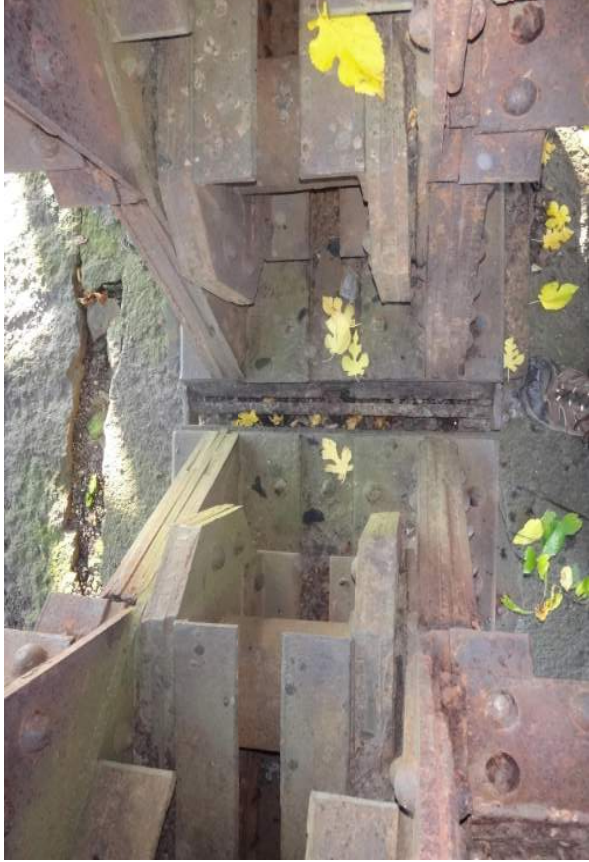
- Pier 1, Span 2, Truss 3: The east bearing shear key is in contact with the south edge of the masonry plate key.
- Pier 1, Spans 1 and 2, Truss 4: The east and west shear keys of the Span 2 bearing are in contact with the south edge of the masonry plate key. There is a gap between the masonry plate and sole plate at the southwest and northwest corners measuring 3/4" high and 1/4" high, respectively. The east and west masonry plate anchor bolts are bent to the south. The Span 1 bearing is over-expanded and the rollers are overhanging the north edge of the masonry plate. (Pedestal stones are settled with retrofit rods in place at this location). There is vegetation growing between the pedestal stones and the east retrofit rod (**Photo 39**).

- The Truss 4 bearing pedestal stones have settled and have steel retrofit rods in place. There is a tree growing between the east side of the retrofit and pedestal stone (**Photo 39**).

<p style="text-align: center;">Photo 39</p> <p>Description: (Looking North) Truss 4, Spans 1 & 2 bearings at Pier 1: View of vegetation growing between the pedestal stones and the east retrofit rod.</p> <p style="text-align: right;">JT2-22</p>	<p style="text-align: center;">Photo 40</p> <p>Description: (Looking West) Truss 2, Spans 2 & 3 bearings at Pier 2; View of typical pack rust between the truss bottom chord members and the bearing gusset plates.</p> <p style="text-align: right;">MS2-08</p>

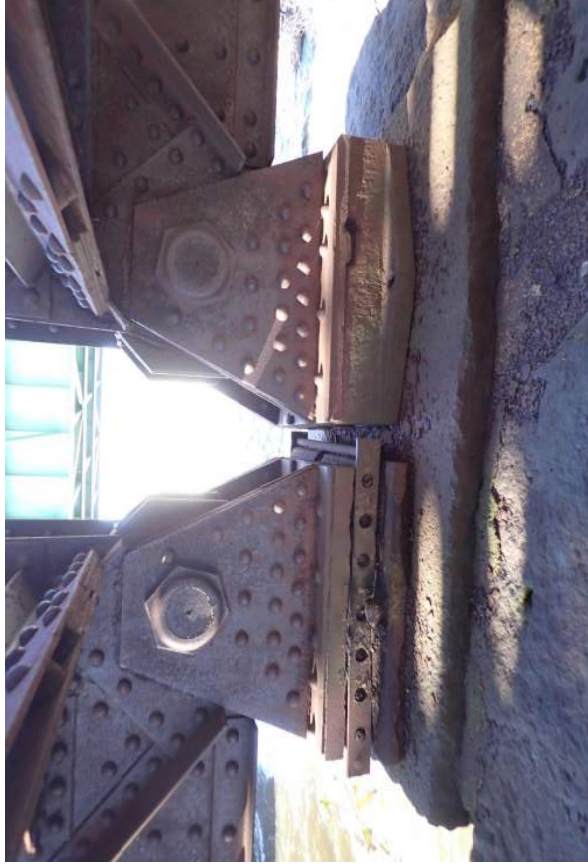
- Pier 3, Span 3, Truss 1: The bearing roller keeper plate on the west side is detached at the south end and the roller keeper plate on the east side is detached at the north end (**Photo 41**).

<p style="text-align: center;">Photo 41</p> <p>Description: (Looking West) Truss 1, Spans 3 & 4 bearings at Pier 3; View of the the Span 3 roller keeper plate detached at the north end.</p> <p style="text-align: right;">MG1-34</p>	<p style="text-align: center;">Photo 42</p> <p>Description: (Looking West) Truss 1, Spans 4 & 5 bearings at Pier 4; View of a typical missing anchor bolt at the Span 5 bearing and improper movement of the rollers.</p> <p style="text-align: right;">MG1-26</p>
