Subject: On-Call Asbestos, Lead, Air Quality & Demolition Compliance  
Agreement No.: 8.07-01 (18)  
HazMat Inspection - Bridge Nos. 00388 & 00389, Route 17 & New London Turnpike  
Interchange, Glastonbury, CT  
ConnDOT Assignment No. 519-6097  
ConnDOT Project No. 53-189  
TRC Project No. 289951.6097.0710

TRC performed a limited survey for hazardous building materials associated with the replacement of Bridge Nos. 00388 & 00389, Route 17 & New London Turnpike Interchange in Glastonbury, Connecticut. Results of the survey identified lead paint to be present on the structural steel/metal bridge railing components and concrete abutments of Bridge Nos. 00388 & 00389. Results obtained from TCLP waste stream sampling and analysis for leachable lead from the paint on the structural steel characterized the paint waste stream at Bridge No. 00388 as CTDEEP/RCRA hazardous waste. At Bridge No. 00389, results obtained from TCLP waste stream sampling and analysis for leachable lead from the paint on the structural steel and metal bridge railing characterized the paint waste stream as CTDEEP/RCRA hazardous waste. Results obtained from TCLP waste stream sampling and analysis for leachable lead f

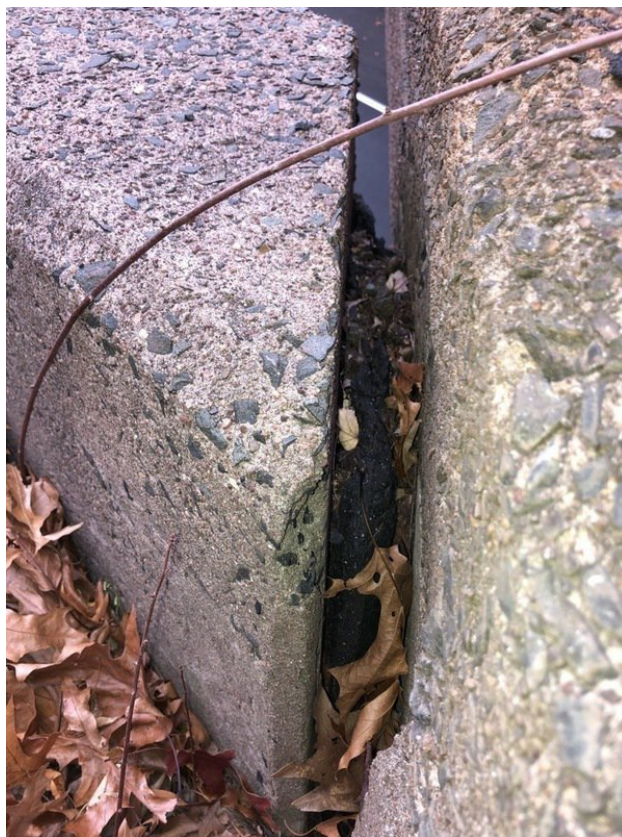
**South side top level**

( 2 ), EJC-1, Hard brittle black expansion joint compound , 2

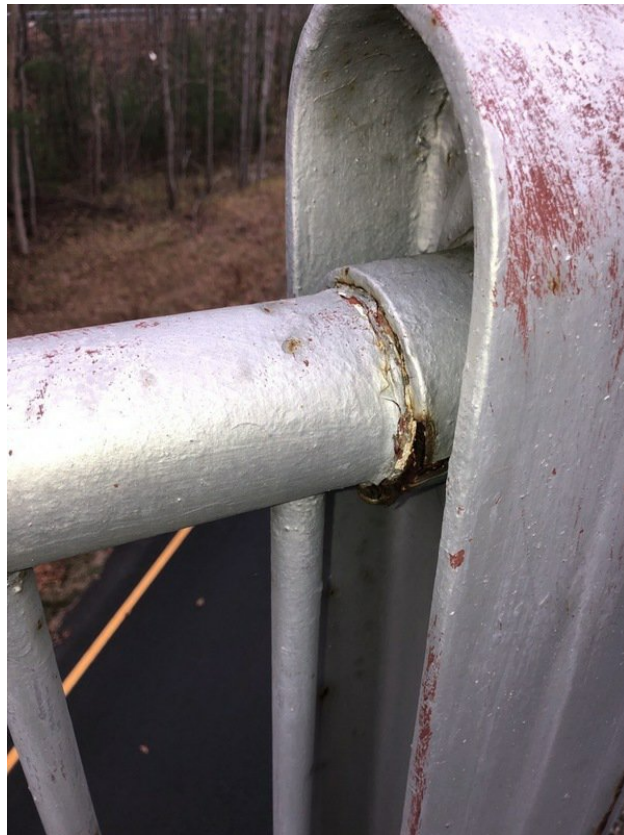
### South side top level

### ( 2 ), C, 2, Soft white railing caulk, 2

Sample Location	South side top level
Analyze by Layer	No
Asbestos Bulk Analysis	PLM EPA 600/R93/116
Grab or Composite	Grab
Date	2019-11-07
Time	12:42

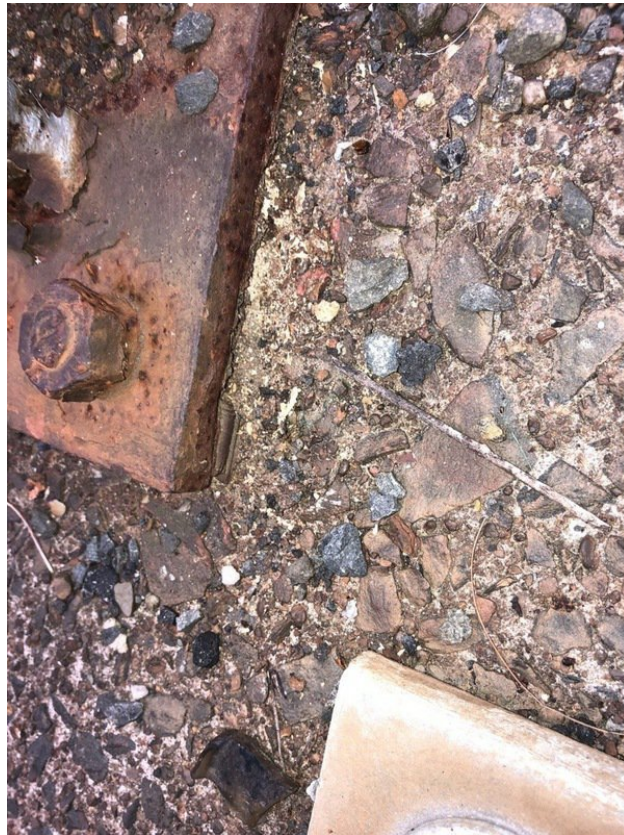
**South side top level**

**( 2 ), C, 3, Soft tan caulk, 2**

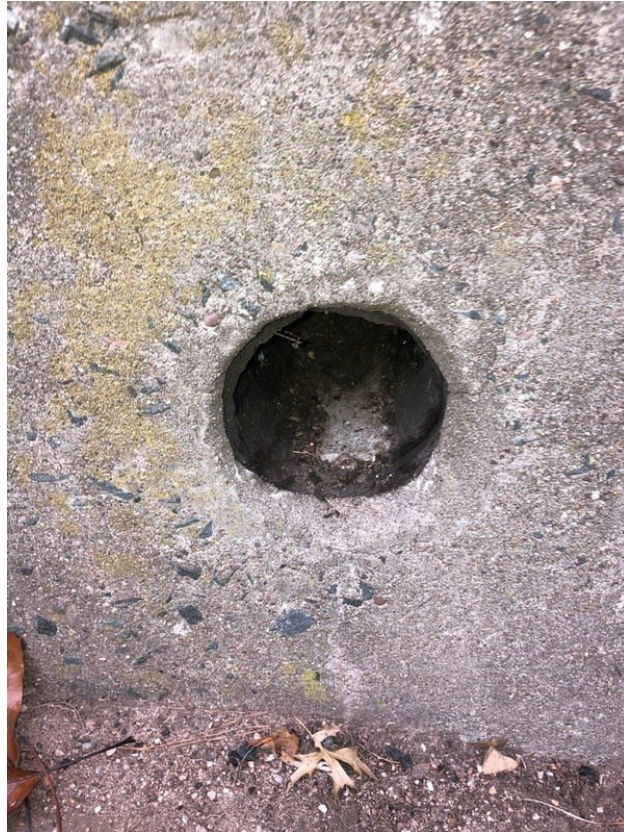
**West side lower level**

**( 2 ), T-1, Soft black pipe tar, 2**

Sample Location	West side lower level
Analyze by Layer	No
Asbestos Bulk Analysis	PLM EPA 600/R93/116
Grab or Composite	Grab
Date	2019-11-07
Time	13:05

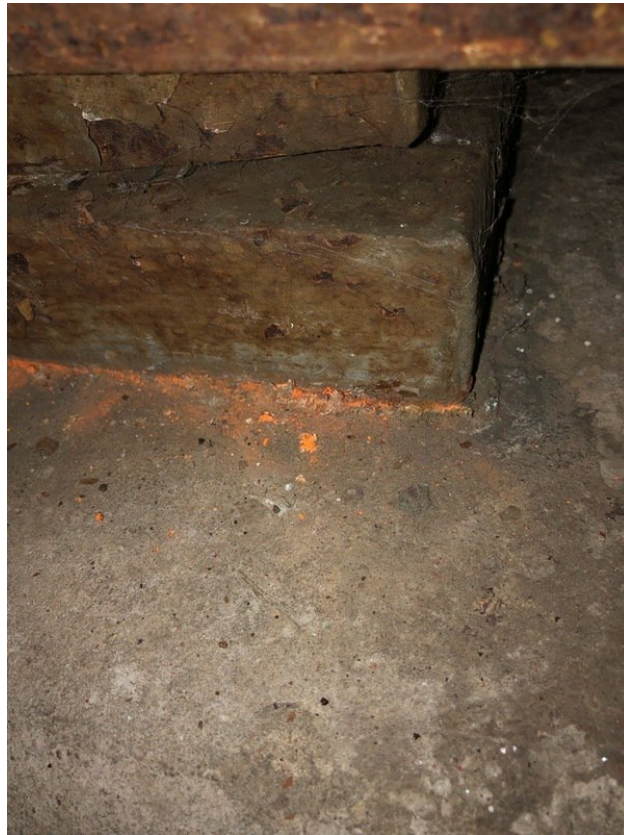
**West side lower level**

**( 2 ), M-1, White fibrous mesh, 2**

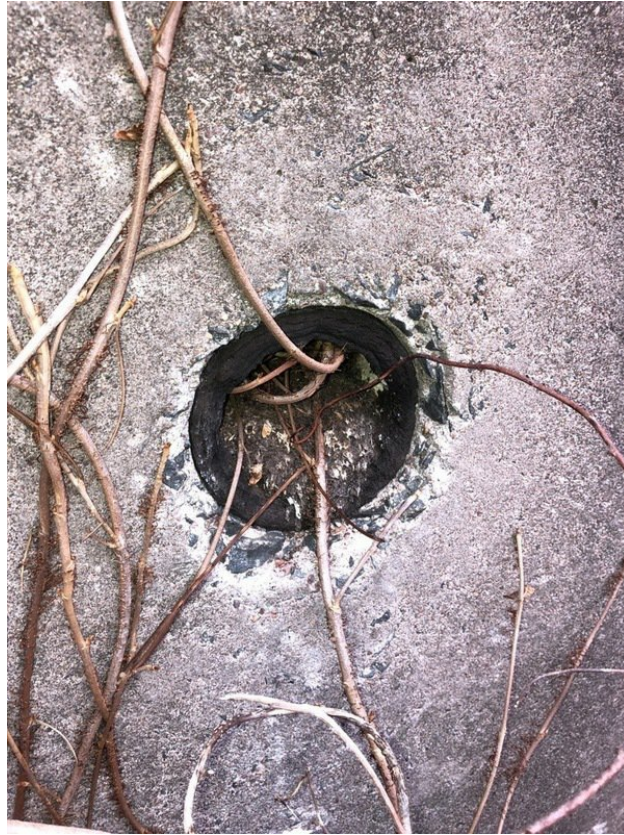
**North side ground level**

**( 2 ), T-1, Black tar pipe , 2**

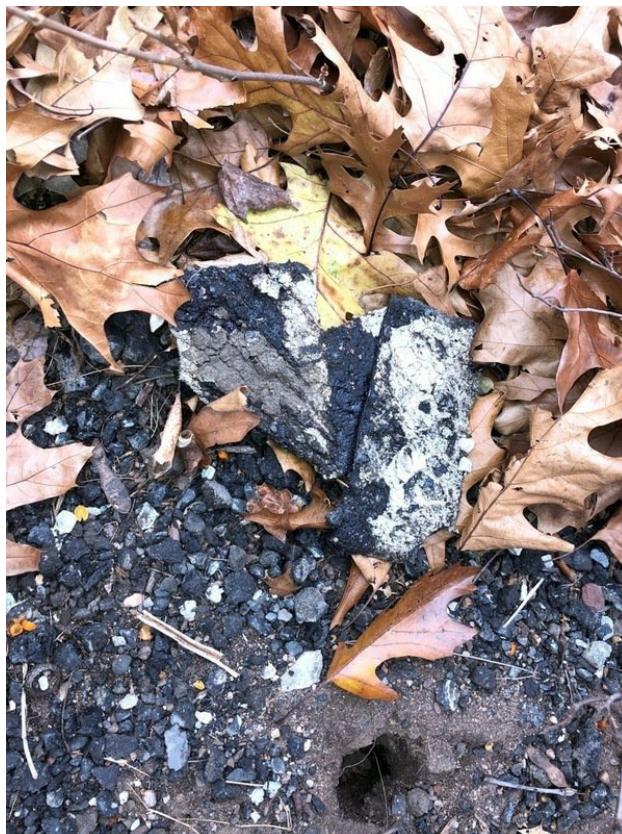
### West side top level

### ( 2 ), T-3, Hard black / white flexible tar, 2

Sample Location	West side top level
Analyze by Layer	No
Asbestos Bulk Analysis	PLM EPA 600/R93/116
Grab or Composite	Grab
Date	2019-11-07
Time	11:09

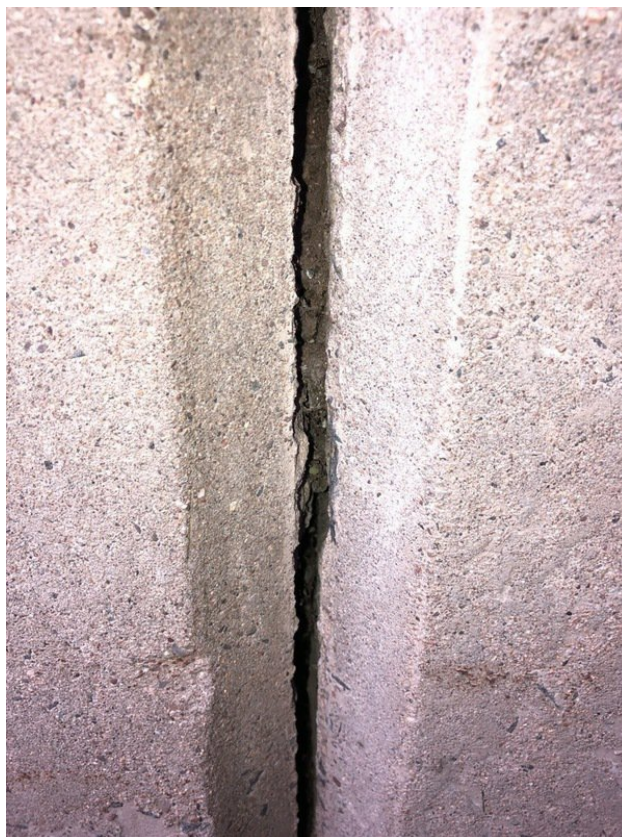
**North side ground level**

**( 2 ), EJC-2, Grey / brown brittle expansion joint compound, 2**

Sample Location	North side ground level
Analyze by Layer	No
Asbestos Bulk Analysis	PLM EPA 600/R93/116
Grab or Composite	Grab
Date	2019-11-07
Time	10:32

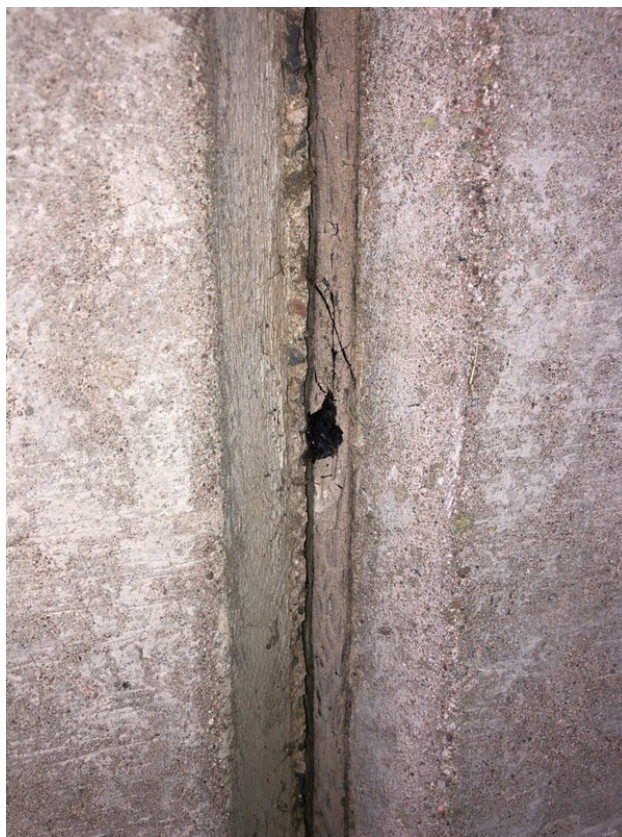
**South side ground level**

**( 2 ), EJC-3, Black expansion joint compound , 2**

Sample Location	South side ground level
Analyze by Layer	No
Asbestos Bulk Analysis	PLM EPA 600/R93/116
Grab or Composite	Grab
Date	2019-11-07
Time	10:35

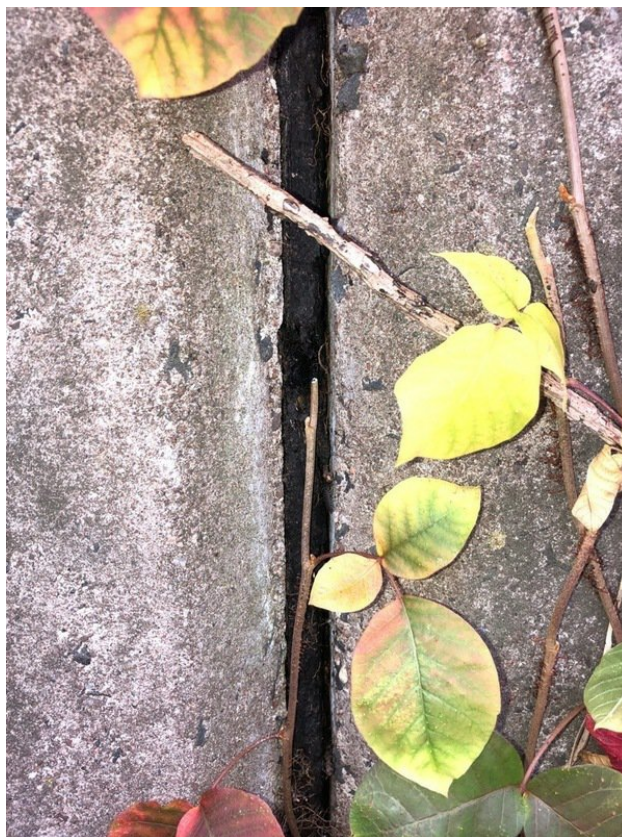
**South Side ground level**

**( 2 ), EJC-4, Black expansion joint compound , 2**

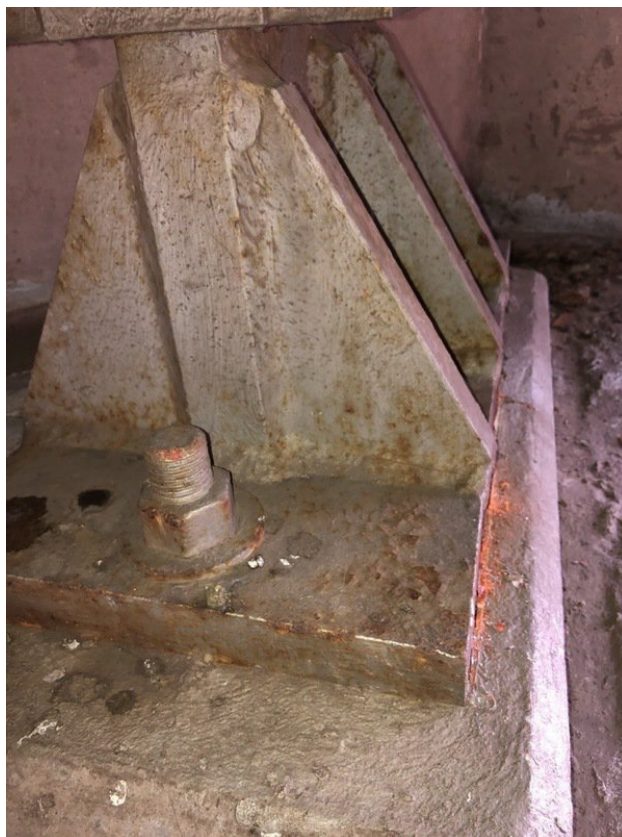
**north side lower level pedestal**

**( 2 ), M-1, Fibrous white / orange pedestal mesh , 2**

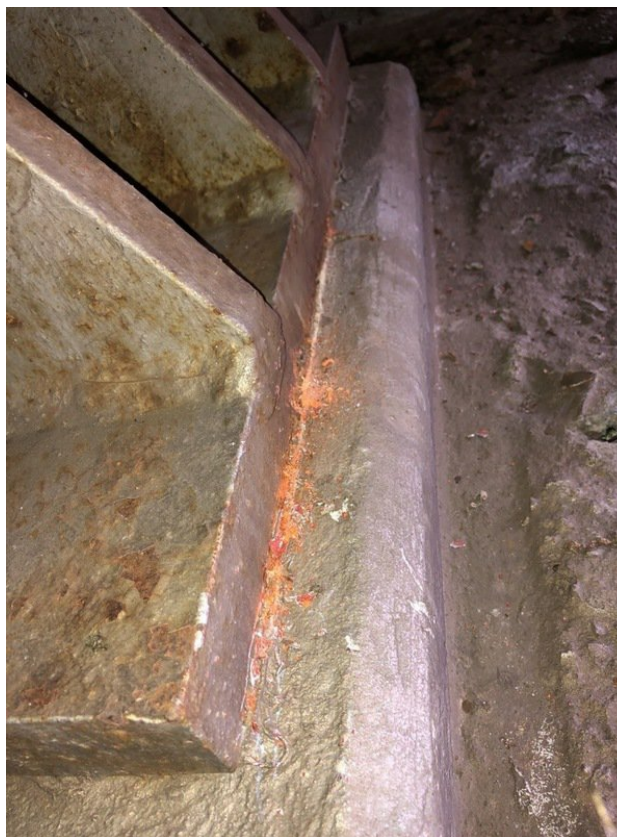
**north side lower level pedestal**

Sample Location	north side lower level pedestal
Analyze by Layer	No
Asbestos Bulk Analysis	PLM EPA 600/R93/116
Grab or Composite	Grab
Date	2019-11-07
Time	11:34
