OLD SHEPARD ROAD OVER MILL RIVER (HOTEL BRIDGE) BRIDGE NO. N-19-027 (0RA) NORTHAMPTON, MASSACHUSETTS

FLOORBEAM REPAIR DETAILS 1 OF 2

STRINGER REPAIR AND DECK DETAILS

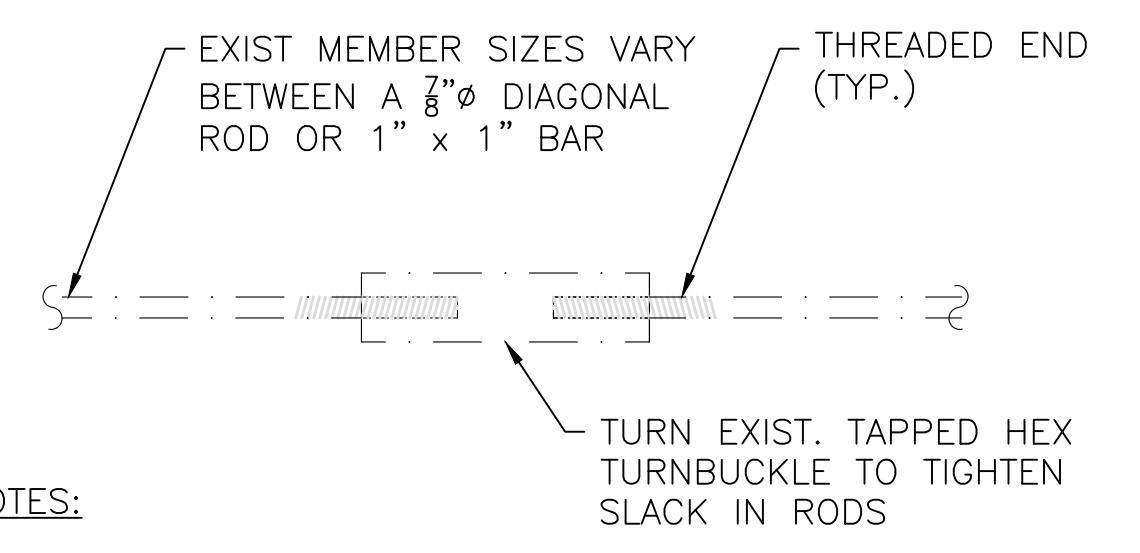
TIGHTEN DIAGONAL ROD - DETAIL
(NORTH TRUSS: L6-U5, L5-U4, U5-L4, & U4-L3)
(SOUTH TRUSS: L6-U5, U5-L4 & U4-L3)
 SCALE: 1 1/2" = 1'-0"

1. THE EXISTING TURNBUCKLES MAY BE CEASED. THE USE OF A PENETRATING OIL TO LOOSEN THE INTERNAL THREADS IS RECOMMENDED.
2. THE CONTRACTOR SHALL STABILIZE BOTH DIAGONAL ROD ENDS AT THE TURNBUCKLE TO PREVENT THE MEMBER FROM BEING DAMAGED BY TWISTING WHILE THE TURNBUCKLE IS TURNED.
3. THE CONTRACTOR SHALL SUBMIT THEIR PROPOSED PROCEDURE TO STABILIZE AND TIGHTEN THE DIAGONAL RODS TO THE ENGINEER FOR APPROVAL.
4. HEATING THE EXISTING DIAGONAL RODS OR TURNBUCKLES SHALL NOT BE PERMITTED.
5. ALL COSTS FOR TIGHTENING DIAGONAL RODS SHALL BE INCLUDED IN PAY ITEM 960.04, "STRUCTURAL STEEL, - TIGHTEN TRUSS DIAGONAL CHORDS".
