# Becker Pond Dam Removal 100% Design Report FINAL

August 31, 2024

Inter-Fluve, Inc.  
220 Concord Avenue, 2<sup>nd</sup> Floor  
Cambridge, MA 02138

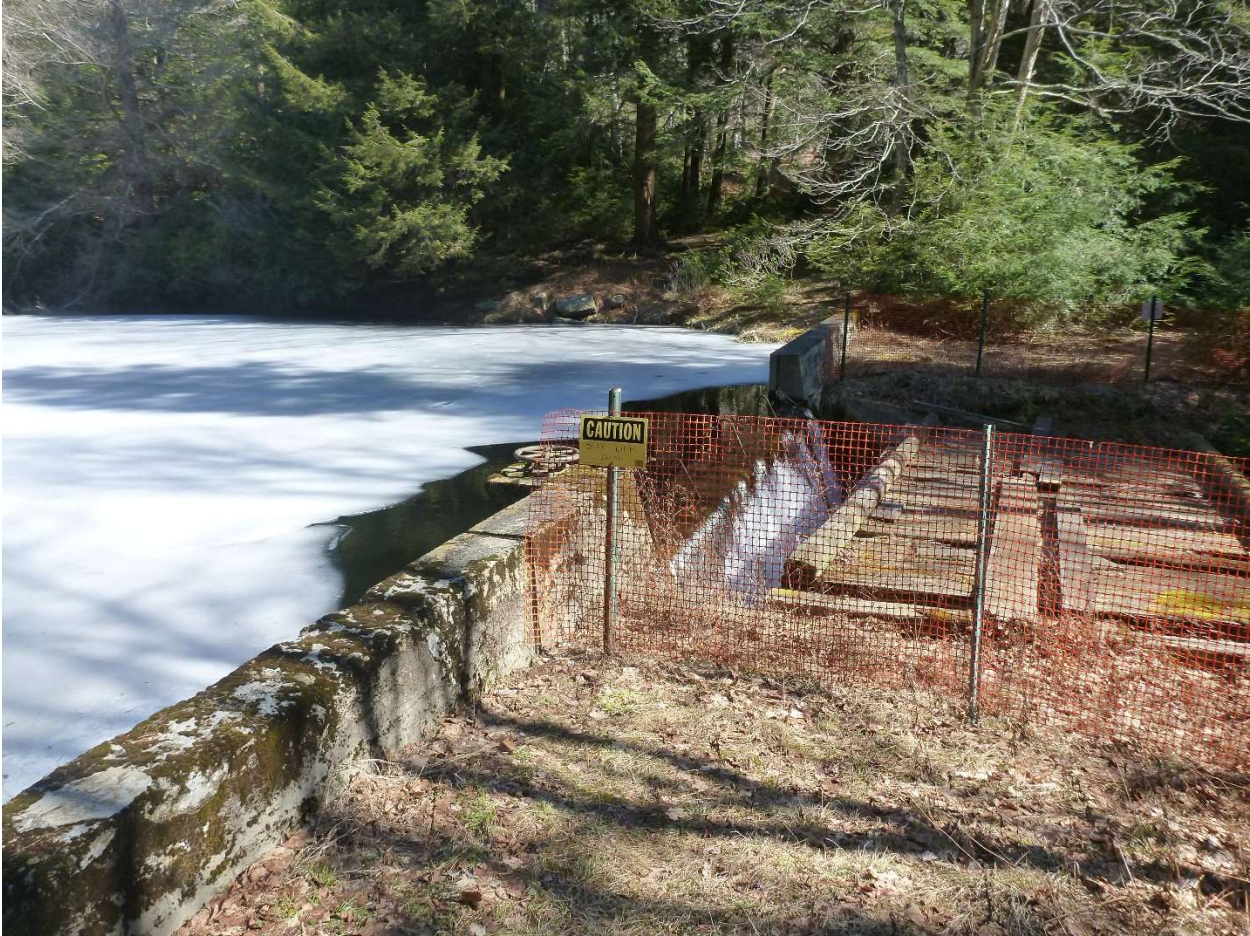
*Figure 2. Becker Pond Dam showing concrete core wall, spillway, and failing bridge*

Becker Pond covers an area of approximately 0.65 acres. Becker Pond Dam is composed of a 95-foot-long earthen embankment and a concrete core wall (Figure 2). The dam outlet consists of a rectangular weir spillway with a concrete apron and concrete training walls. The structural height of the dam is approximately 14.25 feet. The crest of the concrete spillway is set approximately 2.25 feet below the top of the concrete core wall and has a weir length of 23.2 feet. The concrete training walls retain the earthen embankments adjacent to the spillway section and direct flow over the concrete apron. The concrete apron extends approximately 16.75 feet downstream of the base of the spillway (Figure 3). A low-level outlet is present, but we understand from others that it is inoperable.

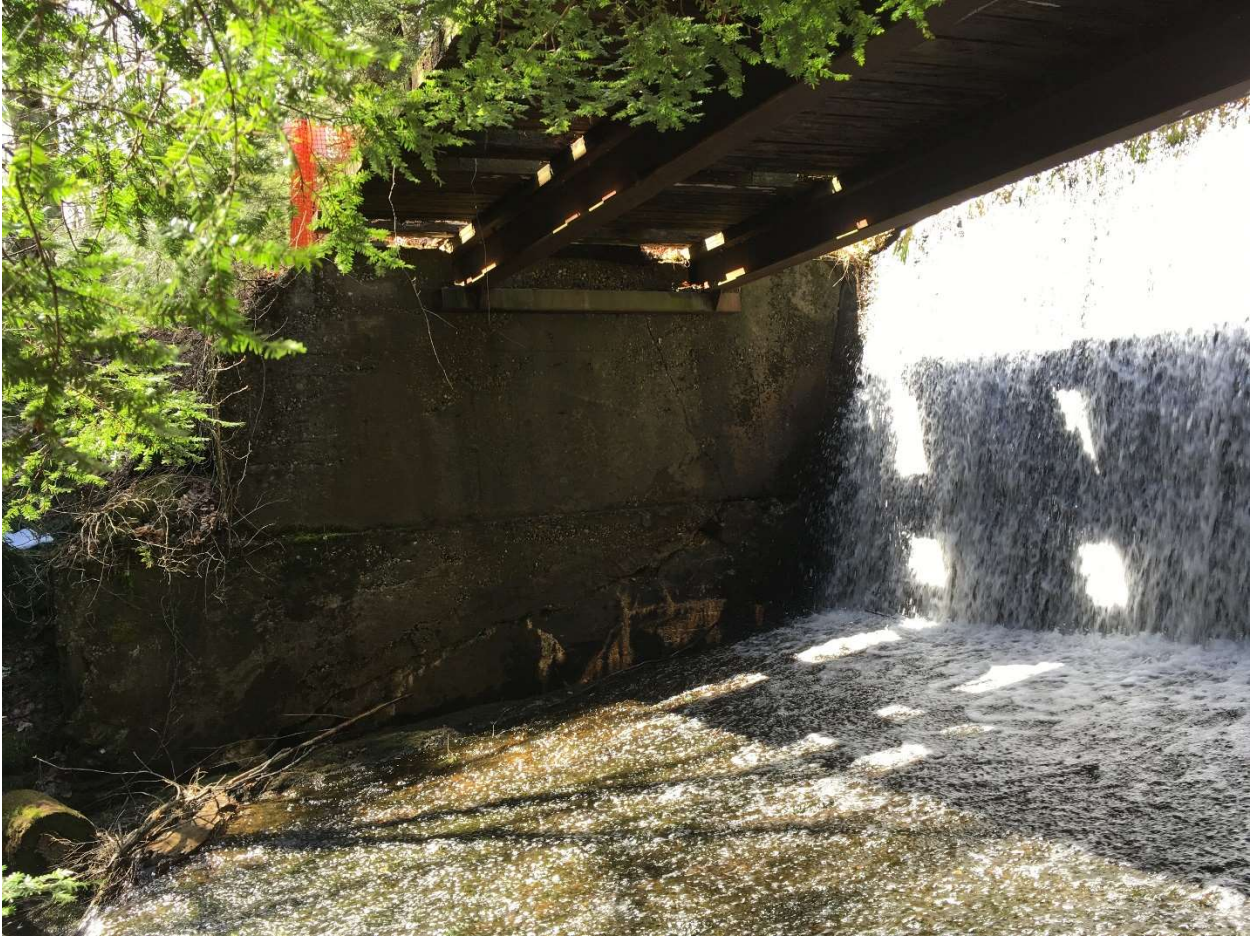
*Figure 3. Right concrete training wall and concrete apron*

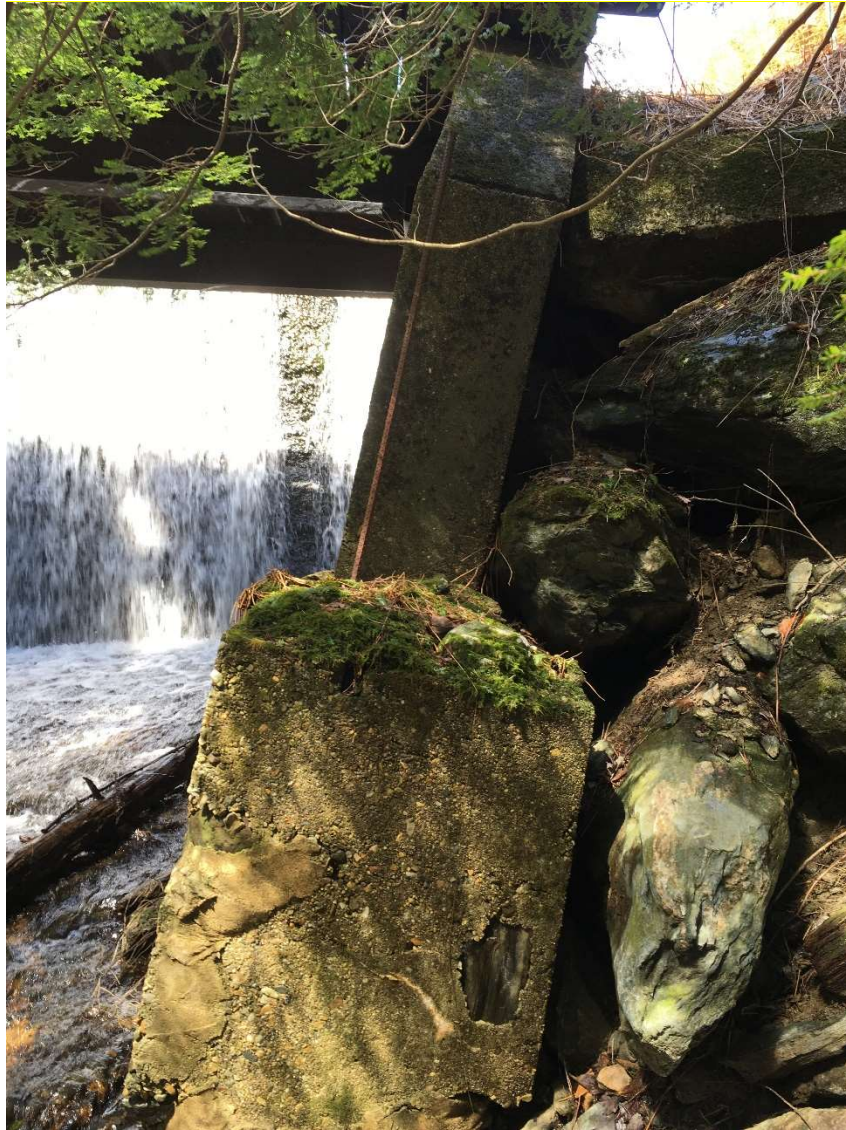
*Figure 4. Left concrete training wall slipped off of its foundation and resting on concrete apron*

A visual inspection carried out in 2016 (Fuss & O'Neill, 2016) found the dam to be in poor condition with several critical issues, notably, the left training wall, which is cracked and failing, has slipped off its foundation (Figure 4). The inspection also found significant erosion of the earthen embankment adjacent to the wall and cracked and spalling concrete in other areas. The wooden bridge crossing the dam has partially collapsed and has been cordoned off by TNC and warning signs posted.

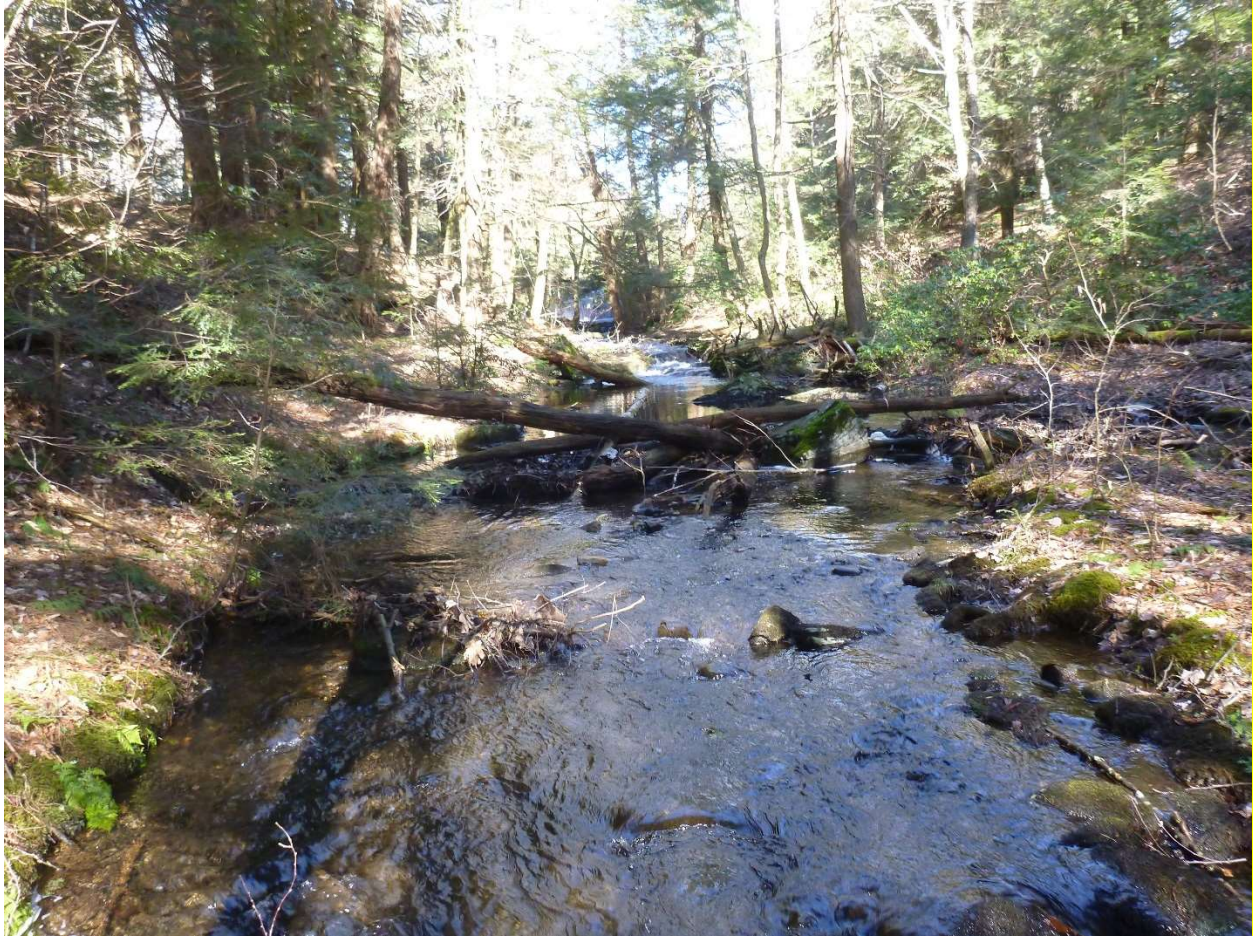
*Figure 5. Looking upstream towards the dam along the channel, which exhibits complexity in substrate, form, and habitat*

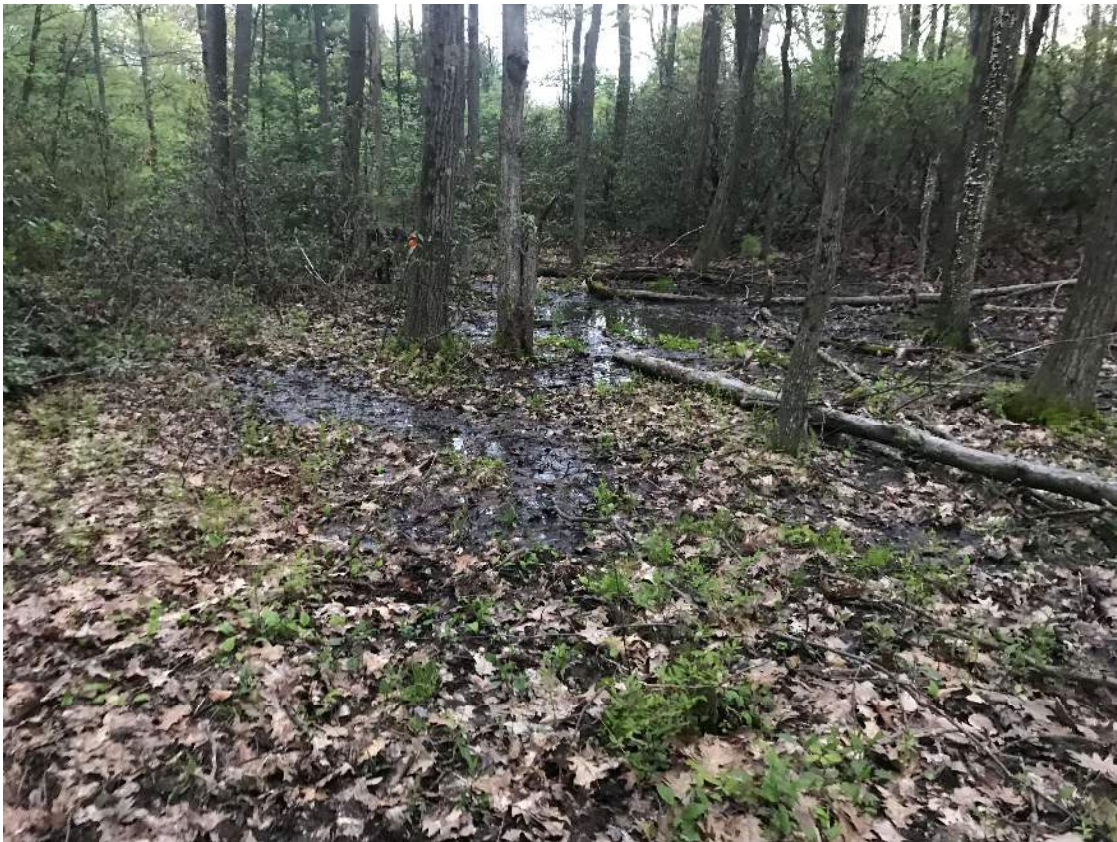
*Figure 8. Wet, low-elevation areas in the foreground, and higher ground dominated by mountain laurel in the background*

Two options for access to the dam are currently being considered. One option (Access Entrance Alternative 1) involves the use of an existing dirt road from East Street to the dam. Approximately 350 feet of this road, beginning at East Street, are within private property. TNC is currently coordinating with the owner to gain access to this road during construction. The alternative access option (Access Entrance Alternative 2) is to construct a new access road that is entirely within TNC property and that connects East Street to the existing dirt road. This new access road would be located approximately 100 feet from a concentrated drainage flow path that originates at the outlet of a drainage relief culvert under East Street. Sand and gravel have accumulated on the downstream (eastern) side of the culvert crossing and have covered the roots of several trees. The accumulated material has also raised the concentrated drainage flow path above the adjacent ground and prevents a small area north of the flow path from draining (Figure 8).

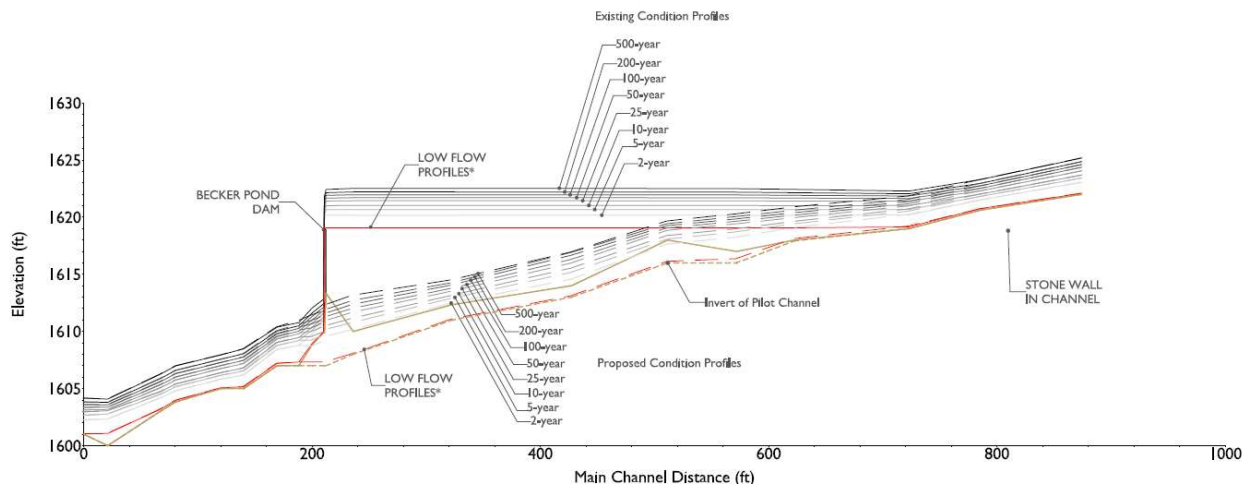
**Figure 9. Comparison of flood profiles: 2-, 10-, 25-, 50-, 100-year events**

Model estimates indicate that the removal of the dam will reduce the elevation of the flood profile (for all events) immediately upstream of the dam by approximately 12 feet. Model results also indicate that hydraulic impact of the dam extends to a location approximately 600 feet upstream of the dam. Upstream of that location, the removal of the dam will not affect the hydraulic conditions within the stream channel. Figure 9 illustrates the impact of the dam removal on the flood profiles of the subject reach for the 2-, 5-, 10-, 25-, 50-, 100-, 200- and 500-year return period events.

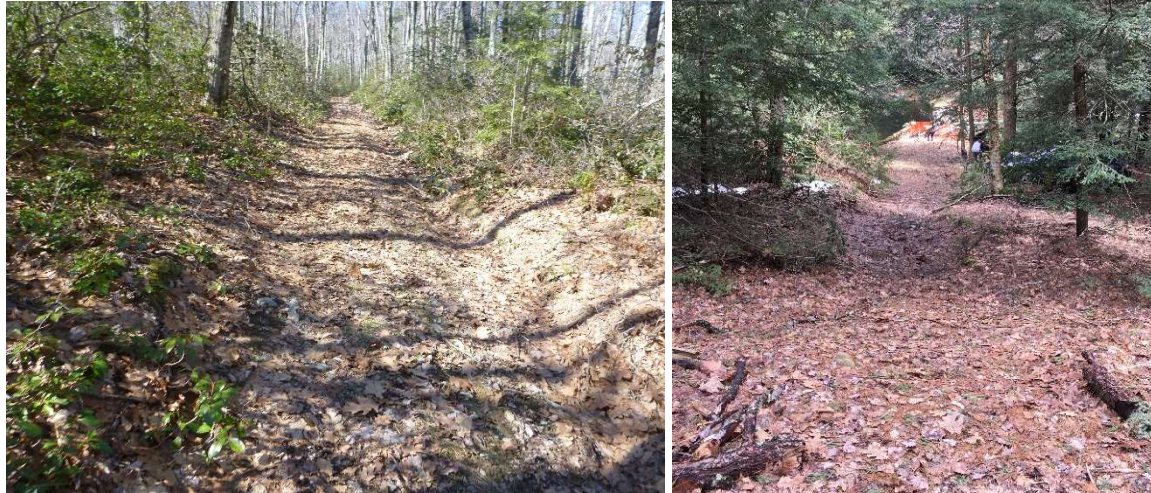
**Figure 10. Existing dirt access road to be used during the removal of Becker Pond Dam (left) looking north along the road and (right) looking east towards the dam.**

At the locations of the access points, East Street is a well-maintained gravel road. In winter, Mount Washington plows the road to the Connecticut State Line. The existing dirt access road is approximately 10 to 12 feet wide and will be wide enough for access of heavy construction vehicles (Figure 10). Some vegetation clearing may be necessary; tree branches may need to be trimmed and removed. Where the existing access road approaches the dam, there is a small loop around a few mature hemlock trees. The interior of this loop may be cleared for access and staging and the harvested large wood may be incorporated into the project.
