Subject: On-Call Asbestos, Lead, Air Quality & Demolition Compliance Agreement No. 10.04-02 (23) HazMat Inspection – Removal of Bridge No. 04671, Carroll Road over the Patchaug River, Griswold, CT ConnDOT Assignment No. 524-7974 ConnDOT Project No. 57-121 TRC Project No. 501871.7974.0710

TRC performed a limited hazardous materials site investigation associated with the removal of Bridge No. 04671, Carroll Road over the Patchaug River in Griswold, Connecticut. Results of the survey identified lead paint on the railing support, cable guardrail and guardrail metal bridge components to be impacted at Bridge No. 04671. Results obtained from TCLP waste stream sampling and analysis for leachable lead from the paint on the railing support, cable guardrail and guardrail metal bridge components characterized the paint waste stream as **CTDEEP/RCRA** hazardous waste. No detectable amounts of lead in paint were identified on the concrete parapet wall/curb paint, therefore any paint waste generated from those bridge components would be non-hazardous, non-RCRA lead waste. Off-white remnant railing support caulk, tan stone abutment mortar, and grey textured parapet wall skim coat were sampled an

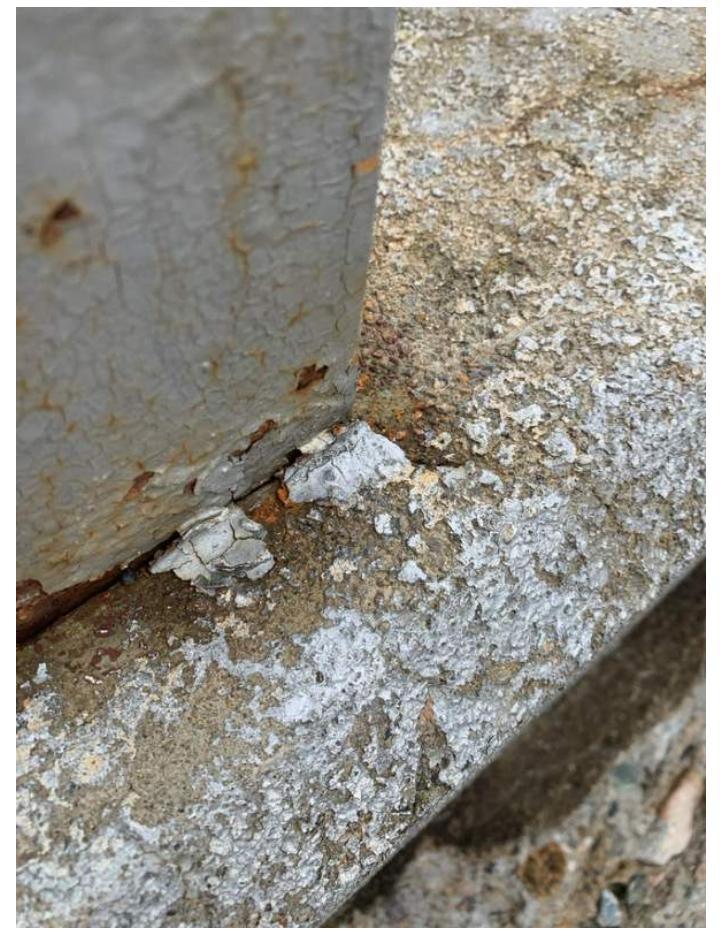
Materials & Samples - 1. (2) Samples #01–02: C1–Remnant off-white railing support caulk

Sampled or Assumed?	Sampled
Material Acronym	C►1
Material Description	Remnant off-white railing support caulk
Material Color

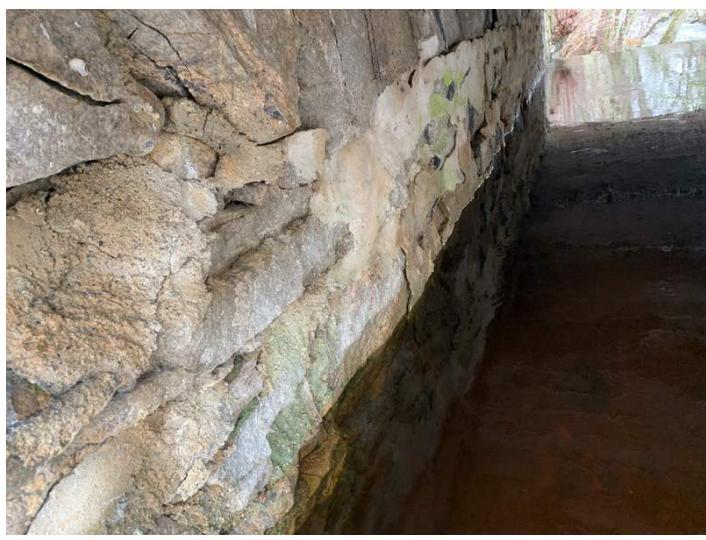
Materials & Samples - 2. (2) Samples #03-04: MRT 1-Tan stone abutment mortar

Material Information	
Sampled or Assumed?	Sampled
Material Acronym	MRT 1

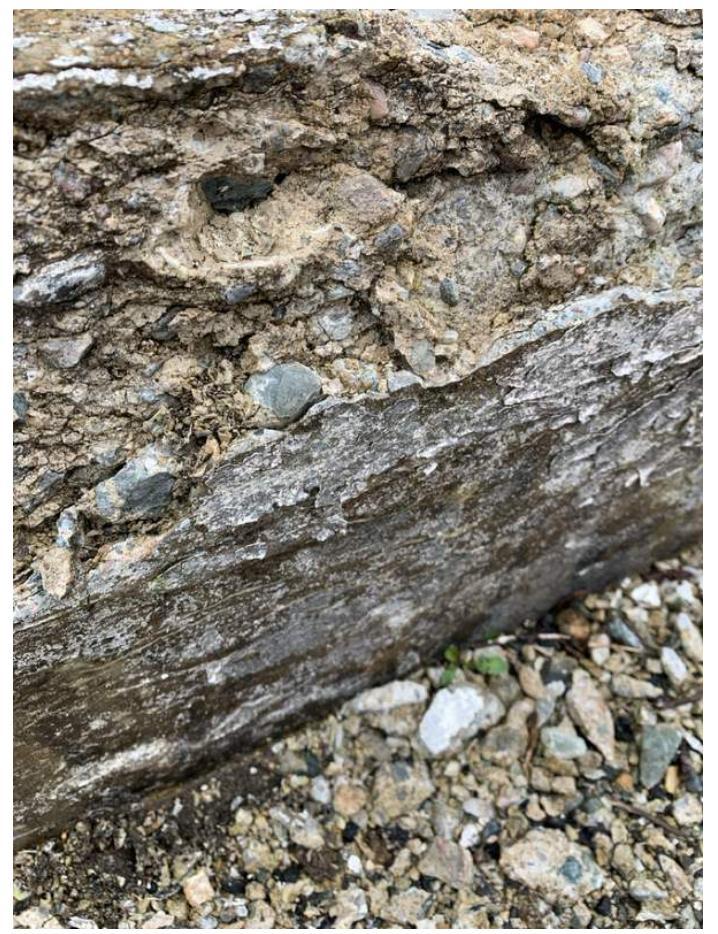
Materials & Samples - 3. (3) Samples #05-07: SK 1-Textured parapet wall skim coat

Sampled or Assumed?	Sampled
Material Acronym	SK 1
Material Description	Textured parapet wall skim coat
Material Color

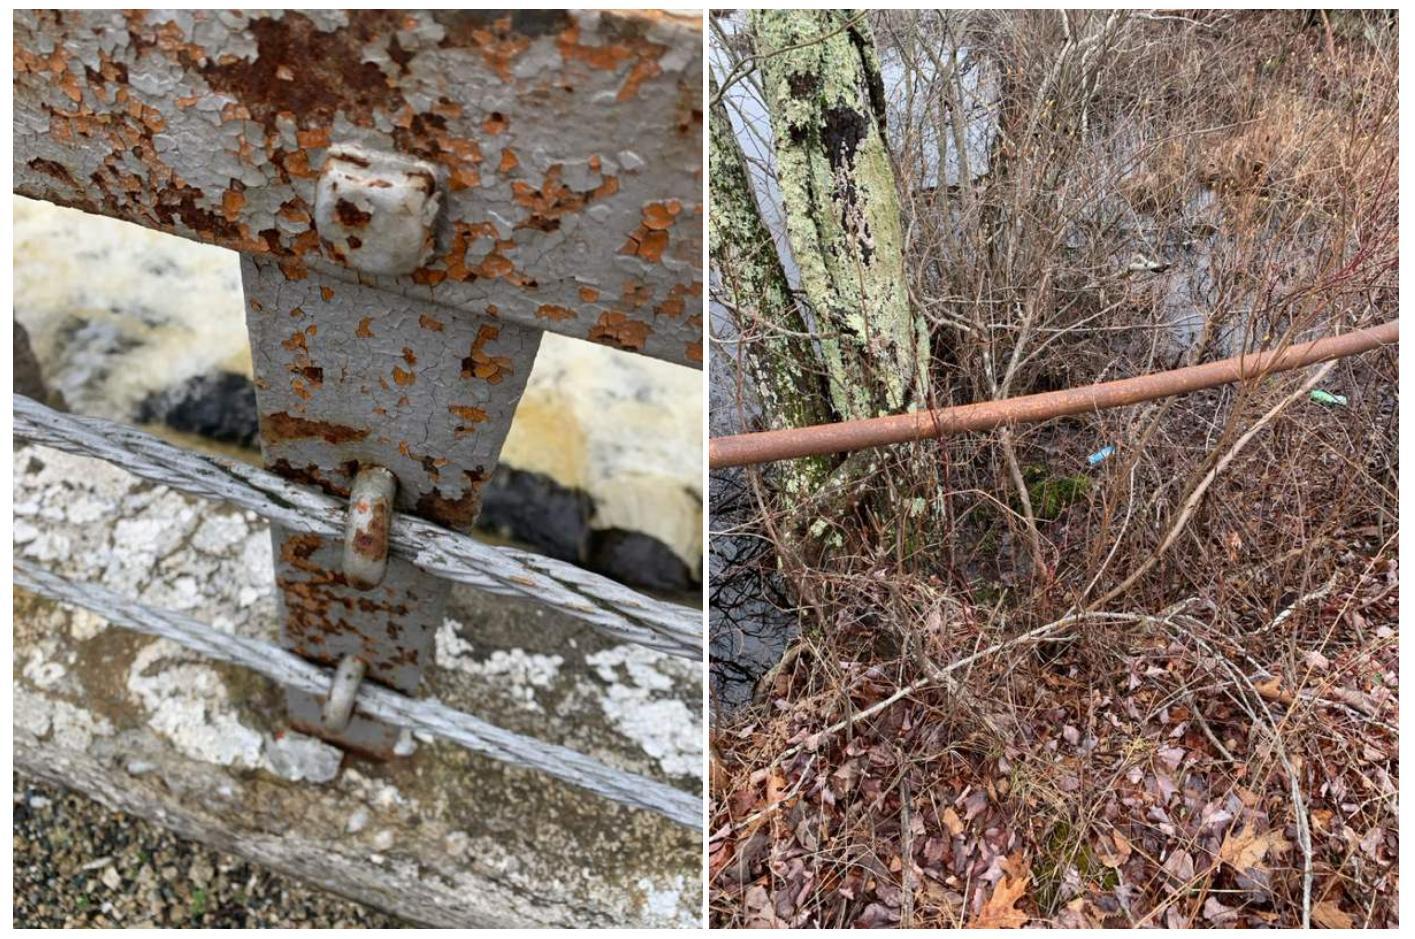
Samples - 1. Silver/orange railing, railing support, cable guardrail paint

Silver/orange railing, railing support, cable guardrail paint

Material	Paint Chips
Square Footage	
Type of Analysis	TCLP Lead
Sample Number	01
Grab or Composite	Grab
Date	March 6, 2024
Time	09:43
TCLP/SPLP/Total Lead Notes

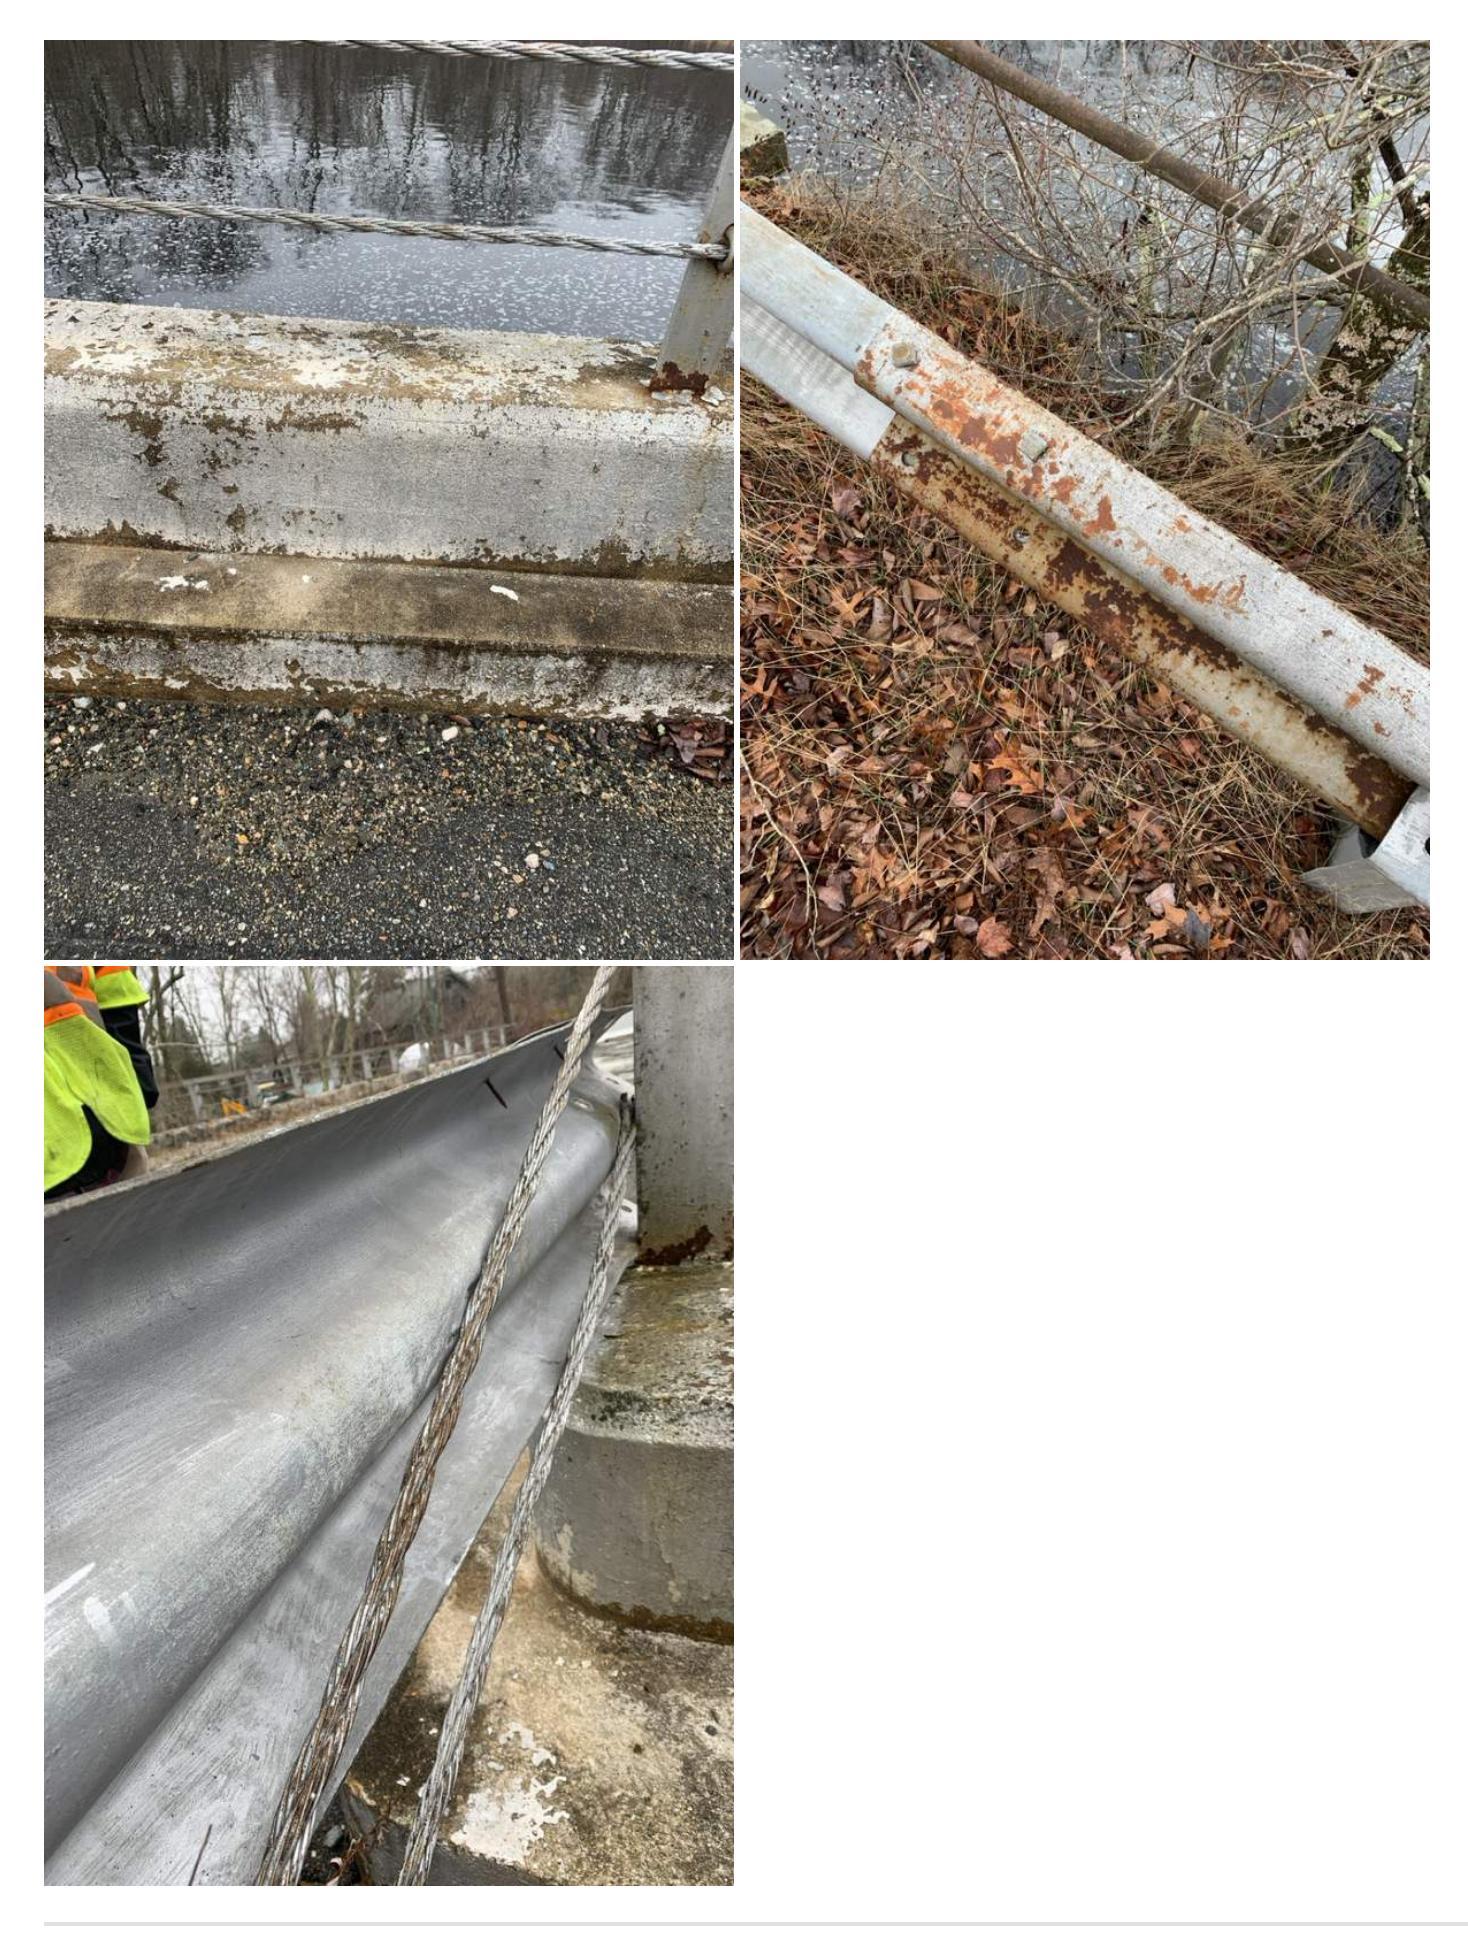
Samples - 3. Silver/white parapet wall, curb, guardrail paint

Silver/white parapet wall, curb, guardrail paint

Material	Paint Chips
Square Footage	
Type of Analysis	TCLP Lead
Sample Number	03
Grab or Composite	Grab
Date	March 6, 2024
Time	09:47
TCLP/SPLP/Total Lead Notes
