BRIDGE NO.04671

33900 - GRISWOLD
CARROLL ROAD
over
PACHAUG RIVER

Routine and Underwater Inspection

4/14/2021

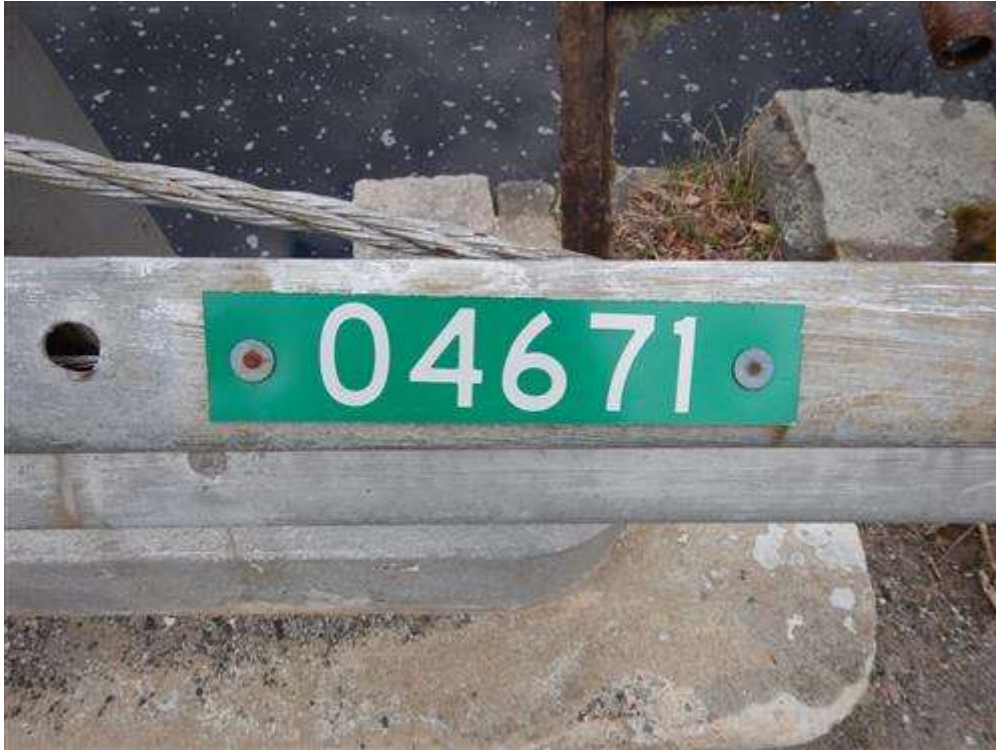
Photo Number: 1

Bridge Identification Number

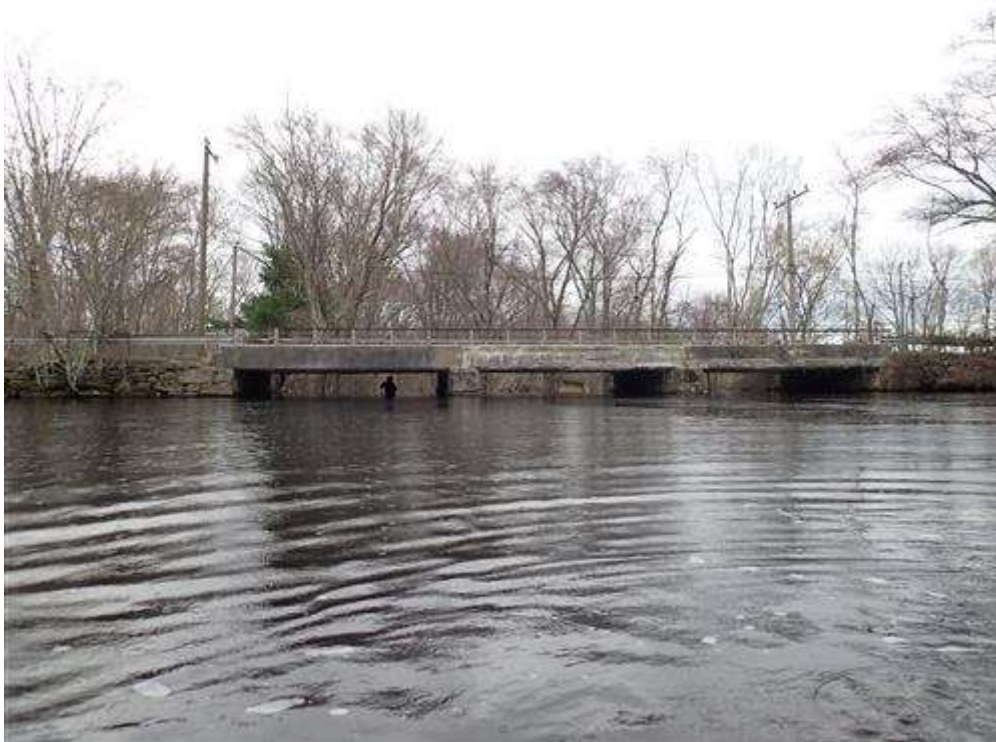
Photo Number: 2

Upstream (North) Bridge Elevation

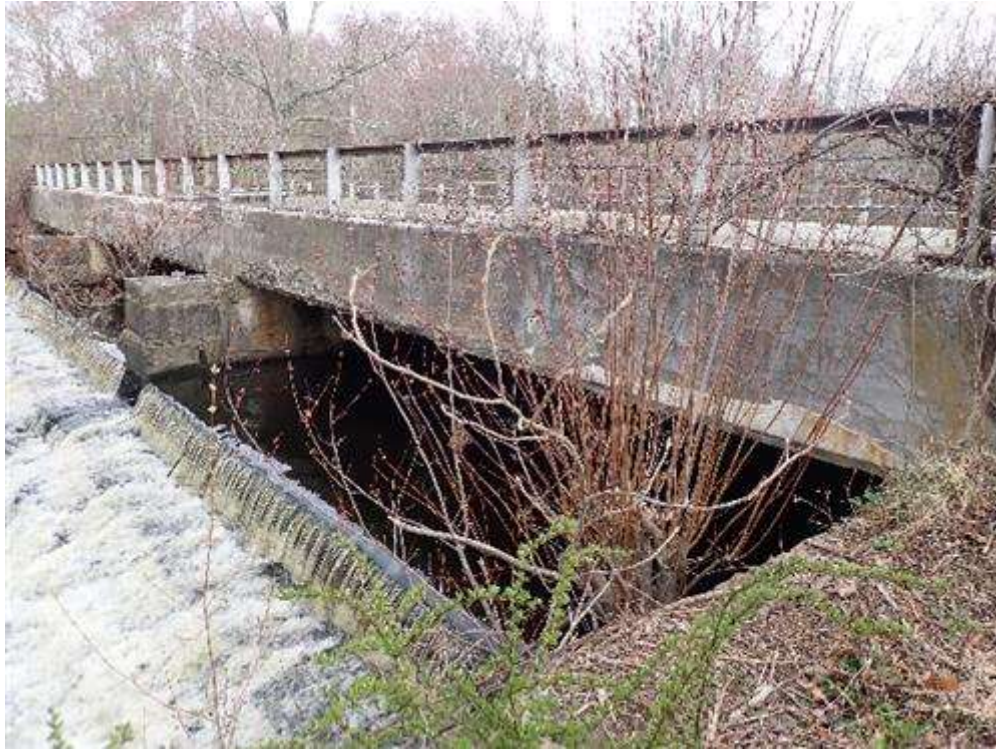
Photo Number: 3

Downstream (South) Bridge Elevation

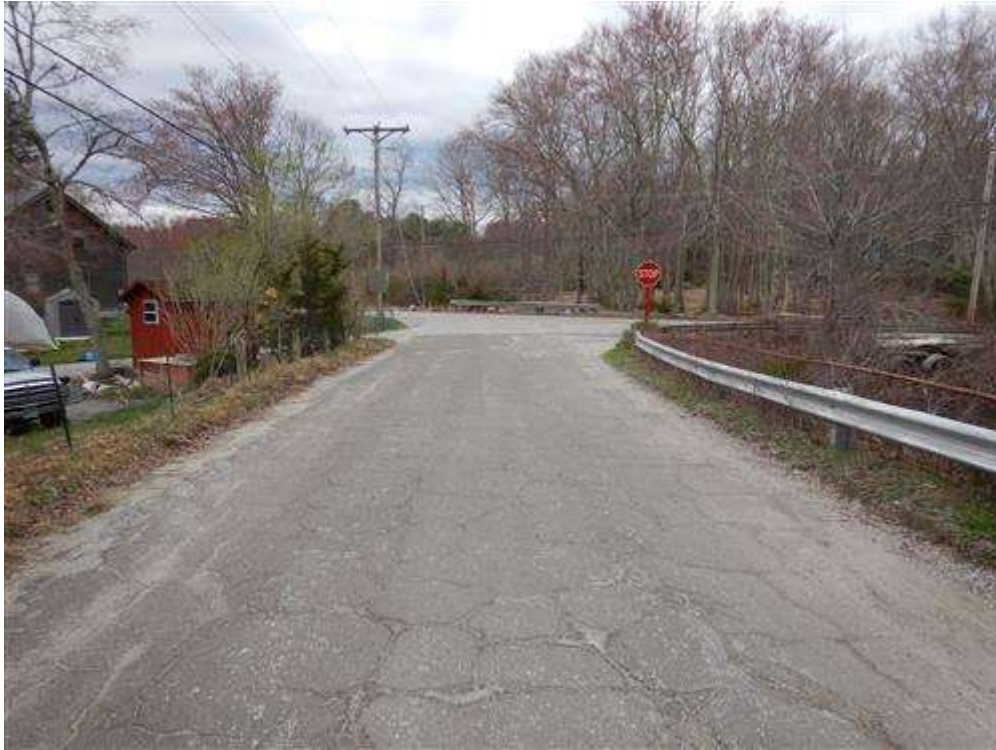
Photo Number: 5

West Approach from the Bridge

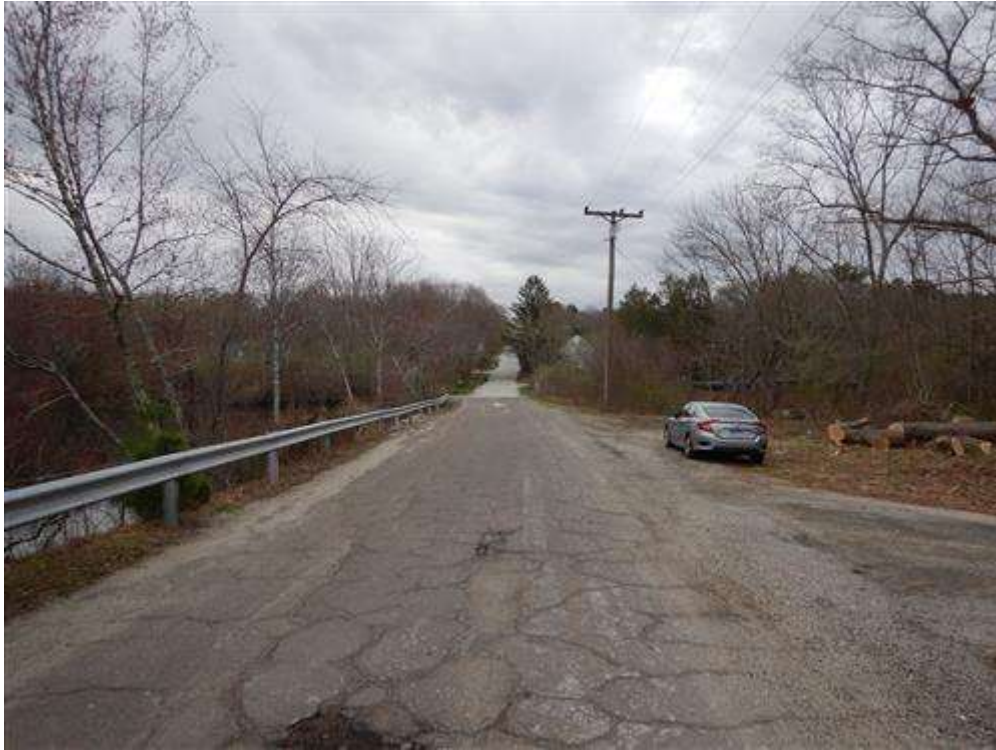
Photo Number: 7

East Approach from the Bridge

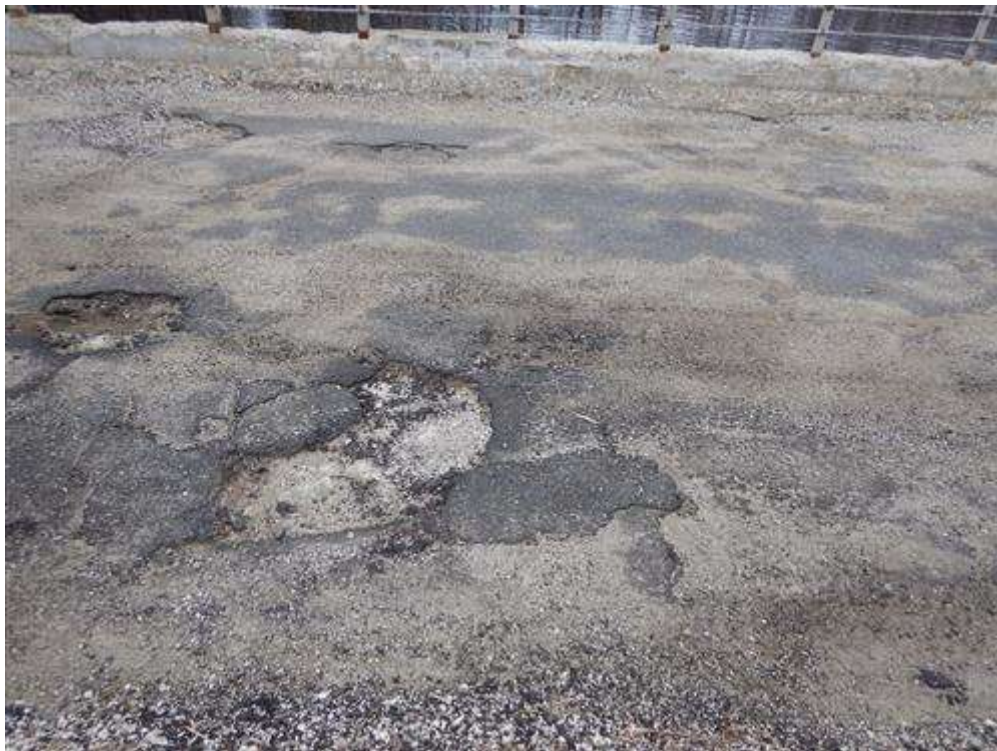
Photo Number: 10

Span 2 Overlay Near Left (North) Curb

Note: Pothole / spall.

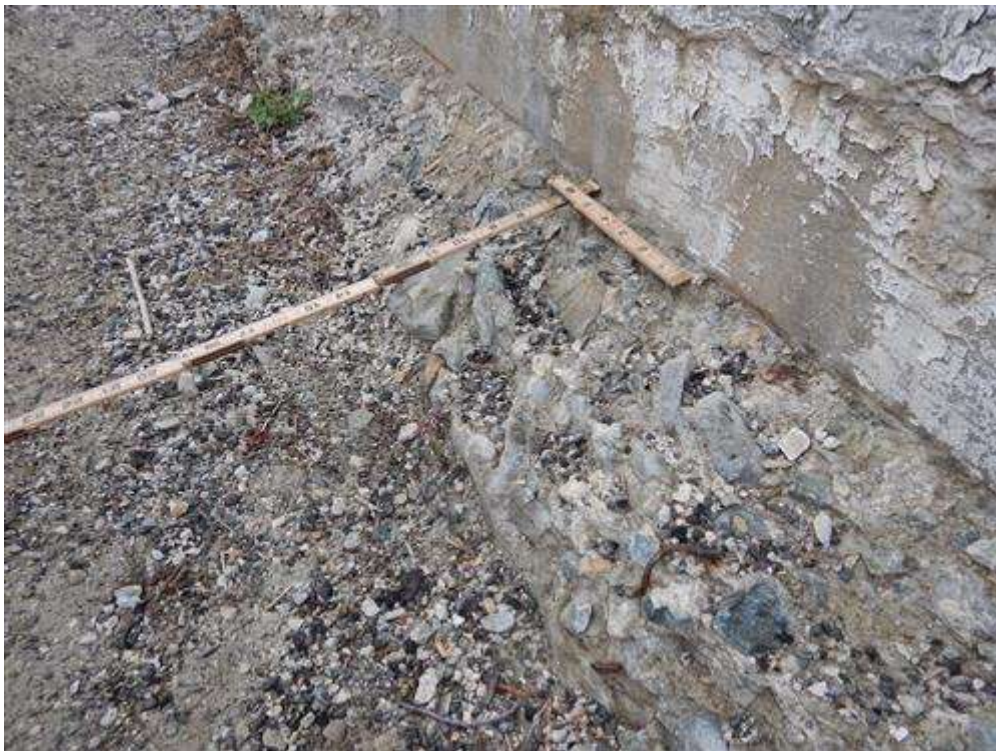
Photo Number: 14

Median: N	
Sidewalks: 4	The right (south) concrete sidewalk has the following deficiencies: <ul style="list-style-type: none"> • Covered with sand and gravel. • Heavy debris accumulations. • Hollow areas throughout with up to 1-1/2" deep spalls with punky concrete x full length of bridge. • Areas of severe scale greater than 1" deep throughout with loose concrete along the edges. <p>Refer to 'Curbs' item above.</p> <p>(See Sketch 2 and Photos 13 & 15)</p>
Parapet: 3	The reinforced concrete parapets have the following deficiencies:

Right (South) Curb, Sidewalk, Parapet and Bridge Rail

Note: Extensive spalling.

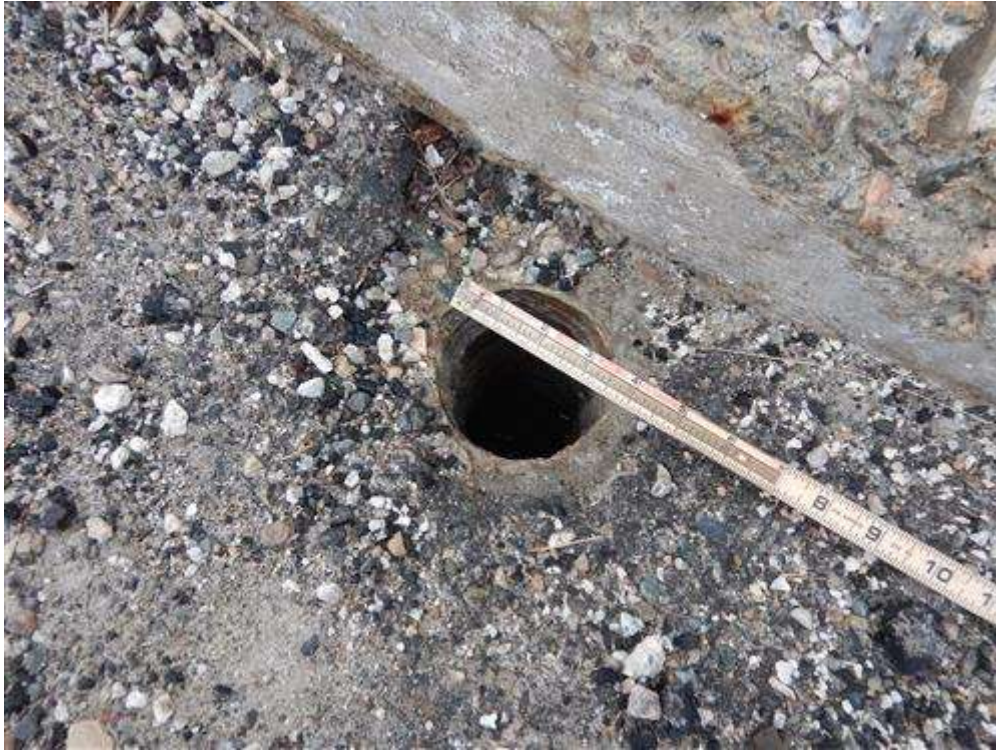
Photo Number: 19

Typical Drain

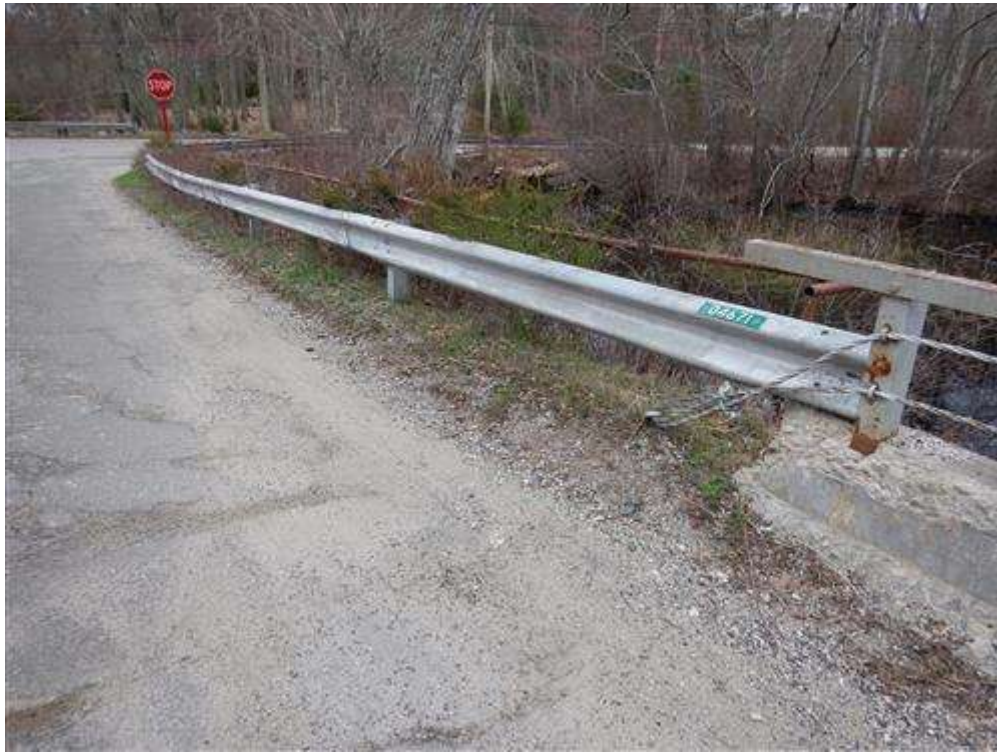
Photo Number: 21

- Southwest approach guide rail has both cables missing; timber posts have checks up to 1/16" wide and rot up to 6" deep on the top.
- Northwest approach guide rail has (4) tilted posts and up to 4" long tears at all splices.
- Northeast approach guide rail has light surface rust and one (1) of five (5) bolts in place at the connection to the bridge (as-built condition).

Northwest Approach Guide Rail

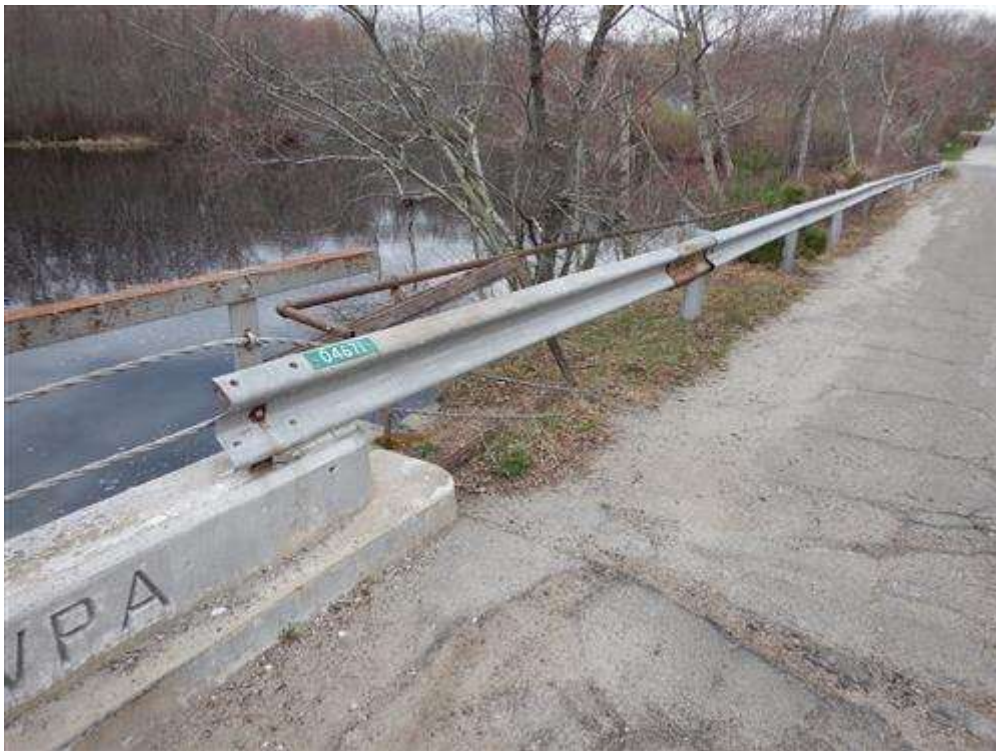
Photo Number: 24

Southeast Approach

Note: No guide rail.

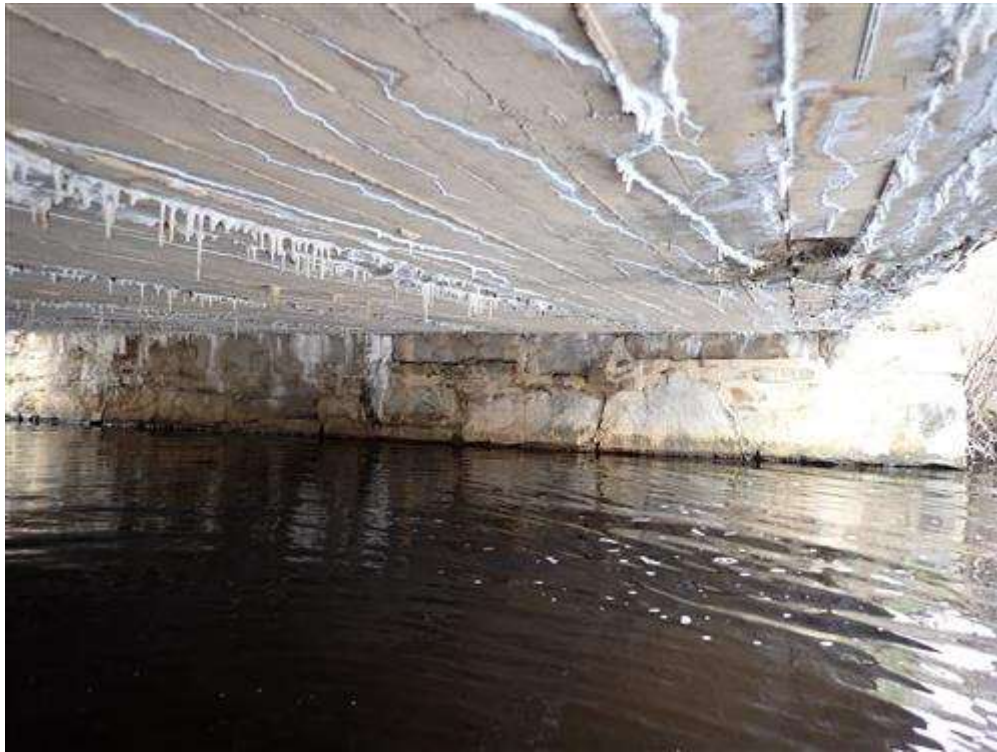
Photo Number: 35

Abutments - Stem:	<input type="text" value="3"/>	<p>The abutments have random patched and partially patched voids with some repointed masonry and the following deficiencies:</p> <ul style="list-style-type: none"> • Deteriorated mortar and missing chinking stones. • Intermittent areas of efflorescence up to full stem length extending down from the bearing seat. <p>Abutment 1:</p> <ul style="list-style-type: none"> • Random cracks up to 4' long x up to 1/4" wide with some extending through stones. • A 1' long x 1/2" wide crack with efflorescence extending from the bearing seat near the upstream (north) end. • Upstream (north) end has an 8' long open masonry joint along the water surface. • Up to 50% cracked/ missing mortar with missing chinking stones with up to 30" penetration extending from 1' above the waterline to channel bottom. • Random voids due to missing stones measuring up to 3.0' long x up to 1.0' high with up to 3.3' penetration. <p>Abutment 2:</p> <ul style="list-style-type: none"> • Random vertical cracks up to full-height x up to 1/4" wide. • Up to 20% mortar loss above the waterline with up to 1.0' penetration. • 100% mortar loss below the water surface with up to 1.0' penetration. • Random voids up to 3.0' long x 0.9' high with up to 6.2' penetration with and without loss of fill or roots growing. <p>Rating lowered from '4' to '3' based on areas with up to 100% mortar loss, missing stone and chinking stone voids with up to 6.2 penetrations.</p> <p>(See UW Drawings 3 & 8 and Photos 35 - 41)</p>

Abutment 1 Elevation

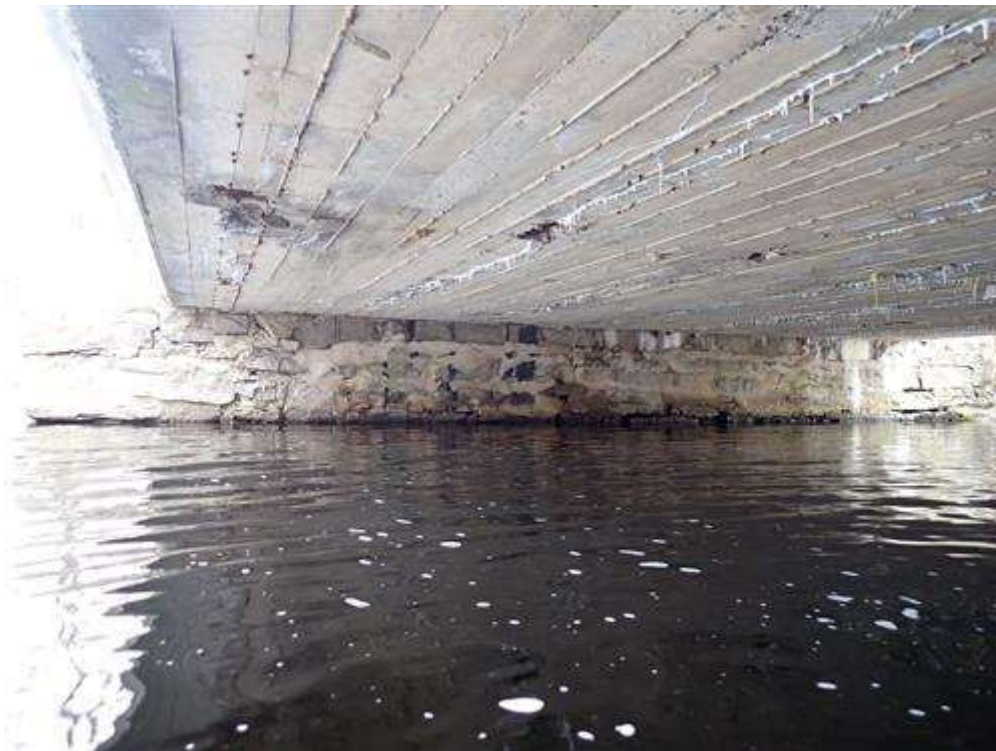
Photo Number: 38

Abutment 1 Downstream End

Note: Efflorescence.

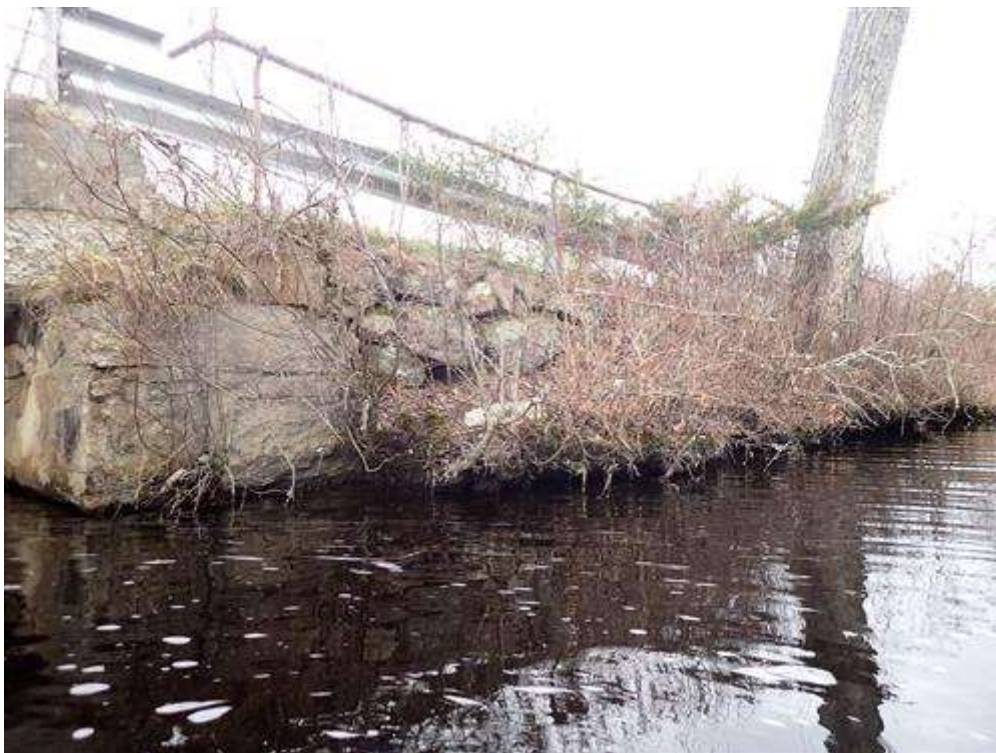
Photo Number: 42

Abutment 2 at Right (South) End

Note: Voiding with penetration near water surface.

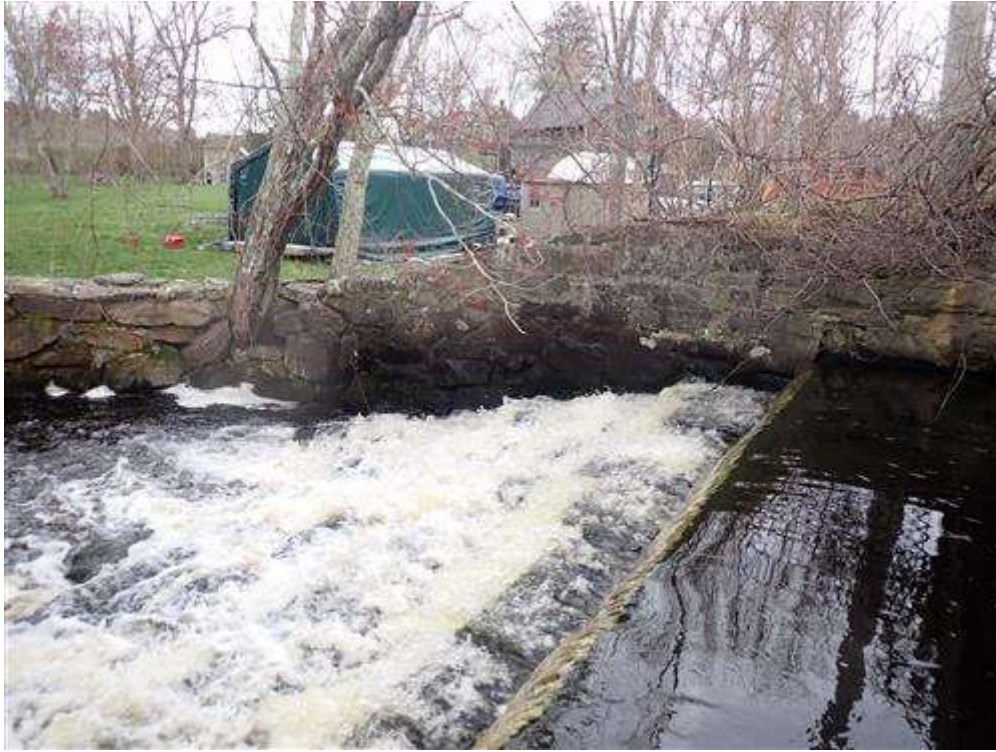
Photo Number: 43

Wingwall 1B and Southwest Retaining Wall

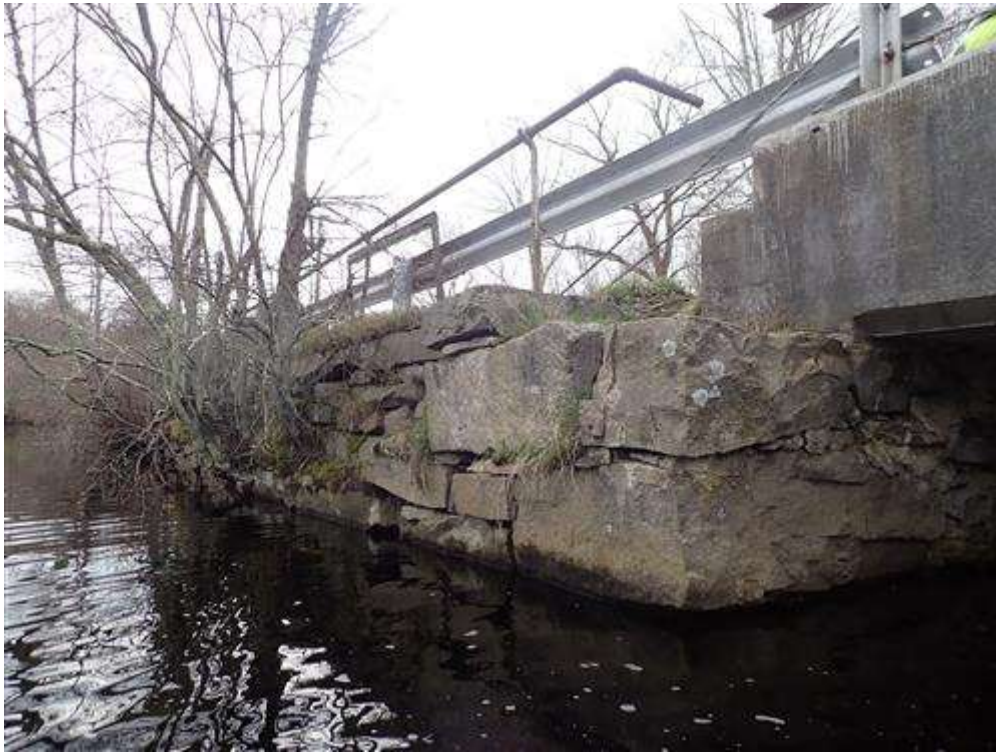
Photo Number: 45

Wingwall 2A and Northeast Retaining Wall

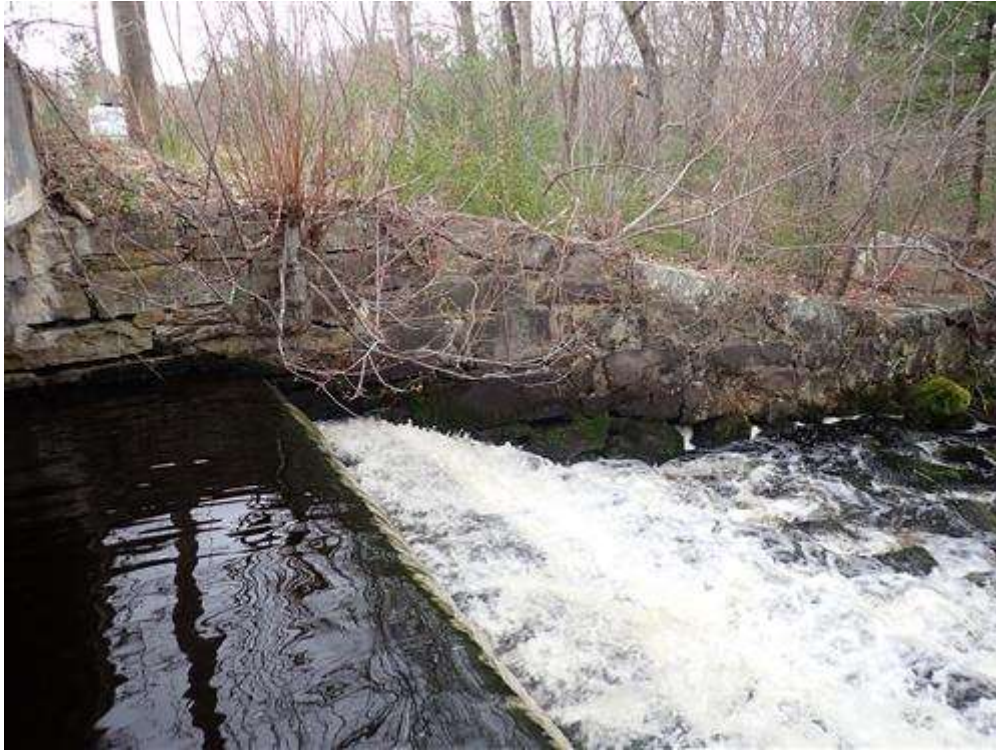
Photo Number: 47

Wingwall 2B and Southeast Retaining Wall

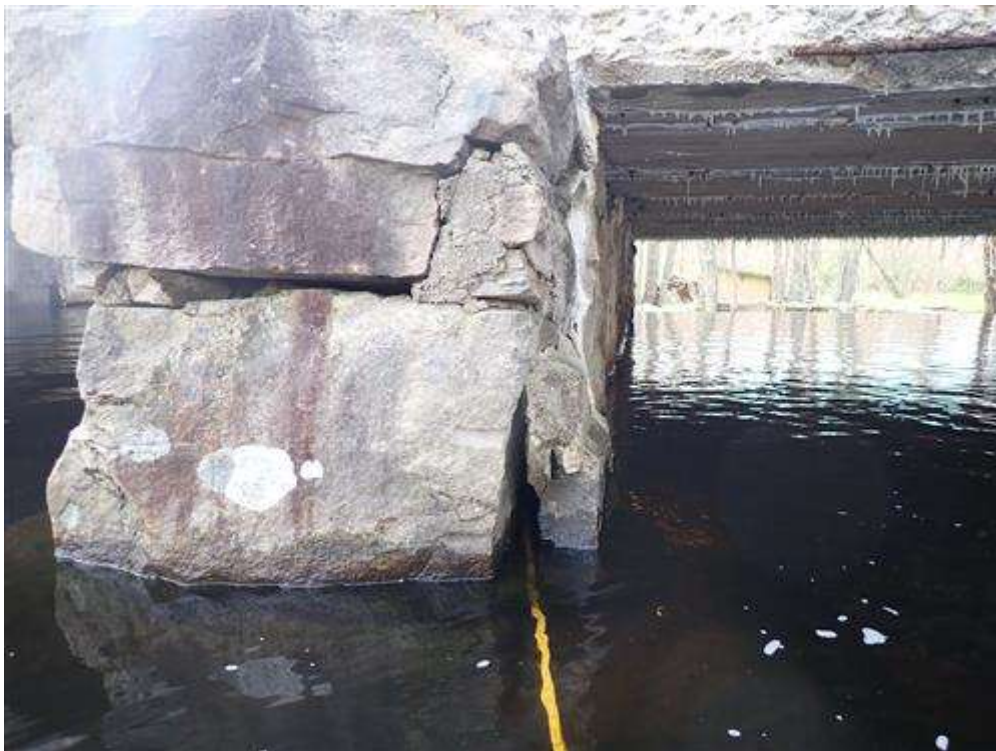
Photo Number: 50

Pier 1 West at Left (North) End

Note: Full depth void.

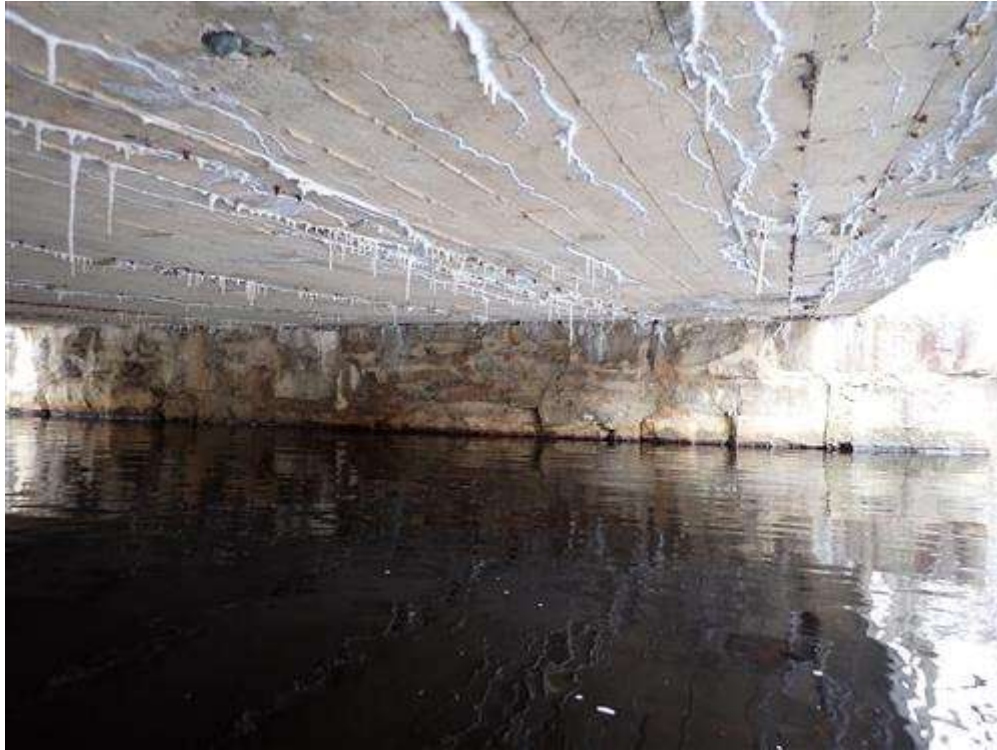
Photo Number: 51

Pier 1 East Face

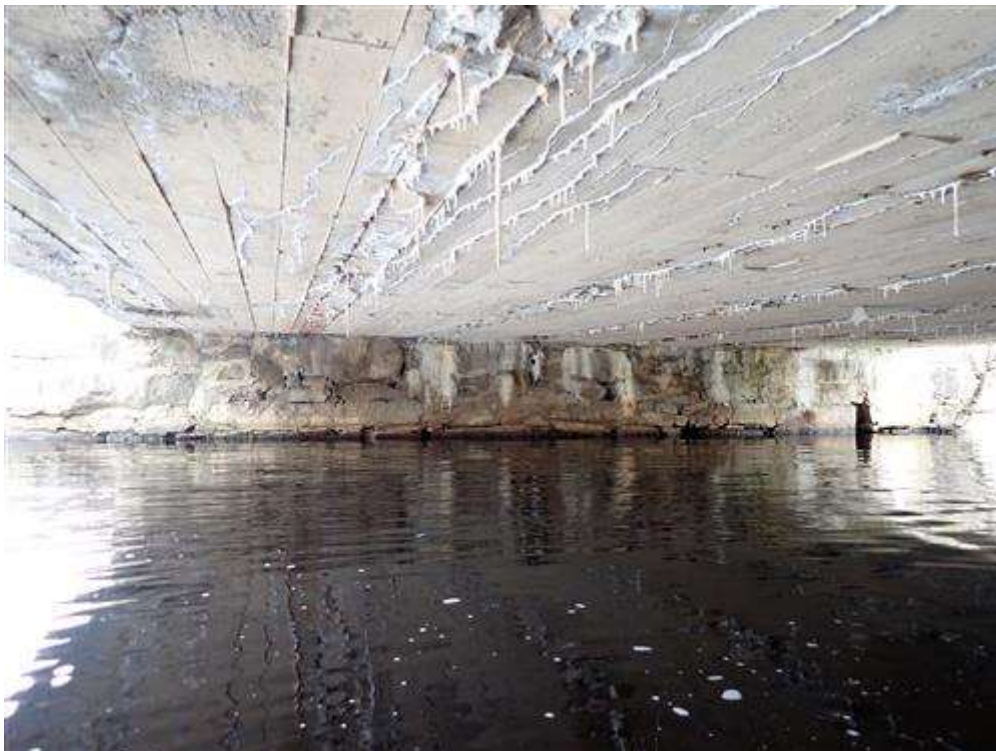
Photo Number: 54

Pier 1 East at Right (South) End

Note: Void with full depth penetration.

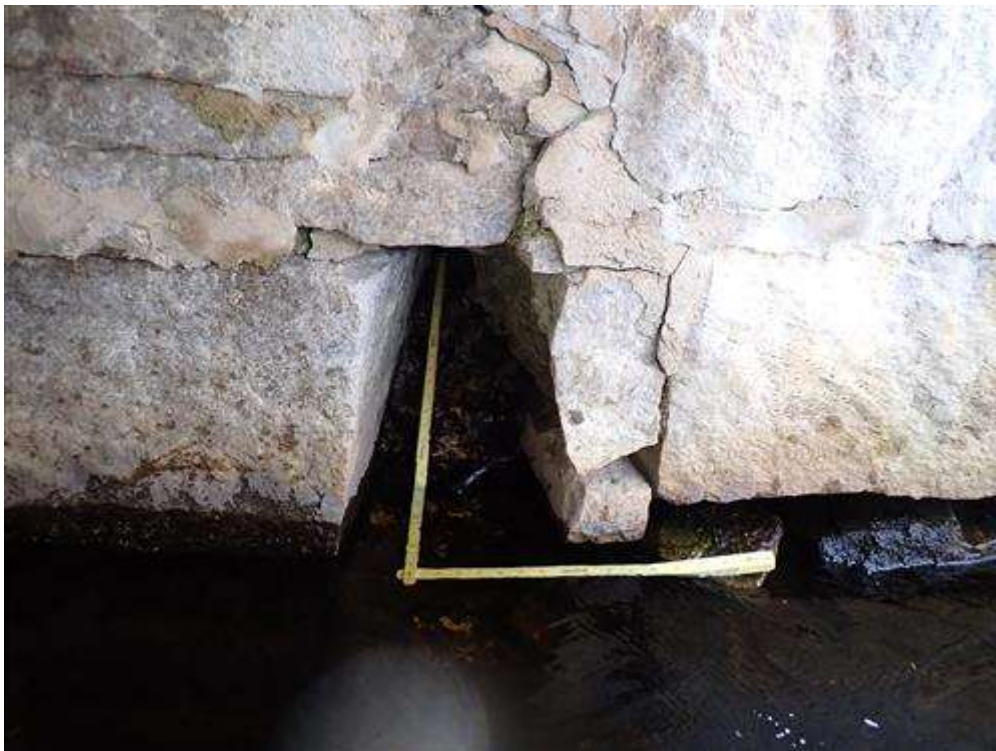
Photo Number: 56

Pier 2 West Left (North) End - Underwater

Note: Mortar loss with penetration.

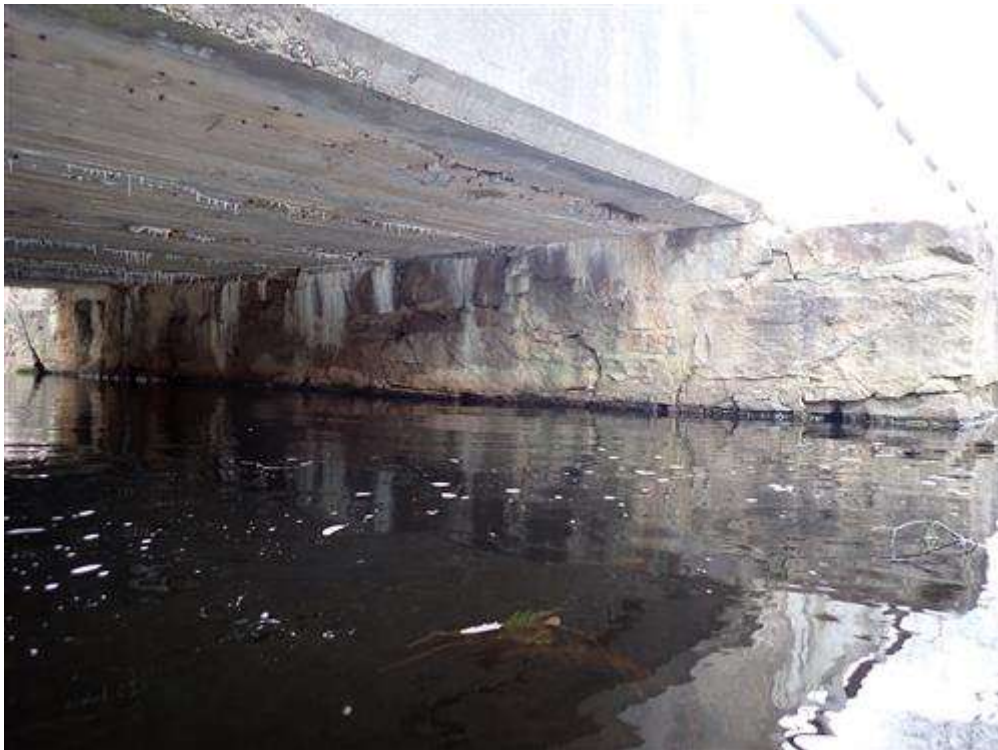
Photo Number: 58

Pier 2 West Downstream Vegetation Growing From Stone

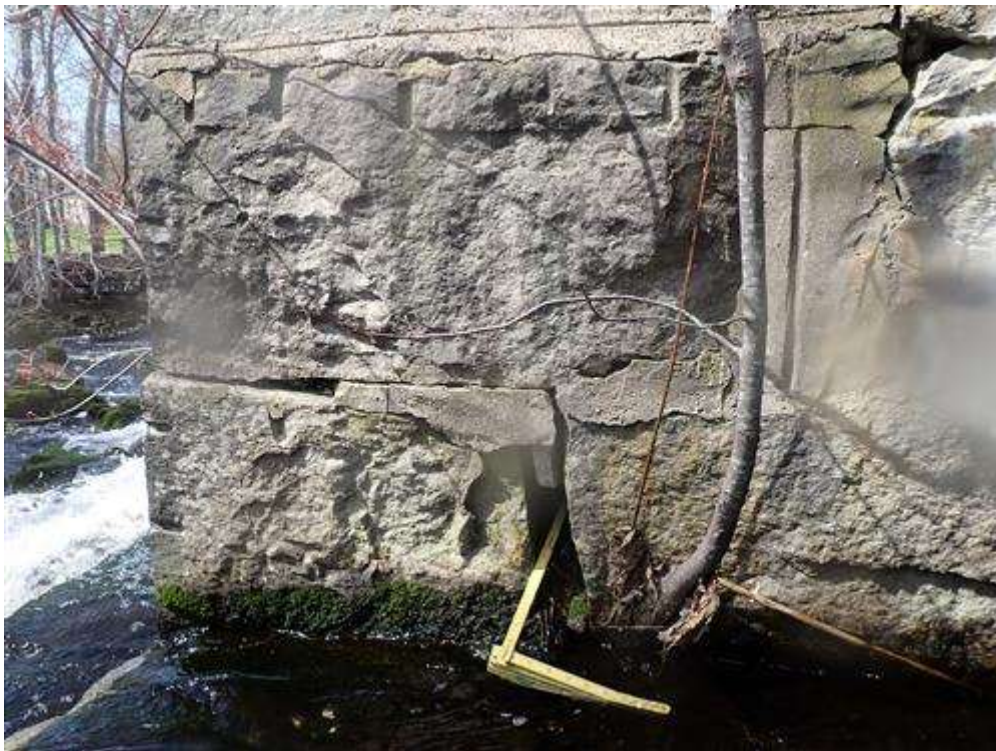
Photo Number: 60

Pier 2 East near Centerline

Note: Hole with penetration; cracks in mortar; efflorescence.

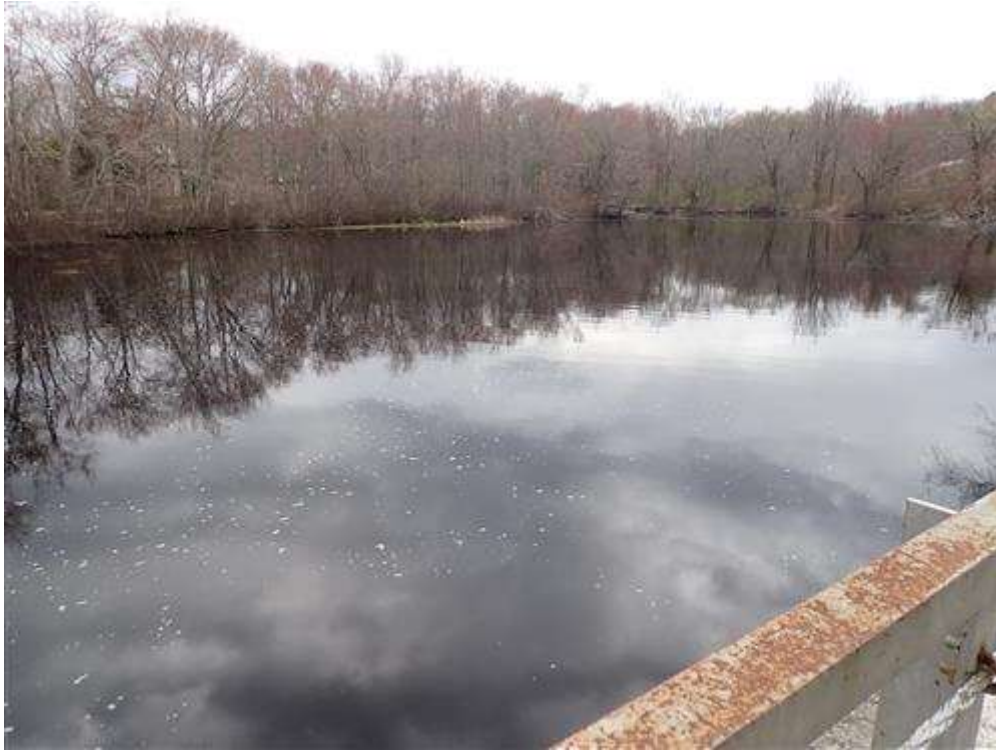
Photo Number: 61

Channel Looking Upstream (Northeast) from the Bridge

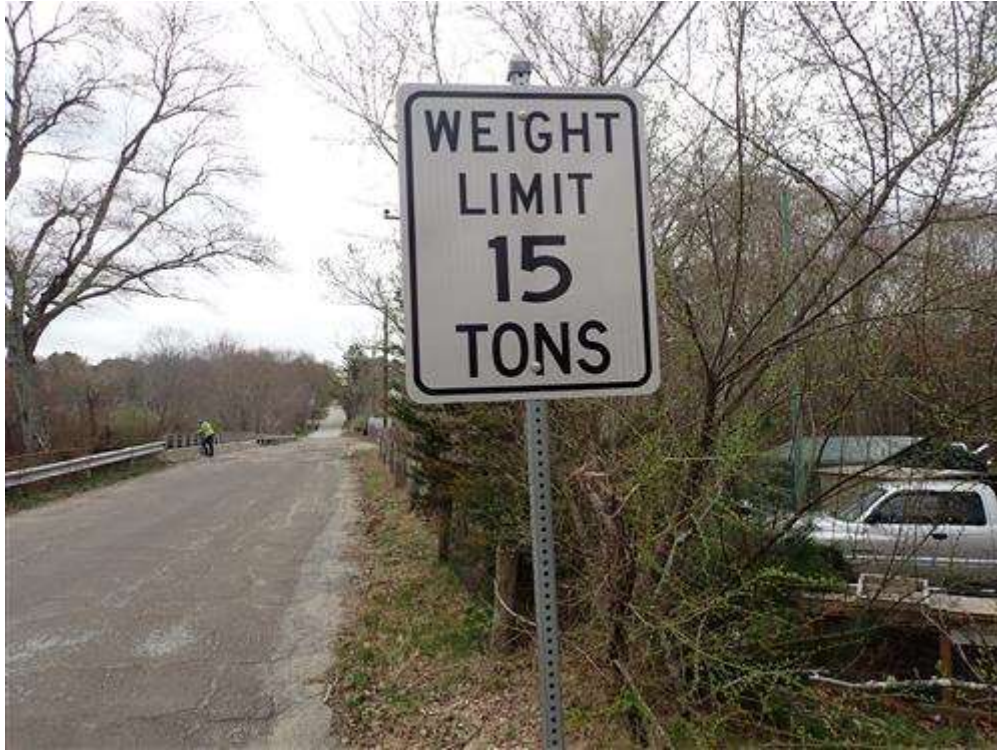
Photo Number: 63

West Approach - Load Posting - 15 Tons
